2023 Data Report for West Maggie Lake, Iron County

Site ID: 360172

West Maggie Lake, Iron County 2023 CLMP Results

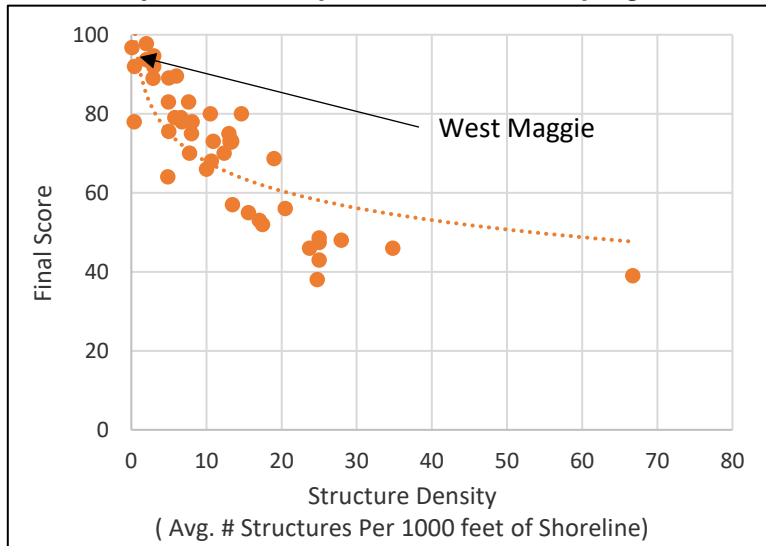
How does your lake compare to others in the program?

West Maggie Lake:	
Number of Sections:	8
Number of Structures:	25
Structure Density:	3.1
Final Score:	95

All 42 Participating Lakes from 2015-2018:	
Avg. Number of Sections:	16.3
Avg. Number of Structures:	248.5
Avg. Structure Density:	15.2
Avg. Final Score:	70.5

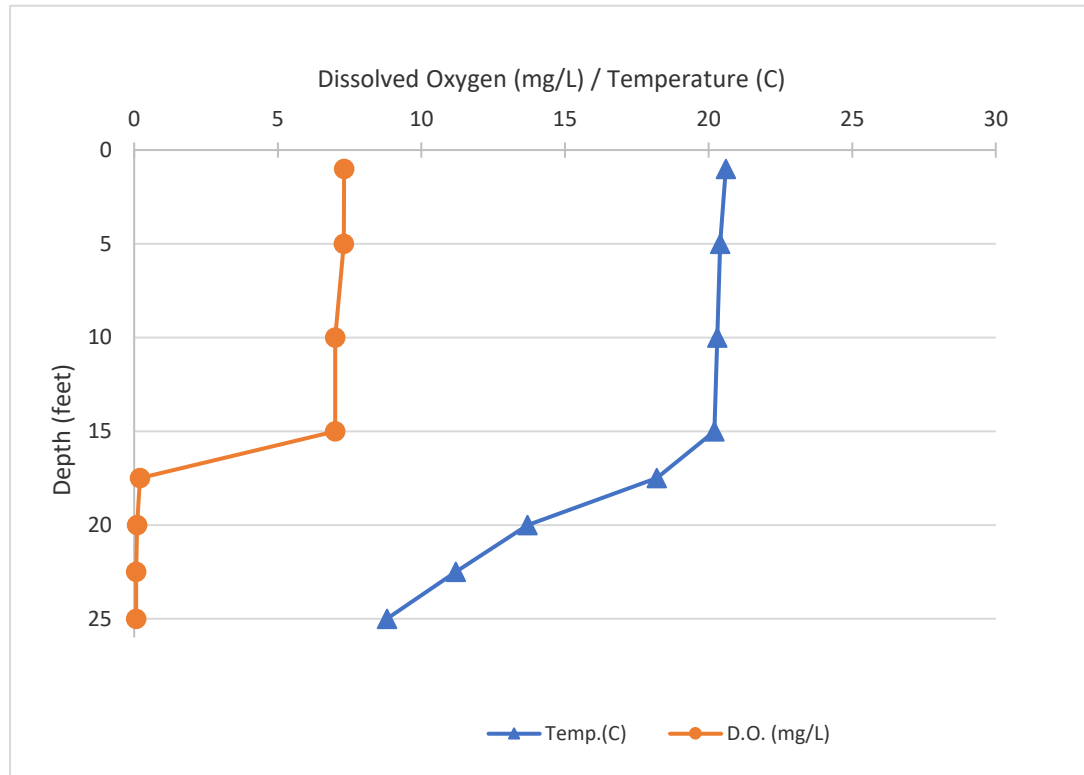
9/11/2016

Depth (ft)	Temp.(C)	D.O. (mg/L)
1	20.6	7.31
5	20.4	7.3
10	20.3	7
15	20.2	7
17.5	18.2	0.2
20	13.7	0.1
22.5	11.2	0.07
25	8.8	0.07
