2023 Data Report for

O'Rourke Lake, Otsego County

Site ID: 690168

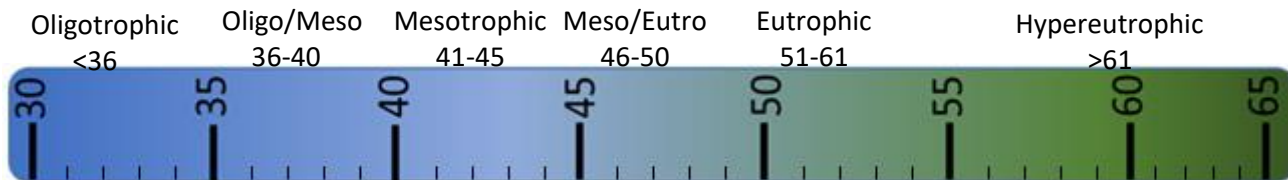
TSI for O'Rourke Lake in 2023	
Average	31
Secchi Disk	37
Summer TP	27
Chlorophyll-a	31

^ Average

^ Secchi Transparency

^ Total Phosphorus

^ Chlorophyll-a

With an average TSI score of 31 based on 2023 Secchi transparency, chlorophyll-a, and summer total phosphorus data, this lake is rated as oligotrophic.

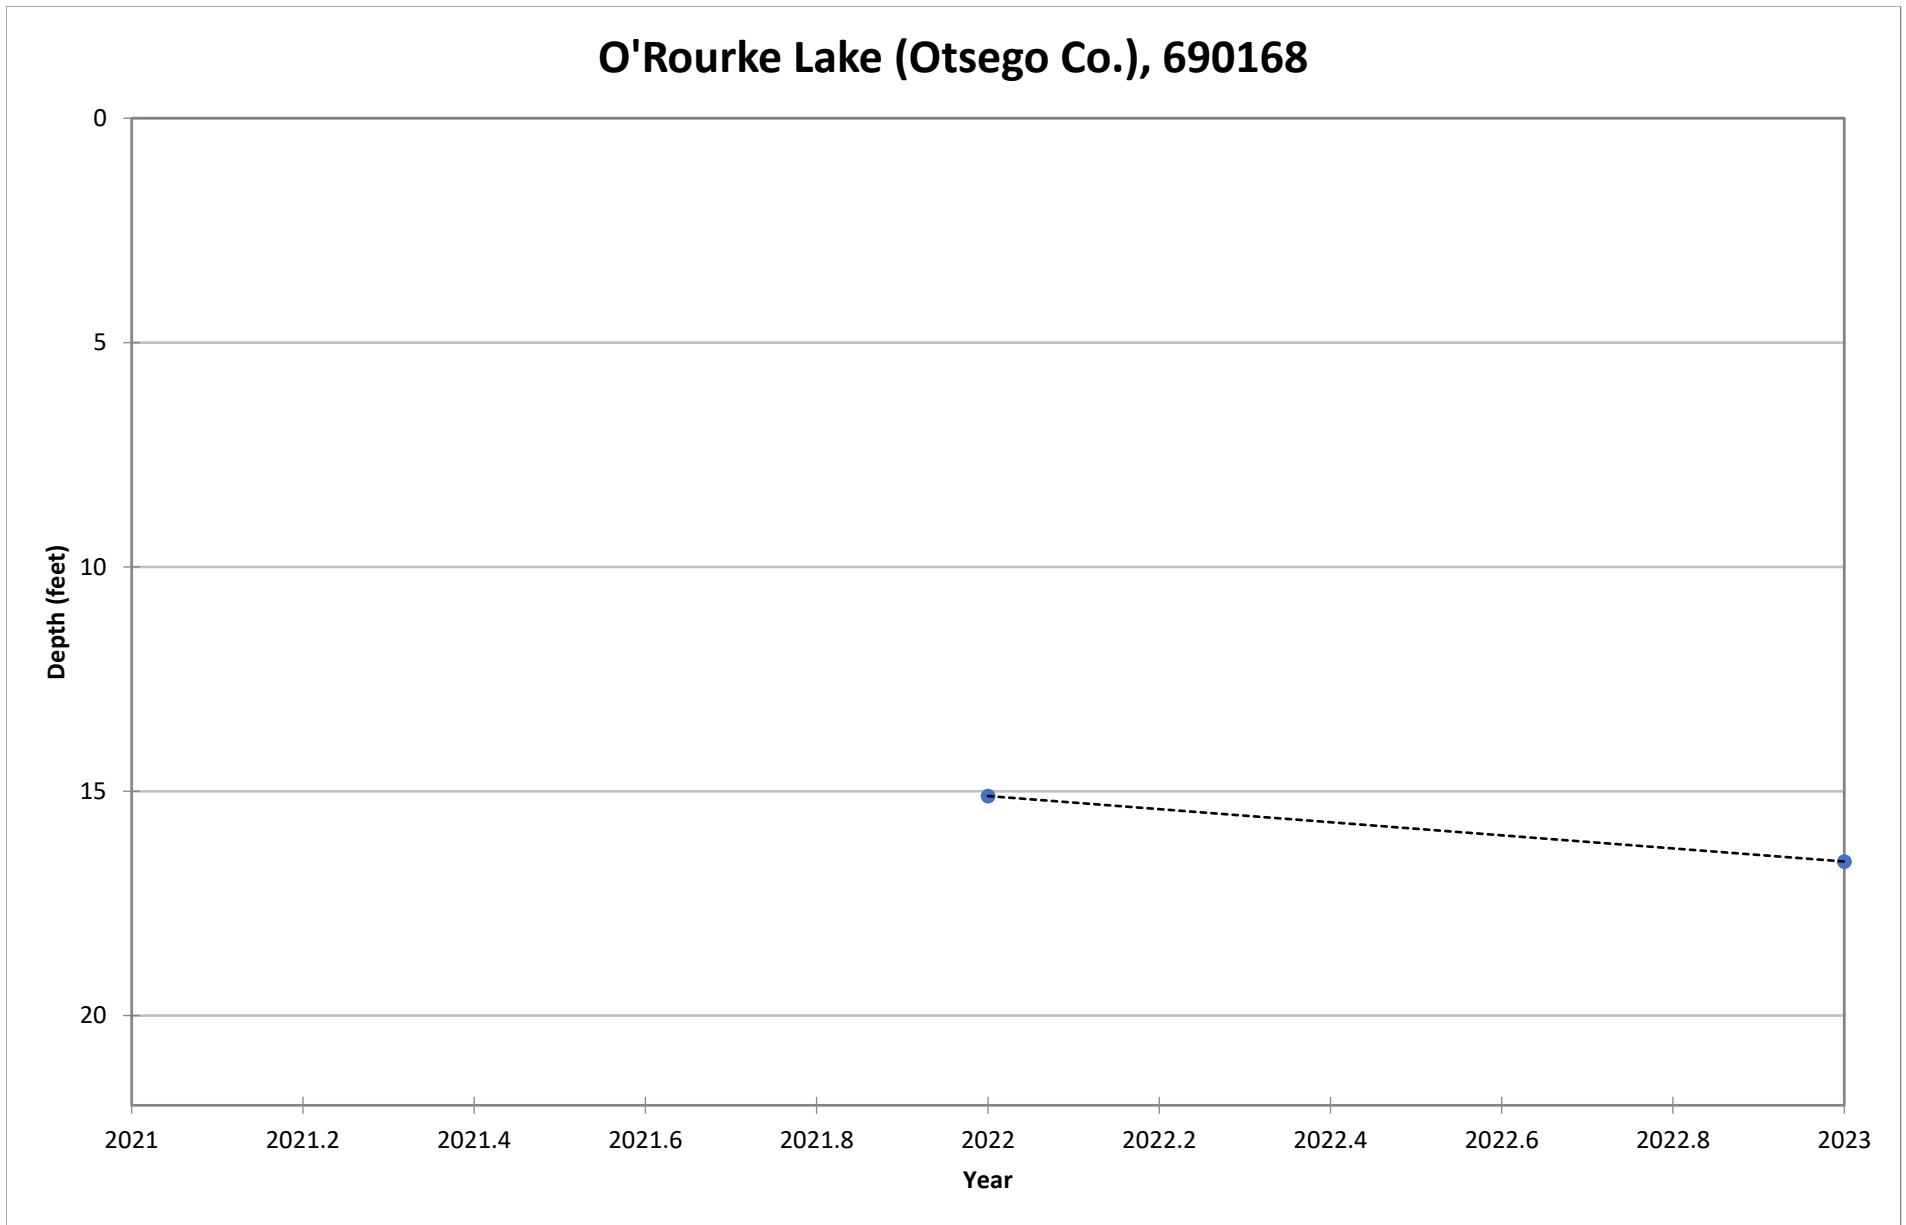
COOPERATIVE LAKES MONITORING PROGRAM
SUMMER MEAN TRANSPARENCY

O'Rourke Lake (Otsego Co.), 690168

Vertical bars indicate standard deviation

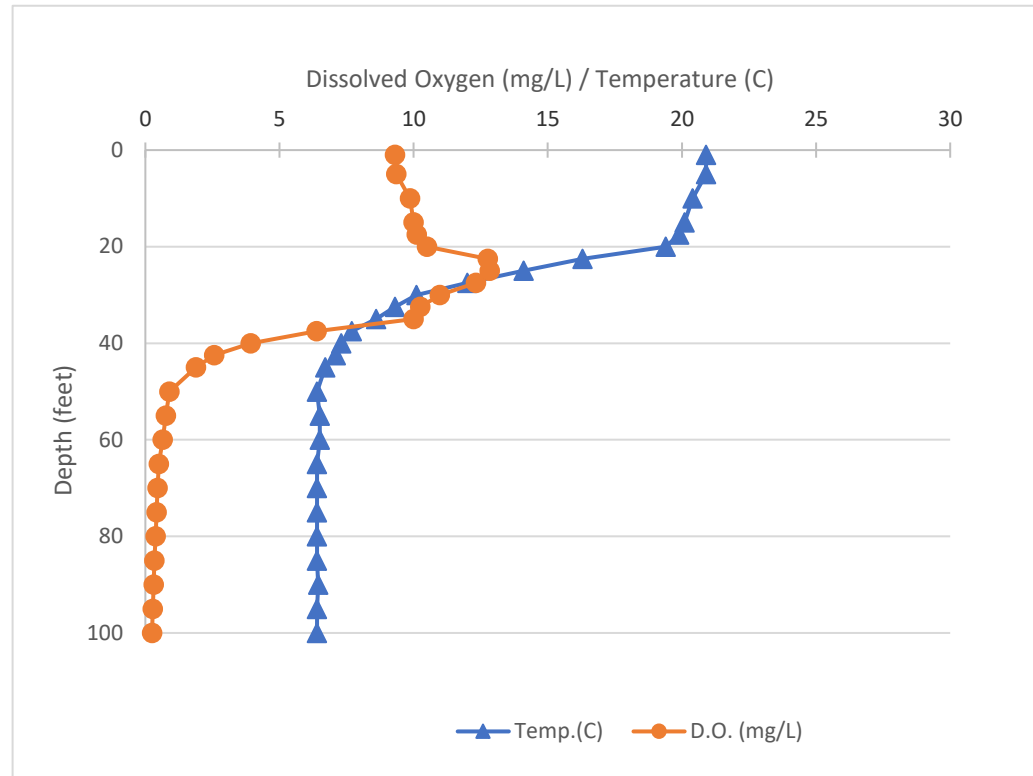
Name: O'Rourke Lake
 County: Otsego
 Site ID: 690168
 Date: 9/4/2023

Dissolved Oxygen and Temperature Profile

Depth (ft)	Temp.(C)	D.O. (mg/L)
1	20.9	9.3
5	20.9	9.35
10	20.4	9.87
15	20.1	10
17.5	19.9	10.12
20	19.4	10.5
22.5	16.3	12.76
25	14.1	12.84
27.5	12	12.32
30	10.1	10.97
32.5	9.3	10.25
35	8.6	10
37.5	7.7	6.38
40	7.3	3.93
42.5	7.1	2.56
45	6.7	1.89
50	6.4	0.9
55	6.5	0.77
60	6.5	0.65
65	6.4	0.5
70	6.4	0.46
75	6.4	0.42
80	6.4	0.38
85	6.4	0.34
90	6.44	0.31
95	6.4	0.27
100	6.4	0.25
