2023 Data Report for

Pickerel Lake, Newaygo County

Site ID: 620066

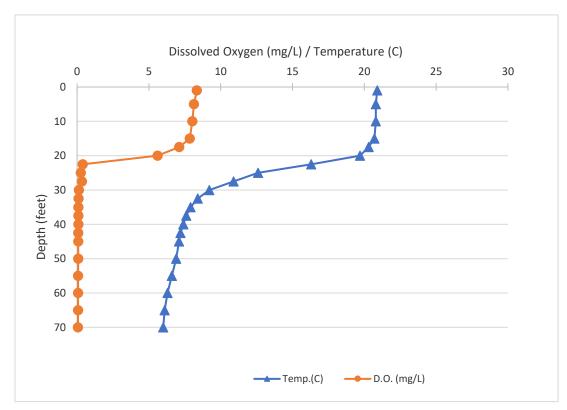
Name: Pickerel Lake County: Newaygo Site ID: 620066 Date: 9/16/2023

Depth (ft)	Temp.(C)	D.O. (mg/L)
1	20.9	8.34
5	20.8	8.14
10	20.8	8.03
15	20.7	7.85
17.5	20.3	7.11
20	19.7	5.61
22.5	16.3	0.39
25	12.6	0.26
27.5	10.9	0.34
30	9.2	0.13
32.5	8.4	0.1
35	7.9	0.09
37.5	7.6	0.09
40	7.4	0.09
42.5	7.2	0.08
45	7.1	0.08
50	6.9	0.08
55	6.6	0.07
60	6.3	0.07
65	6.1	0.07
70	6	0.06
