# 2023 Data Report for

# Scram Lake, Kent County

Site ID: 410728

# Scram Lake, Kent County 2023 CLMP Results

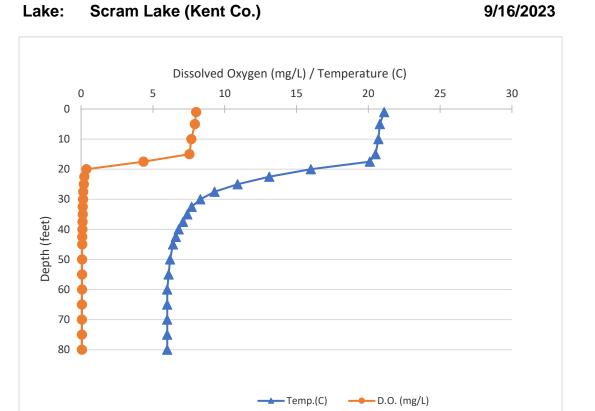
Name:Scram LakeCounty:KentSite ID:410728Date:9/16/2023

#### **Dissolved Oxygen and Temperature Profile**

Depth (ft)	Temp.(C)	D.O. (mg/L)
1	21.1	8.01
5	20.8	7.92
10	20.7	7.68
15	20.5	7.54
17.5	20.1	4.35
20	16	0.37
22.5	13.1	0.23
25	10.9	0.19
27.5	9.3	0.15
30	8.3	0.14
32.5	7.7	0.11
35	7.4	0.11
37.5	7.1	0.1
40	6.8	0.09
42.5	6.6	0.08
45	6.4	0.08
50	6.2	0.07
55	6.1	0.07
60	6	0.07
65	6	0.06
70	6	0.06
75	6	0.06
80	6	0.06
