2023 Data Report for Stony Lake, Oceana County

Site ID: 640049

Stony Lake, Oceana County 2023 CLMP Results

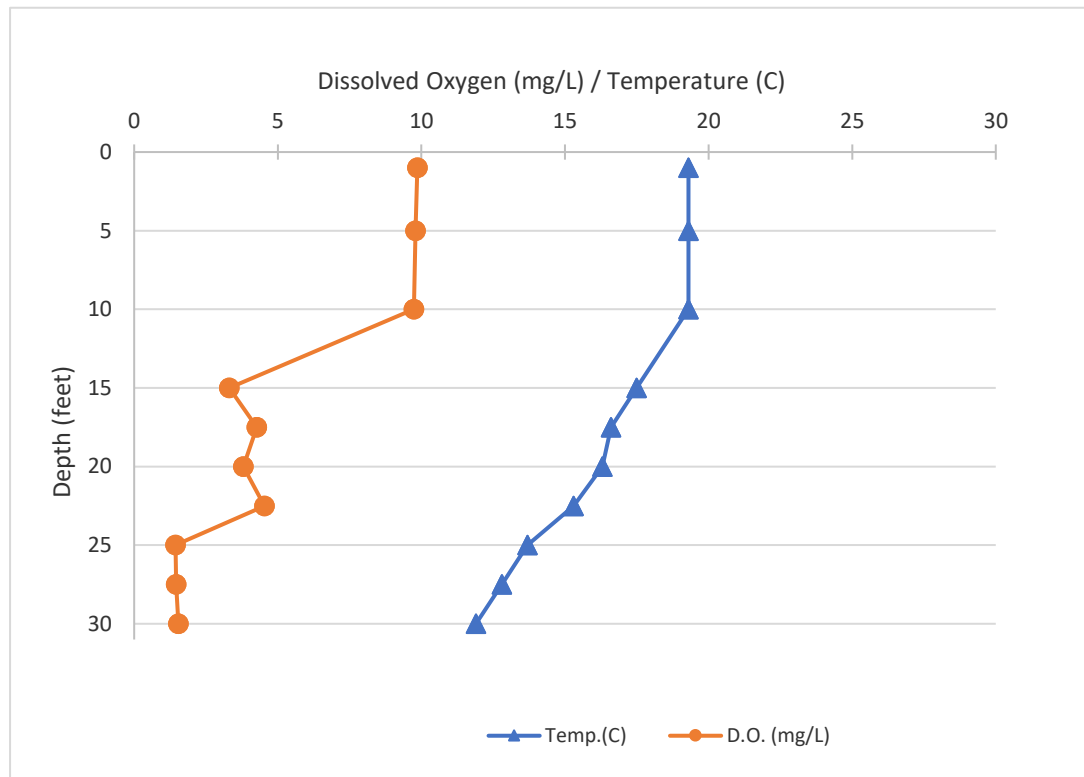
9/16/2023

Dissolved Oxygen and Temperature Profile

Depth (ft)	Temp.(C)	D.O. (mg/L)
1	19.3	9.86
1	19.3	9.86
5	19.3	9.8
5	19.3	9.8
10	19.3	9.74
10	19.3	9.74
15	17.5	3.31
15	17.5	3.31
17.5	16.6	4.27
17.5	16.6	4.27
20	16.3	3.8
20	16.3	3.8
22.5	15.3	4.54
22.5	15.3	4.54
25	13.7	1.44
25	13.7	1.44
27.5	12.8	1.46
27.5	12.8	1.46
30	11.9	1.54
30	11.9	1.54
