# 2023 Data Report for

# Van Etten Lake, Iosco County

Site ID: 350201

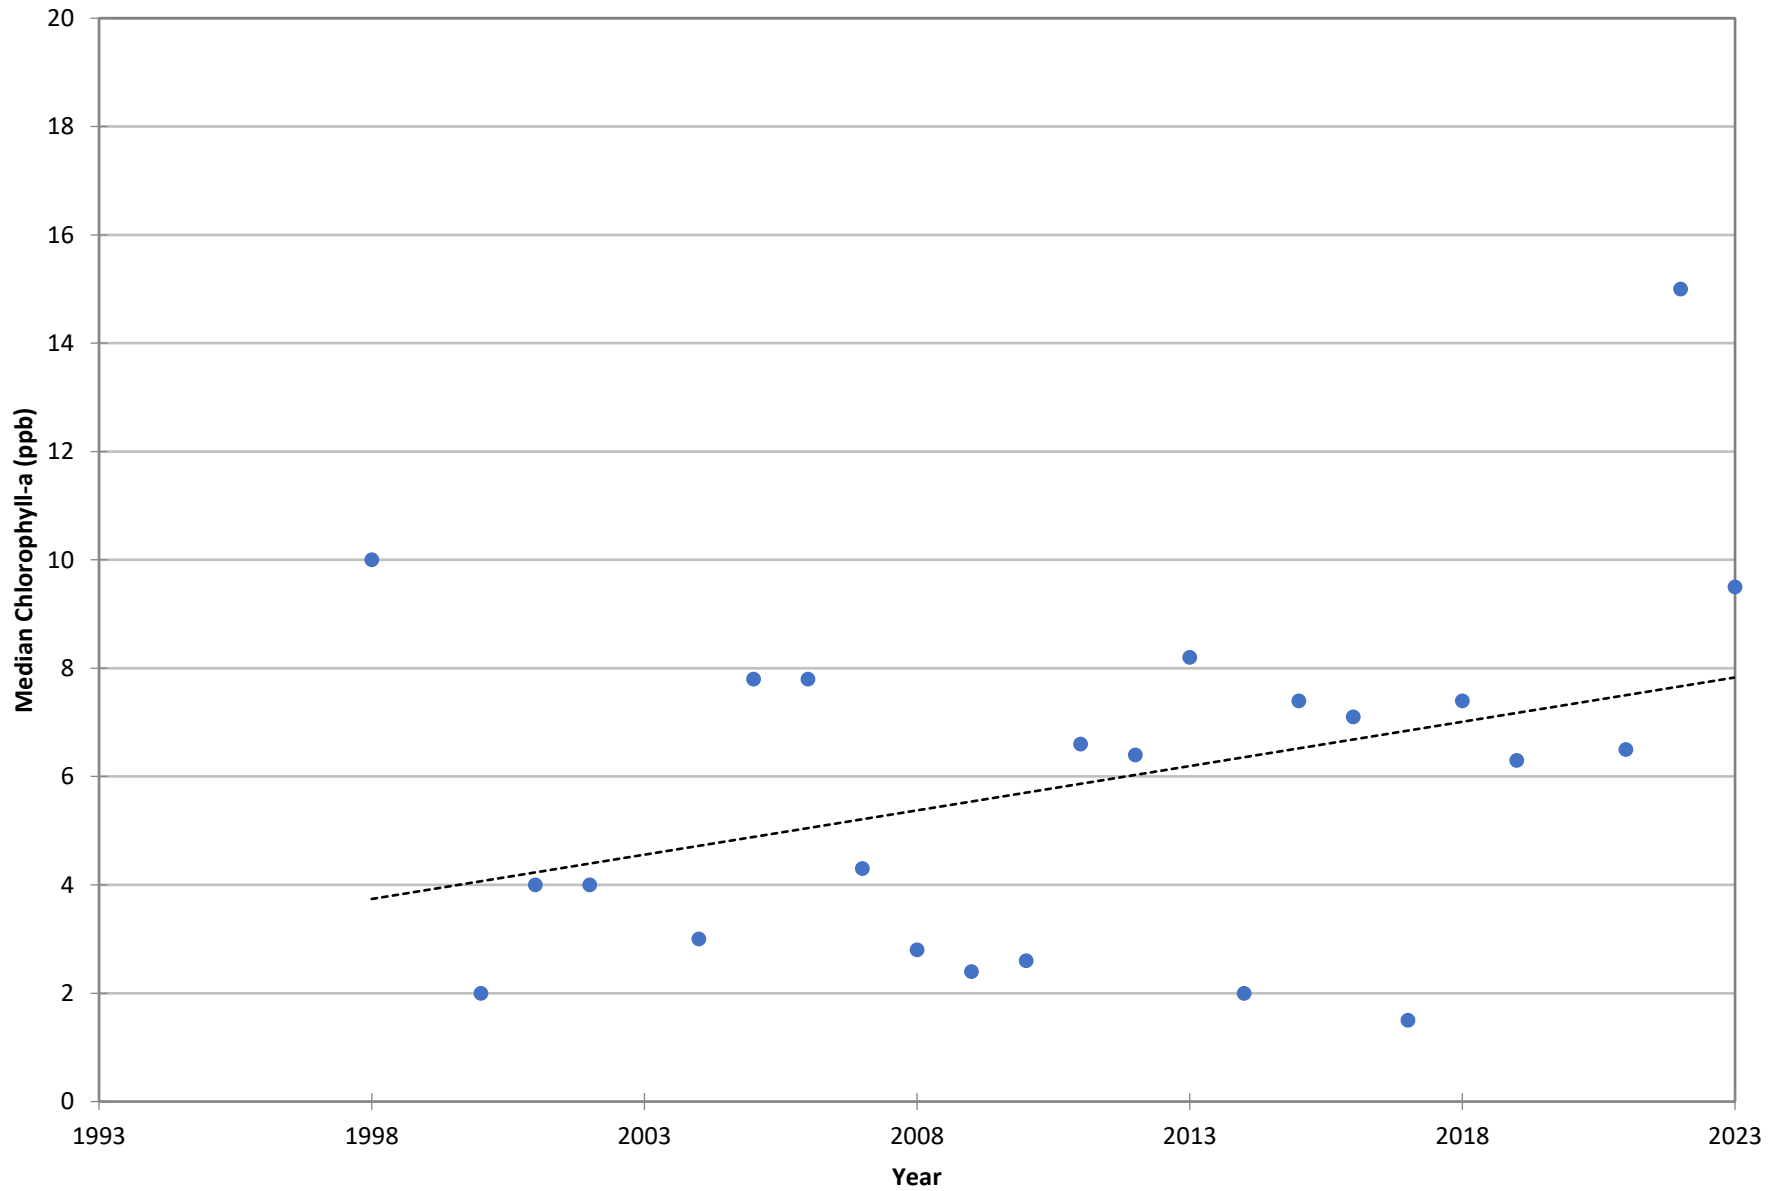
**Van Etten Lake (Iosco Co.), 350201**

COOPERATIVE LAKES MONITORING PROGRAM  
SUMMER MEDIAN CHLOROPHYLL-A
