# **2023 Data Report for Birch Lake, Cass County**

Site ID: 140187

# Birch Lake, Cass County 2023 CLMP Results

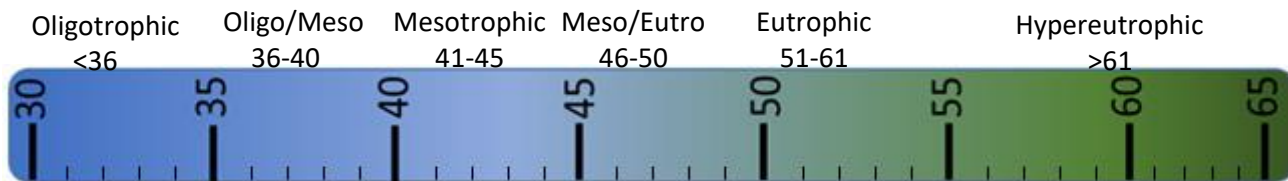
TSI for Birch Lake in 2023	
Average	38
Secchi Disk	38
Summer TP	39
Chlorophyll-a	38

- ^ Average
- ^ Secchi Transparency
- ^ Total Phosphorus
- ^ Chlorophyll-a

With an average TSI score of 38 based on 2023 Secchi transparency, chlorophyll-a, and summer total phosphorus data, this lake is rated between the oligotrophic and mesotrophic classification.

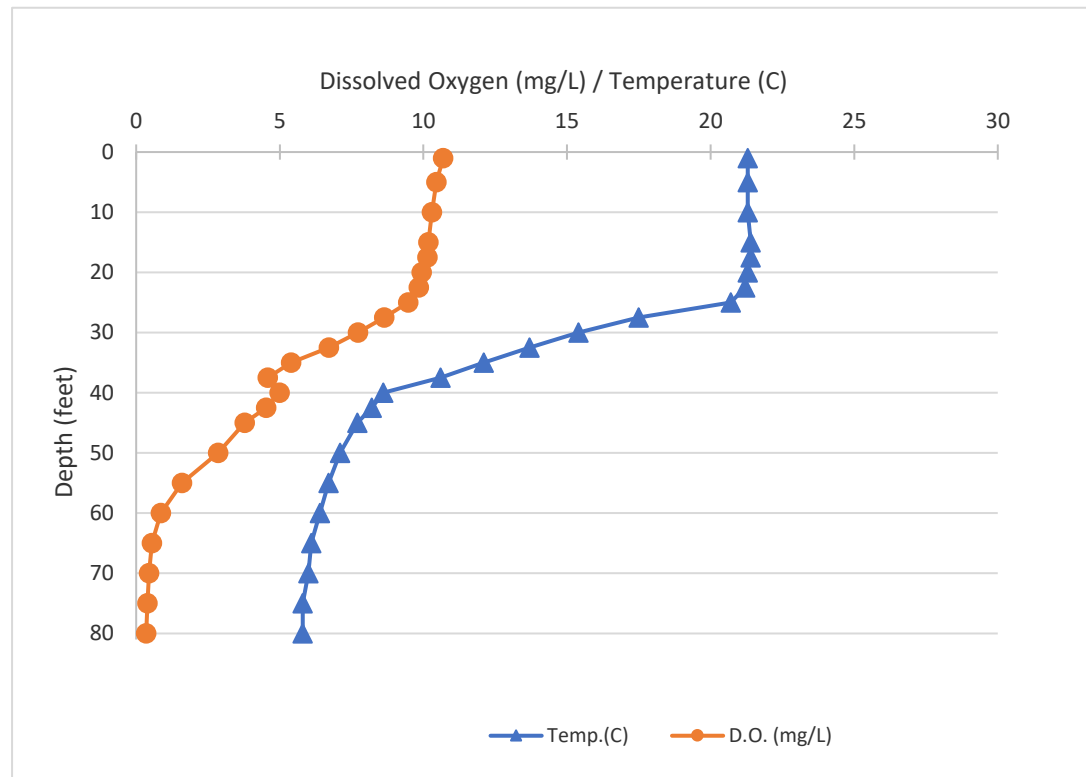
9/23/2023

Depth (ft)	Temp.(C)	D.O. (mg/L)
1	21.3	10.69
5	21.3	10.45
10	21.3	10.3
15	21.4	10.17
17.5	21.4	10.14
20	21.3	9.94
22.5	21.2	9.84
25	20.7	9.47
27.5	17.5	8.64
30	15.4	7.72
32.5	13.7	6.71
35	12.1	5.4
37.5	10.6	4.58
40	8.6	4.99
42.5	8.2	4.53
45	7.7	3.78
50	7.1	2.85
55	6.7	1.6
60	6.4	0.86
65	6.1	0.55
70	6	0.45
75	5.8	0.39
80	5.8	0.35

The lake keeps some dissolved oxygen in the bottom waters through mid-summer, but by late summer the lake has stratified and the bottom water is devoid of oxygen.
