2023 Data Report for Juno Lake, Cass County

Site ID: 140058

Juno Lake, Cass County 2023 CLMP Results

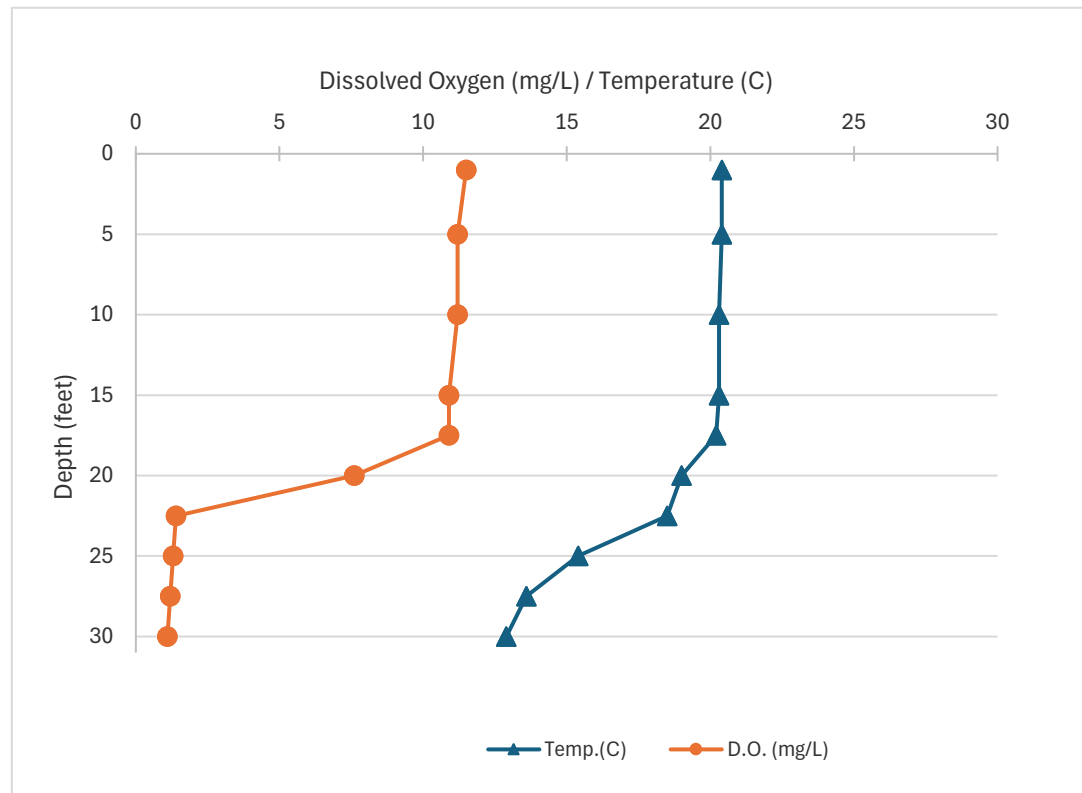
Dissolved Oxygen and Temperature Profile

Depth (ft)	Temp.(C)	D.O. (mg/L)
1	20.4	11.5
1	20.4	11.5
5	20.4	11.2
5	20.4	11.2
10	20.3	11.2
10	20.3	11.2
15	20.3	10.9
15	20.3	10.9
17.5	20.2	10.9
17.5	20.2	10.9
20	19	7.6
20	19	7.6
22.5	18.5	1.4
22.5	18.5	1.4
25	15.4	1.3
25	15.4	1.3
27.5	13.6	1.2
27.5	13.6	1.2
30	12.9	1.1
30	12.9	1.1
