2023 Data Report for Little Bass Lake, Lake County

Site ID: 430640

Little Bass Lake, Lake County 2023 CLMP Results

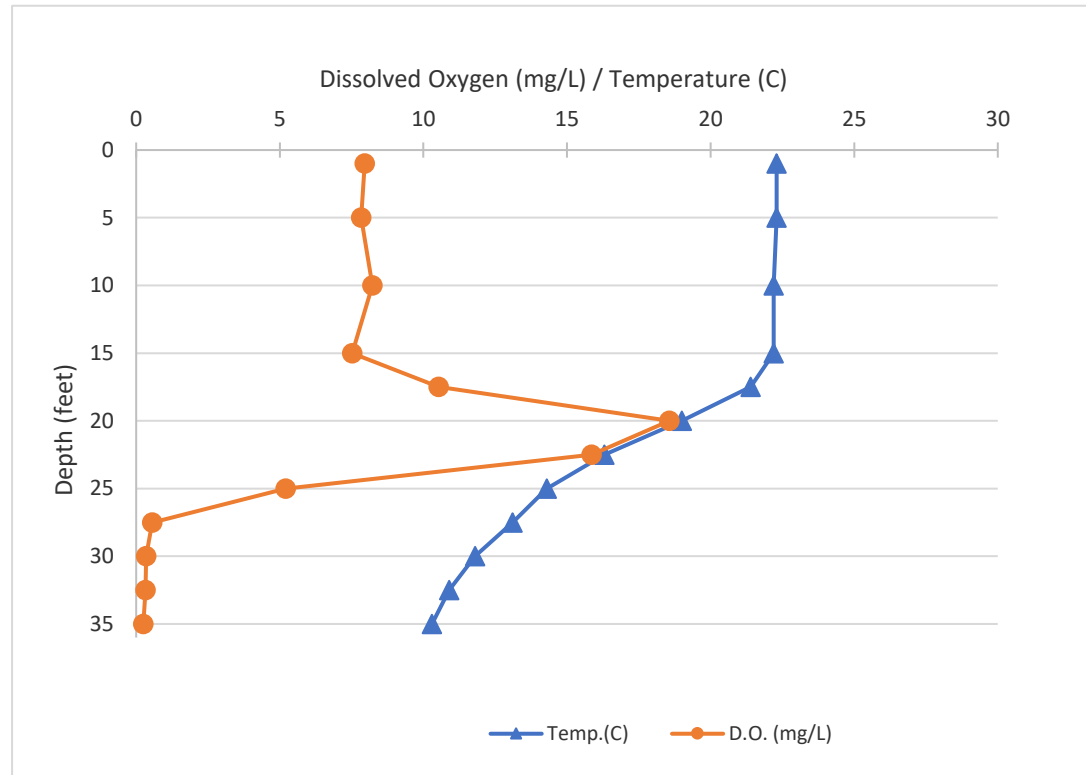
9/8/2023

Depth (ft)	Temp.(C)	D.O. (mg/L)
1	22.3	7.96
5	22.3	7.84
10	22.2	8.23
15	22.2	7.52
17.5	21.4	10.53
20	19	18.57
22.5	16.3	15.86
25	14.3	5.21
27.5	13.1	0.56
30	11.8	0.35
32.5	10.9	0.32
35	10.3	0.25
