2023 Data Report for

Lower Hamlin Lake, Mason County

Site ID: 530073

Lower Hamlin Lake, Mason County 2023 CLMP Results

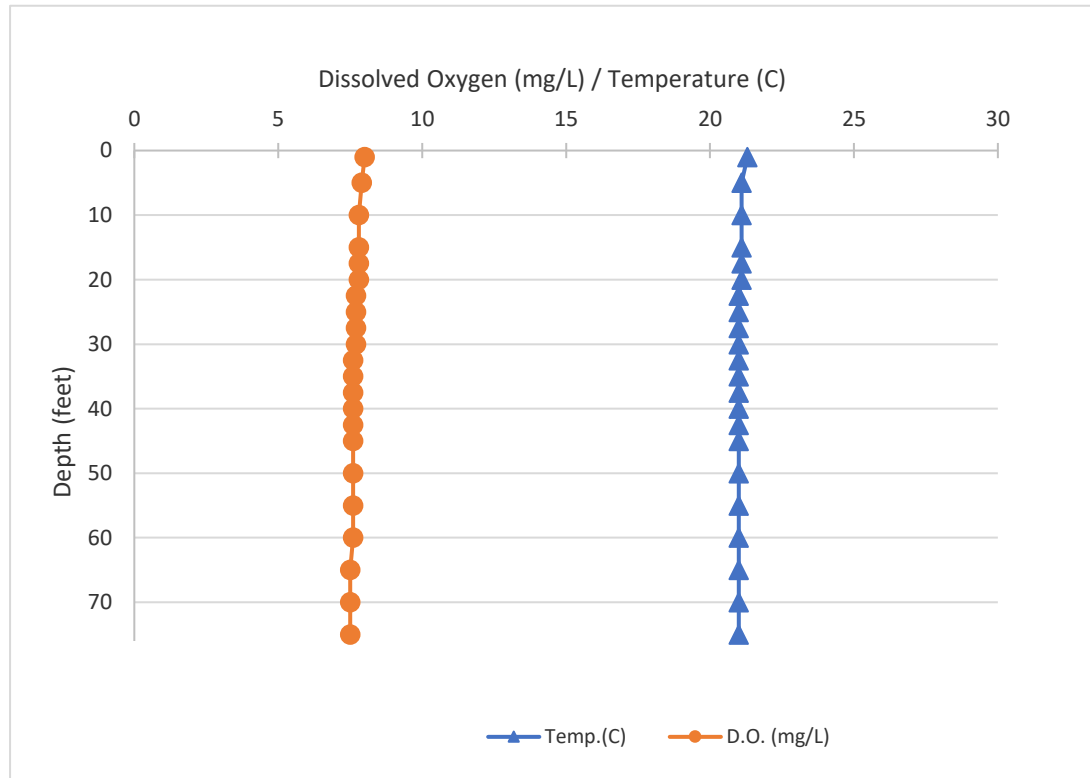
9/15/2023

Dissolved Oxygen and Temperature Profile

Depth (ft)	Temp.(C)	D.O. (mg/L)
1	21.3	8
5	21.1	7.9
10	21.1	7.8
15	21.1	7.8
17.5	21.1	7.8
20	21.1	7.8
22.5	21	7.7
25	21	7.7
27.5	21	7.7
30	21	7.7
32.5	21	7.6
35	21	7.6
37.5	21	7.6
40	21	7.6
42.5	21	7.6
45	21	7.6
50	21	7.6
55	21	7.6
60	21	7.6
65	21	7.5
70	21	7.5
75	21	7.5
