2023 Data Report for

Perch Lake, Otsego County

Site ID: 690150

Perch Lake, Otsego County 2023 CLMP Results

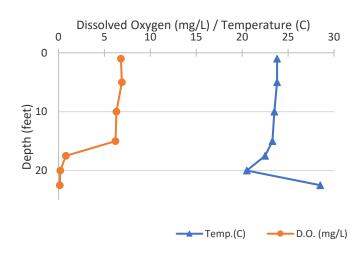
Dissolved Oxygen and Temperature Profile

The lake keeps some dissolved oxygen in the bottom waters through mid-summer, but by late summer the lake has stratified and the bottom water is devoid of oxygen.

If you enrolled in Dissolved Oxygen/Temperature, the summary page will have a graph of one of the profiles taken during the late summer (typically August or September). If your lake stratifies, we will use a graph showing the earliest time of stratification, because identifying the timing of this condition and the depth at which it occurs is typically the most important use of dissolved oxygen measurements.

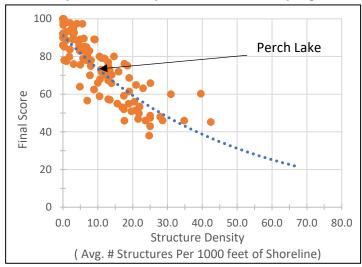
How does your lake compare to others in the program?

Overall, the lakeshore habitat of Perch Lake scored about average when compared to other lakes in the program with similar amount of development. All of the 1000 foot sections scored either Fair or Good (7 fair and 3 good).

Note about graph to the left: The dotted line sets your average expectation of the score of your lake. If your lake is lower than the dotted line, then your shoreline health is lower than average compared to *lakes with similar amount of shoreline development*. And vice-versa in regards to a lake above the dotted line.

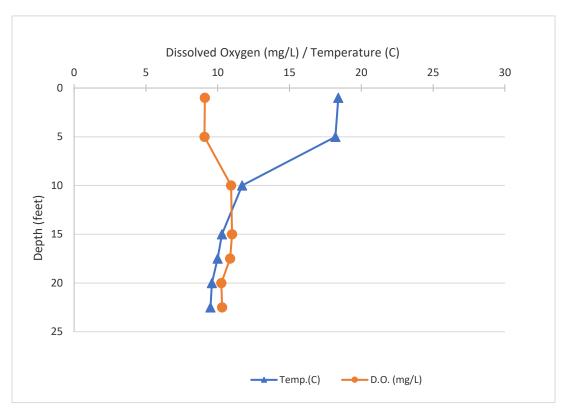
Name: Perch Lake County: Otsego Site ID: 690150 Date: 5/13/2023

Depth (ft)	Temp.(C)	D.O. (mg/L)
1	18.4	9.1
5	18.2	9.08
10	11.7	10.93
15	10.3	11
17.5	10	10.87
20	9.6	10.25
22.5	9.5	10.31

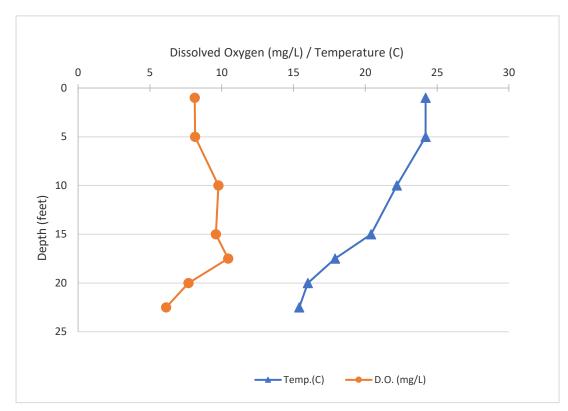
Dissolved Oxygen and Temperature Profile

Name: Perch Lake
County: Otsego
Site ID: 690150
Date: 6/25/2023

Depth (ft)	Temp.(C)	D.O. (mg/L)
1	24.2	8.13
5	24.2	8.15
10	22.2	9.77
15	20.4	9.59
17.5	17.9	10.45
20	16	7.69
22.5	15.4	6.13

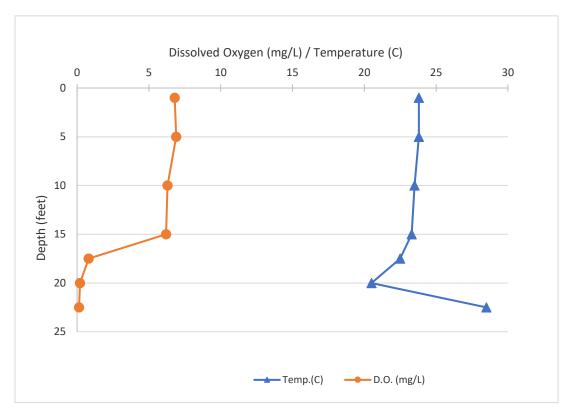
Name: Perch Lake
County: Otsego
Site ID: 690150
Date: 8/11/2023

Depth (ft)	Temp.(C)	D.O. (mg/L)
1	23.8	6.8
5	23.8	6.9
10	23.5	6.3
15	23.3	6.2
17.5	22.5	0.8
20	20.5	0.2
22.5	28.5	0.14

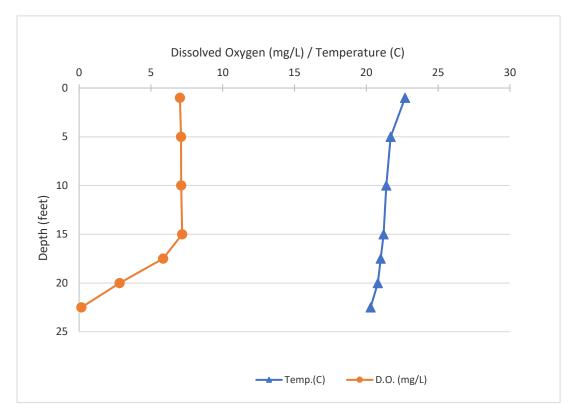
Dissolved Oxygen and Temperature Profile

Name: Perch Lake County: Otsego Site ID: 690150 Date: 8/28/2023

Depth (ft)	Temp.(C)	D.O. (mg/L)
1	22.7	7.02
5	21.7	7.1
10	21.4	7.11
15	21.2	7.18
17.5	21	5.85
20	20.8	3 2.82
22.5	20.3	0.16

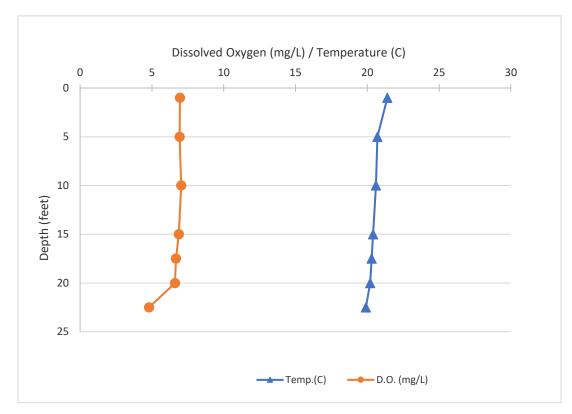
Dissolved Oxygen and Temperature Profile

Name: Perch Lake
County: Otsego
Site ID: 690150
Date: 9/1/2023

Depth (ft)	Temp.(C)	D.O. (mg/L)
1	21.4	6.95
5	20.7	6.93
10	20.6	7.04
15	20.4	6.88
17.5	20.3	6.68
20	20.2	6.61
22.5	19.9	4.8
