# 2023 Data Report for

# Rose Lake, Shiawassee County

Site ID: 780276

# Rose Lake, Shiawassee County 2023 CLMP Results

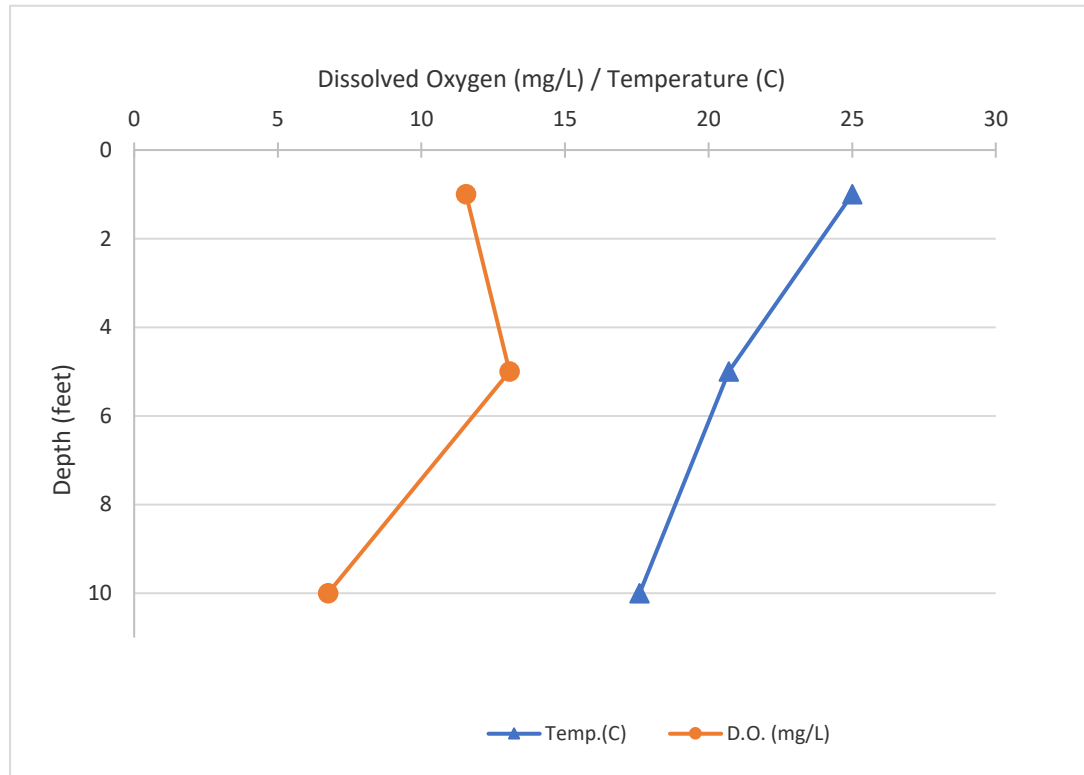
9/5/2023

Depth (ft)	Temp.(C)	D.O. (mg/L)
1	25	11.56
5	20.7	13.07
10	17.6	6.75
