# 2023 Data Report for

# Spider Lake, Grand Traverse County

Site ID: 280395

# Spider Lake, Grand Traverse County 2023 CLMP Results

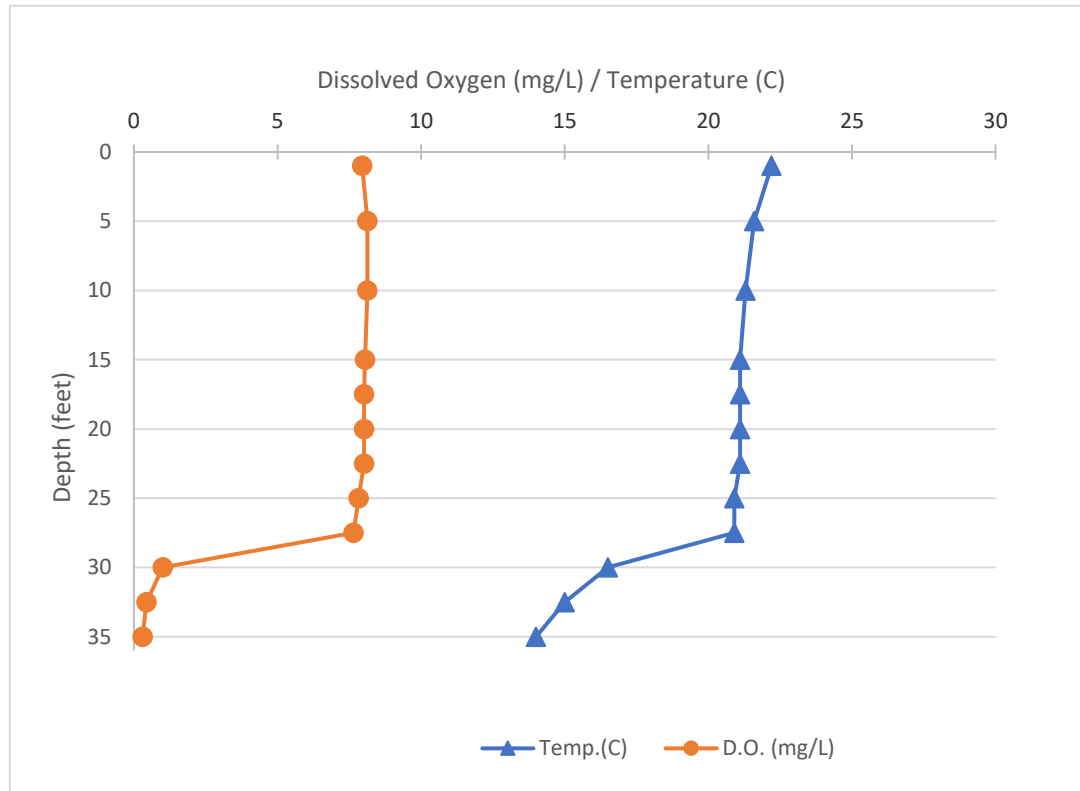
Name: Spider Lake  
 County: Grand Traverse  
 Site ID: 280395  
 Date: 9/10/2021

Depth (ft)	Temp.(C)	D.O. (mg/L)
1	22.2	7.95
5	21.6	8.13
10	21.3	8.13
15	21.1	8.05
17.5	21.1	8.01
20	21.1	8.01
22.5	21.1	8.01
25	20.9	7.82
27.5	20.9	7.65
30	16.5	1
32.5	15	0.44
35	14	0.3
