2023 Data Report for

Wall Lake, Barry County

Site ID: 080294

Wall Lake, Barry County 2023 CLMP Results

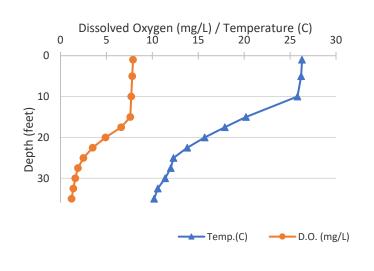
Dissolved Oxygen and Temperature Profile 7/7/23

The lake keeps some dissolved oxygen in the bottom waters through early summer, but by mid-summer the lake has stratified and the bottom water is devoid of oxygen.

If you enrolled in Dissolved Oxygen/Temperature, the summary page will have a graph of one of the profiles taken during the late summer (typically August or September). If your lake stratifies, we will use a graph showing the earliest time of stratification, because identifying the timing of this condition and the depth at which it occurs is typically the most important use of dissolved oxygen measurements.

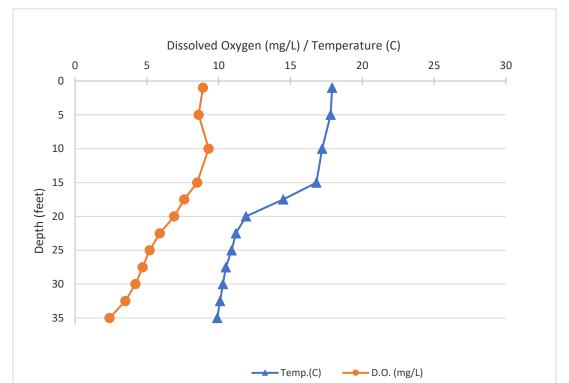
Lake:Wall Lake (Barry Co.)5/31/2023

Dissolved Oxygen and Temperature Profile

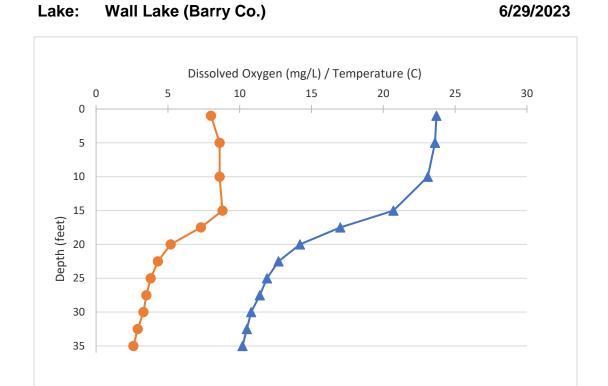
Name:Wall LakeCounty:BarrySite ID:80294Date:6/29/2023

Dissolved Oxygen and Temperature Profile
