# 2024 Data Report for First Fortune Lake, Iron County

Site ID: 360080

# First Fortune Lake, Iron County 2024 CLMP Results

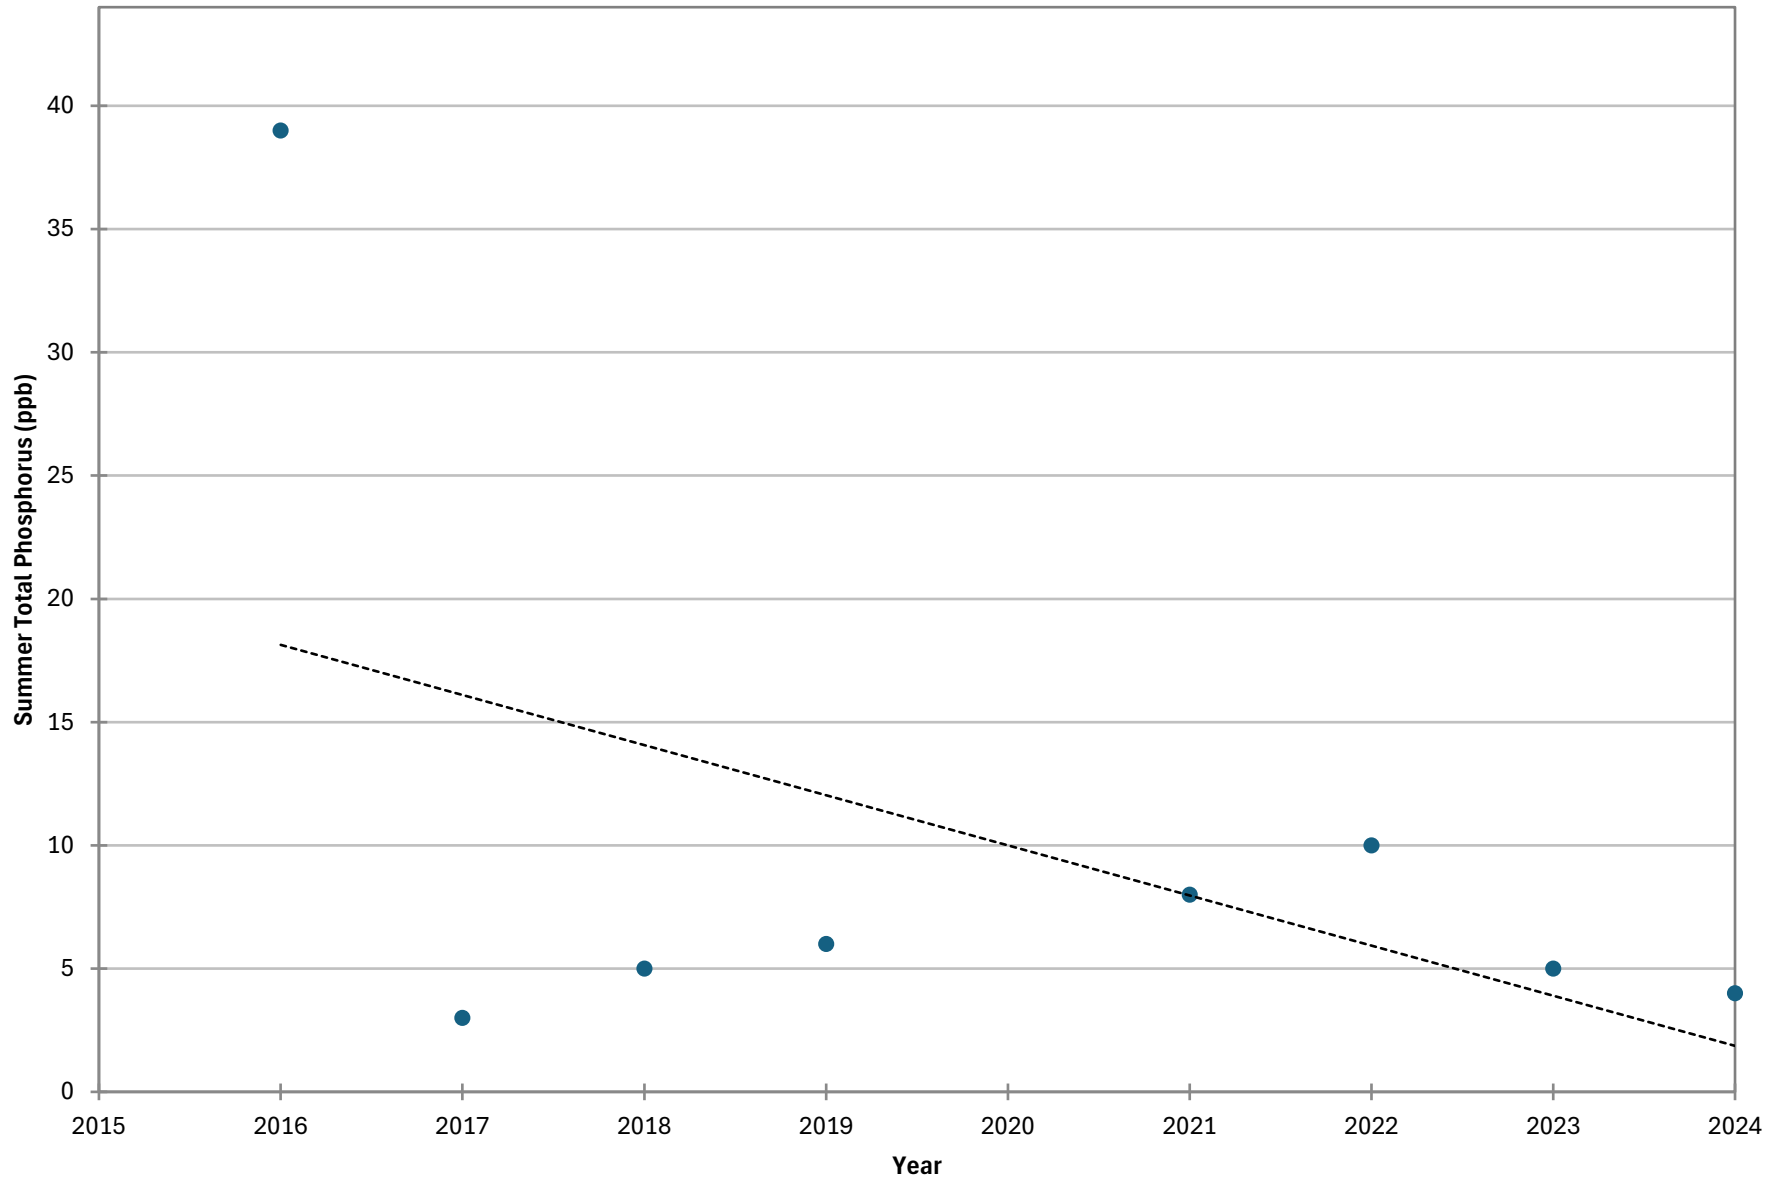
COOPERATIVE LAKES MONITORING PROGRAM  
SUMMER TOTAL PHOSPHORUS

**First Fortune Lake (Iron Co.), 360080**

MICHIGAN STATE  
UNIVERSITY
