2024 Data Report for

Hunter Lake, Gladwin County

Site ID: 260119

Hunter Lake, Gladwin County 2024 CLMP Results

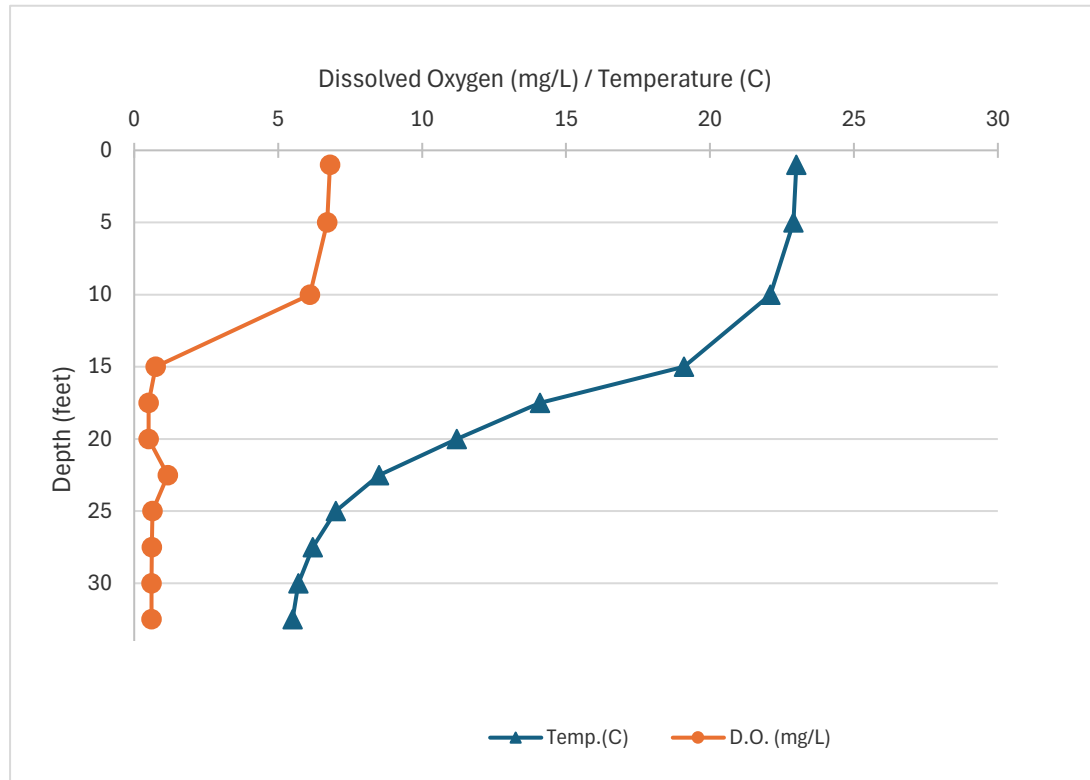
9/12/2016

Dissolved Oxygen and Temperature Profile

Depth (ft)	Temp.(C)	D.O. (mg/L)
1	23	6.8
5	22.9	6.7
10	22.1	6.1
15	19.1	0.75
17.5	14.1	0.5
20	11.2	0.5
22.5	8.5	1.17
25	7	0.63
27.5	6.2	0.61
30	5.7	0.6
32.5	5.5	0.6
