# 2024 Data Report for Painter Lake, Cass County

Site ID: 140108

# Painter Lake, Cass County 2024 CLMP Results

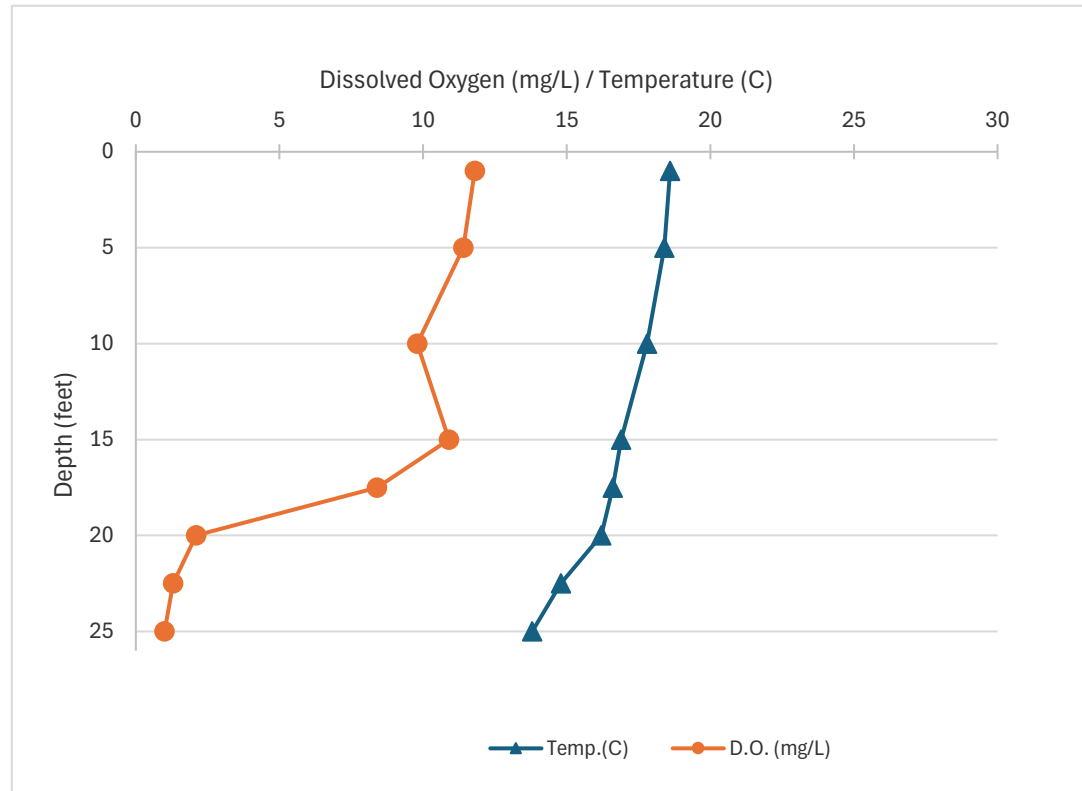
9/24/2022

### Dissolved Oxygen and Temperature Profile

Depth (ft)	Temp.(C)	D.O. (mg/L)
1	18.6	11.8
5	18.4	11.4
10	17.8	9.8
15	16.9	10.9
17.5	16.6	8.4
20	16.2	2.1
22.5	14.8	1.3
25	13.8	1
