2024 Data Report for

Tamarack Lake, Livingston County

Site ID: 470610

Tamarack Lake, Livingston County 2024 CLMP Results

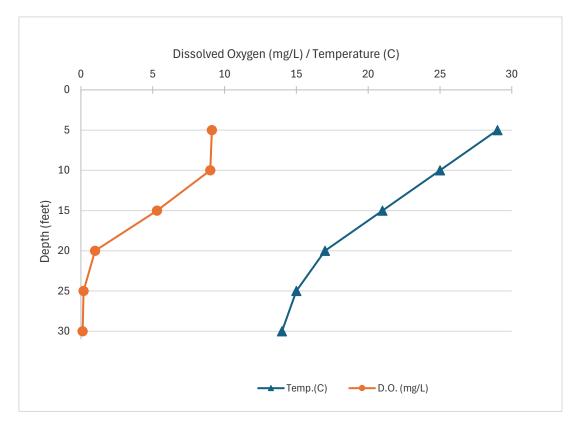
8/14/2013

Depth (ft)	Temp.(C)		D.O. (mg/L)
5		29	9.12
10		25	9.01
15		21	5.3
20		17	0.99
25		15	0.18
30		14	0.12

Dissolved Oxygen and Temperature Profile
