2024 Data Report for Eagle Lake, Van Buren County

Site ID: 800261

Eagle Lake, Van Buren County 2024 CLMP Results

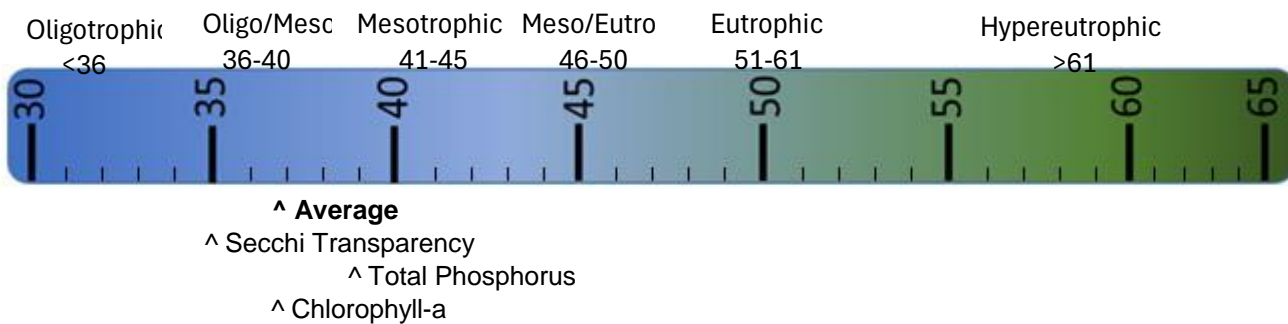
In 1977, limnologist Dr. Robert Carlson developed a numerical scale (0-100) where the numbers indicate the level of nutrient enrichment. Using the proper equations, we can convert results from Summer Total Phosphorus, Secchi Depth, and Chlorophyll-a to this Trophic Status Index (TSI). The TSI numbers are furthermore grouped into general categories (oligotrophic, mesotrophic, eutrophic, and hypereutrophic), to quickly give us a way to understand the general nutrient level of any lake.

Oligotrophic: Generally deep and clear lakes with little aquatic plant or algae growth. These lakes maintain sufficient dissolved oxygen in the cool, deep-bottom waters during late summer to support cold water fish, such as trout and whitefish.

Mesotrophic: Lakes that fall between oligotrophic and eutrophic. Mid-ranged amounts of nutrients.

Eutrophic: Highly productive eutrophic lakes are generally shallow, turbid, and support abundant aquatic plant growth. In deep eutrophic lakes, the cool bottom waters usually contain little or no dissolved oxygen. Therefore, these lakes can only support warm water fish, such as bass and pike.

Hypereutrophic: A specialized category of eutrophic lakes. These lakes exhibit extremely high productivity, such as nuisance algae and weed growth.

With an average TSI score of 37 based on 2024 Secchi transparency, chlorophyll-a, and summer total phosphorus data, this lake is rated between the oligotrophic and mesotrophic classification. The lake leans slightly more oligotrophic than mesotrophic.

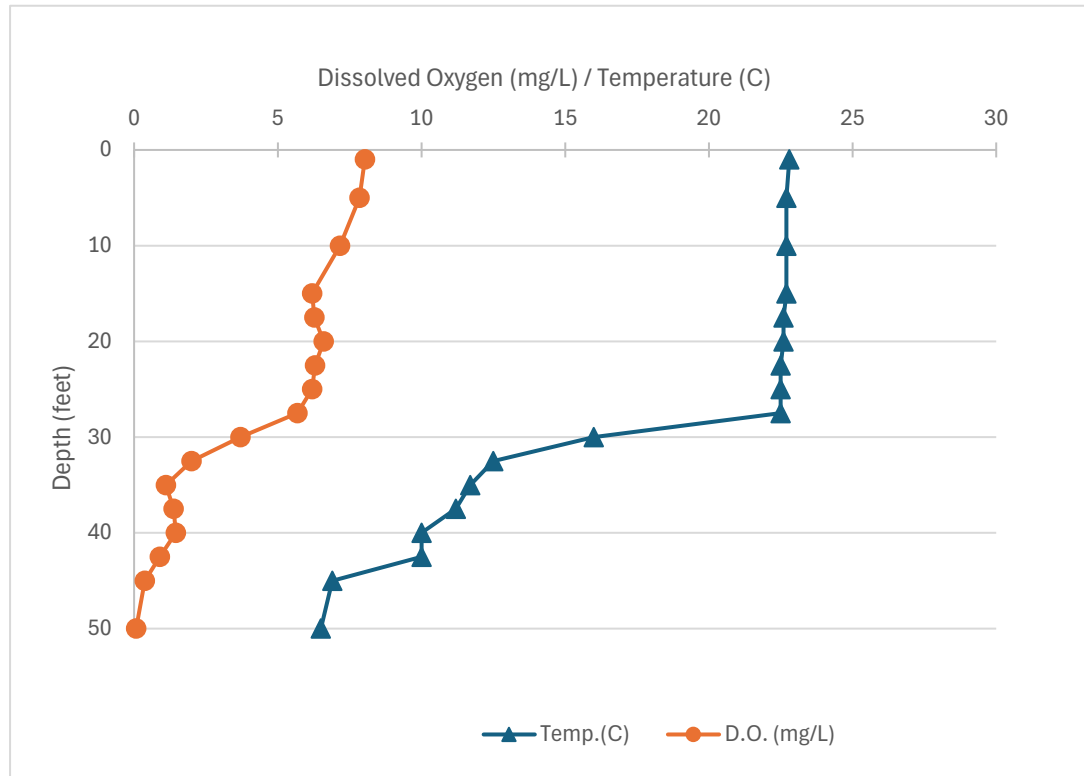
9/12/2024

Dissolved Oxygen and Temperature Profile
