# 2024 Data Report for Hubbard Lake, Alcona County

Site ID: 010106

# Hubbard Lake, Alcona County 2024 CLMP Results

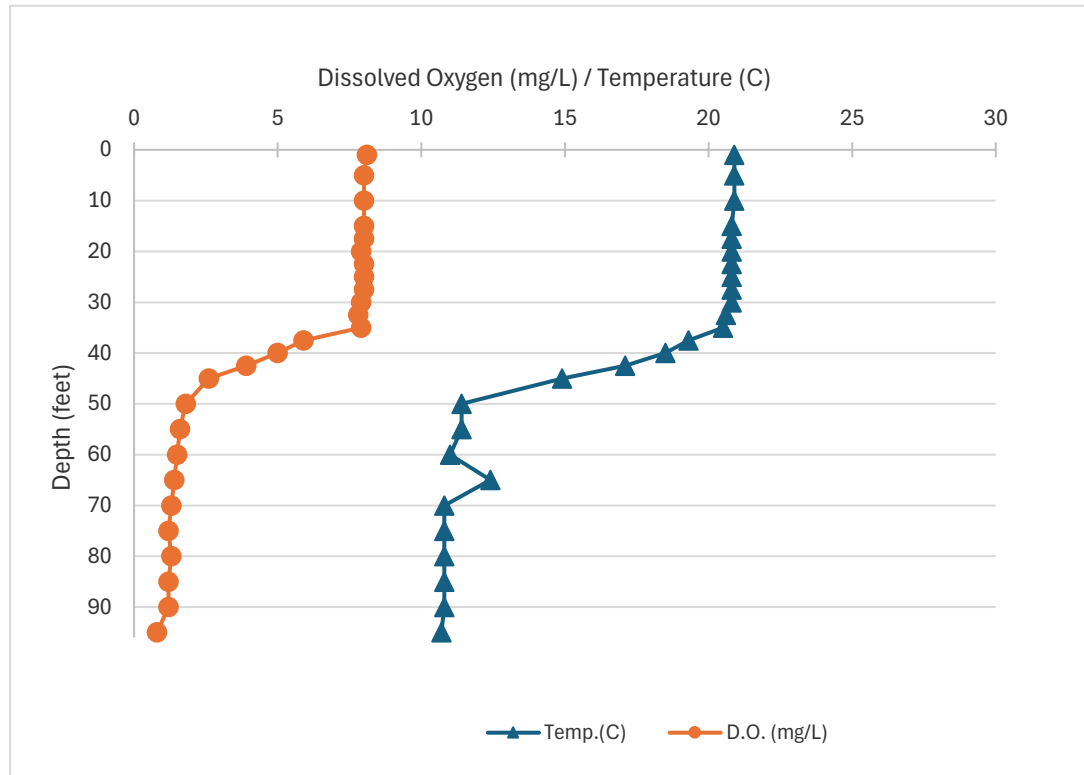
9/5/2024

### Dissolved Oxygen and Temperature Profile

Depth (ft)	Temp.(C)	D.O. (mg/L)
1	20.9	8.1
5	20.9	8
10	20.9	8
15	20.8	8
17.5	20.8	8
20	20.8	7.9
22.5	20.8	8
25	20.8	8
27.5	20.8	8
30	20.8	7.9
32.5	20.6	7.8
35	20.5	7.9
37.5	19.3	5.9
40	18.5	5
42.5	17.1	3.9
45	14.9	2.6
50	11.4	1.8
55	11.4	1.6
60	11	1.5
65	12.4	1.4
70	10.8	1.3
75	10.8	1.2
80	10.8	1.3
85	10.8	1.2
90	10.8	1.2
95	10.7	0.8
