# 2024 Data Report for

# Kassuba Lake, Otsego County

Site ID: 690170

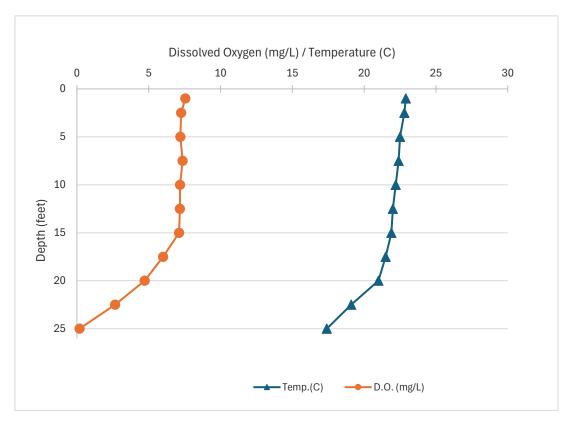
County: Otsego Site ID: 690170 Date: 9/2/2024

Depth (ft)	Temp.(C)	D.O. (mg/L)
1	22.9	7.55
2.5	22.8	7.26
5	22.5	7.2
7.5	22.4	7.36
10	22.2	7.18
12.5	22	7.17
15	21.9	7.11
17.5	21.5	6
20	21	4.72
22.5	19.1	2.66
25	17.4	0.18
