# **2024 Data Report for Kimball Lake, Newaygo County**

Site ID: 620276

# Kimball Lake, Newaygo County

## 2024 CLMP Results

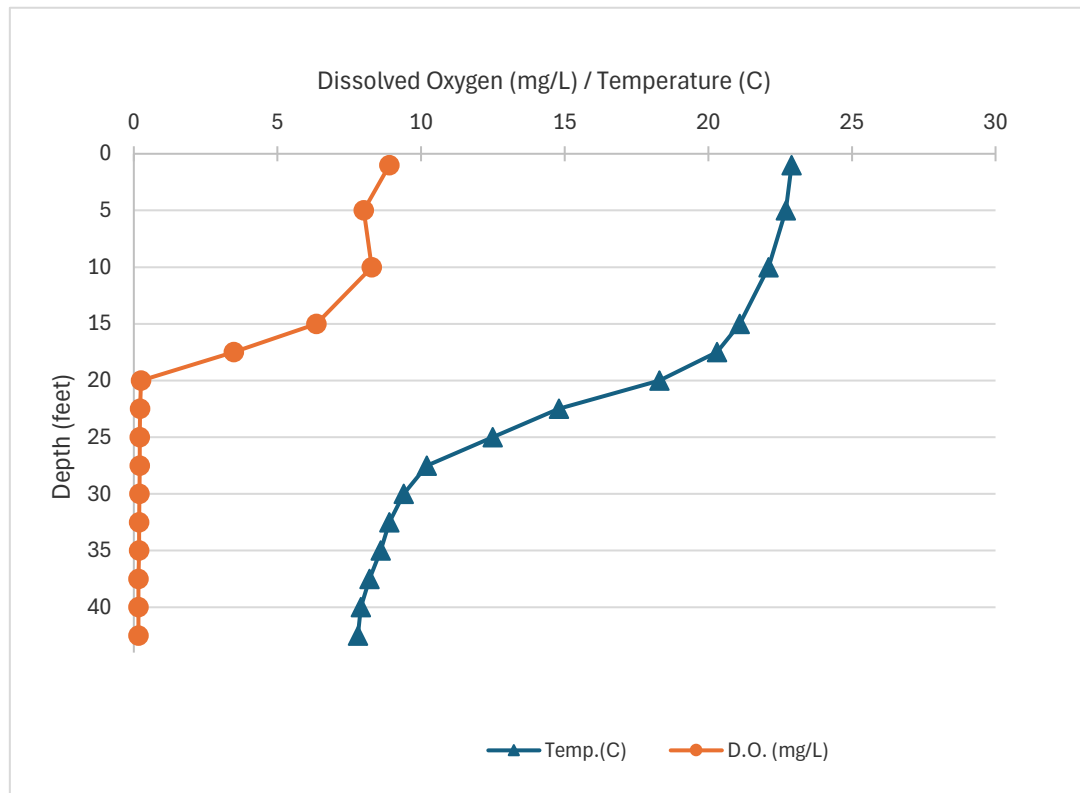
Name: Kimball Lake  
County: Newaygo  
Site ID: 620276  
Date: 9/16/2024

## Dissolved Oxygen and Temperature Profile
