2024 Data Report for

West Maggie Lake, Iron County

Site ID: 360172

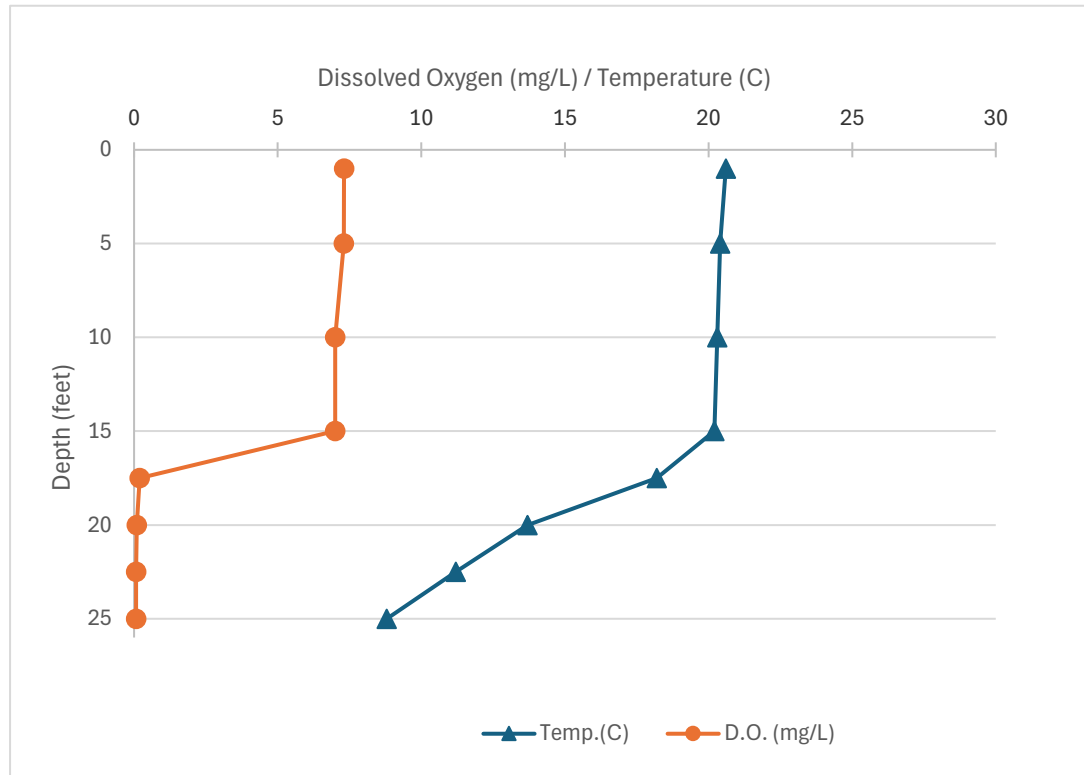
9/11/2016

Dissolved Oxygen and Temperature Profile

Depth (ft)	Temp.(C)	D.O. (mg/L)
1	20.6	7.31
5	20.4	7.3
10	20.3	7
15	20.2	7
17.5	18.2	0.2
20	13.7	0.1
22.5	11.2	0.07
25	8.8	0.07
