# 2024 Data Report for

# Round Lake, Mecosta County

Site ID: 540073

# Round Lake, Mecosta County 2024 CLMP Results

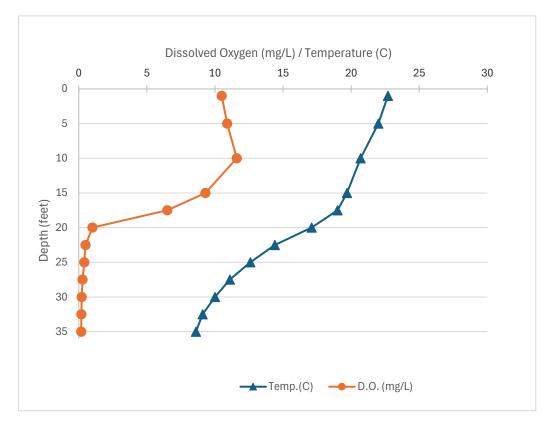
Name: Round Lake County: Mecosta Site ID: 540073 Date: 9/15/2024

Depth (ft)	Temp.(C)	D.O. (mg/L)
1	22.7	10.5
5	22	10.9
10	20.7	11.6
15	19.7	9.3
17.5	19	6.5
20	17.1	1
22.5	14.4	0.5
25	12.6	0.4
27.5	11.1	0.28
30	10	0.22
32.5	9.1	0.19
35	8.6	0.18
