2024 Data Report for Birch Lake, Cass County

Site ID: 140187

2024 CLMP Results

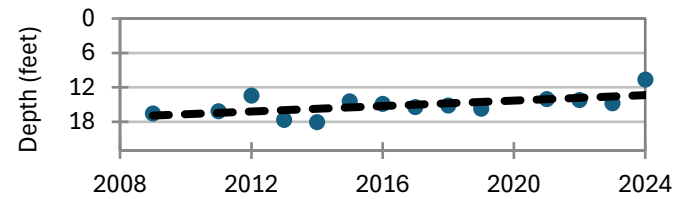
Secchi Disk Transparency (feet)

Year	# Readings	Min	Max	Average	Std. Dev	Carlson TSI
2024	10	6.0	20.0	10.7	4.7	43
2019-2023	45	5.0	32.0	14.7	5.4	38
2009-2018	132	6.0	50.0	15.8	6.3	37
2024 All CLMP Lakes	3348	0.5	85.0	11.7	6.2	43

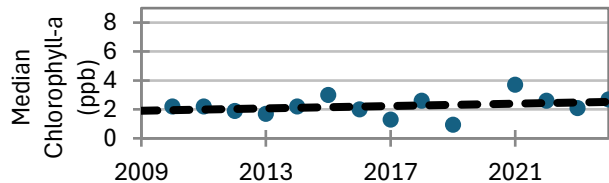
Chlorophyll-a (parts per billion)

Year	# Samples	Min	Max	Median	Std. Dev	Carlson TSI
2024	5	1.1	3.2	2.7	0.8	40
2019-2023	19	<1.0	7.4	2.4	1.4	39
2009-2018	47	<1.0	3.7	2.4	0.8	38
2024 All CLMP Lakes	708	< 1.0	63.0	2.8	7.3	41

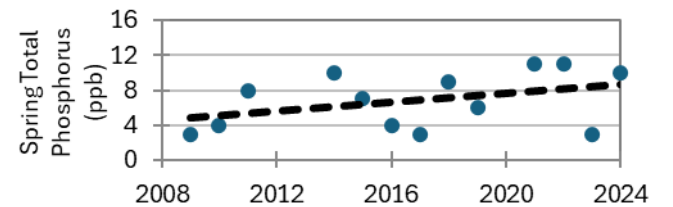
Spring Phosphorus (parts per billion)

Year	# Samples	Min	Max	Average	Std. Dev
2024	1	10.0	10.0	10.0	NA
2019-2023	4	<=3 W	11.0	7.8	3.9
2009-2018	8	<=3 W	10.0	6.0	2.8
2024 All CLMP Lakes	259	<= 5	140.0	14.3	39.7

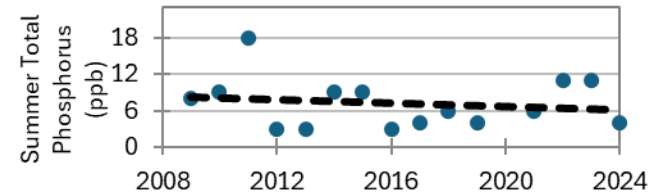
Summer Phosphorus (parts per billion)

Year	# Samples	Min	Max	Average	Std. Dev	Carlson TSI
2024	1	<5 T	<5 T	<5 T	NA	27
2019-2023	4	<5 T	11.0	8.0	3.6	34
2009-2018	10	<=3 W	18.0	7.2	4.6	33
2024 All CLMP Lakes	261	<= 5	140.0	14.6	11.9	43

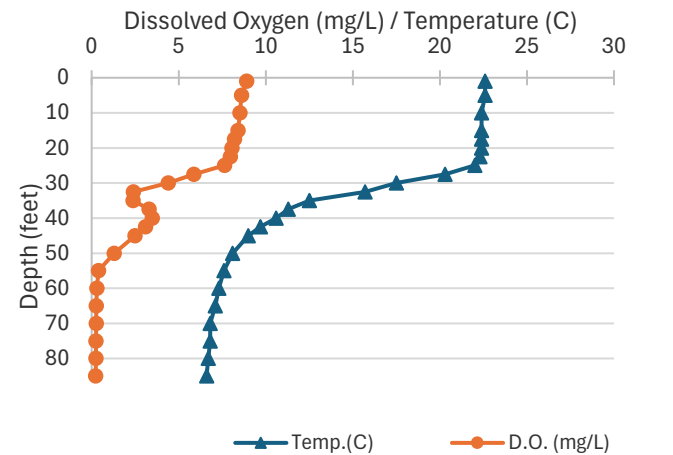
Dissolved Oxygen and Temperature Profile

If you enrolled in Dissolved Oxygen/Temperature, the summary page will have a graph of one of the profiles taken during the late summer (typically August or September). If your lake stratifies, we will use a graph showing the earliest time of stratification, because identifying the timing of this condition and the depth at which it occurs is typically the most important use of dissolved oxygen measurements.

The low level of nutrients in the lake results in dissolved oxygen being available throughout the water column for most of the summer. Only by the end of the summer does the lake fully stratify and the bottom waters become anoxic.

9/10/2024

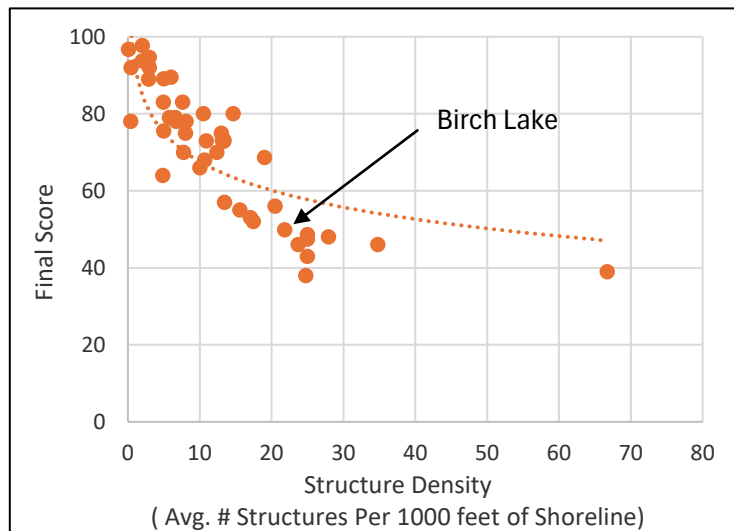
How does your lake compare to others in the program?

Birch Lake:	
Number of Sections:	16
Number of Structures:	349
Structure Density:	21.8
Final Score:	49.9

All 43 Participating Lakes from 2015-2017:	
Avg. Number of Sections:	16.3
Avg. Number of Structures:	248.5
Avg. Structure Density:	15.2
Avg. Final Score:	70.5

Overall, the lakeshore habitat of Birch Lake is below average when compared to the other lakes in the program. All of the lake sections score poor or fair (9 poor, 7 fair).

This Lake scored best in the littoral score (with an average of 69), meaning that (in general) erosion was low and aquatic vegetation was present.

The riparian zone and erosion control scores were approximately the same (scoring an average of 46 and 45).

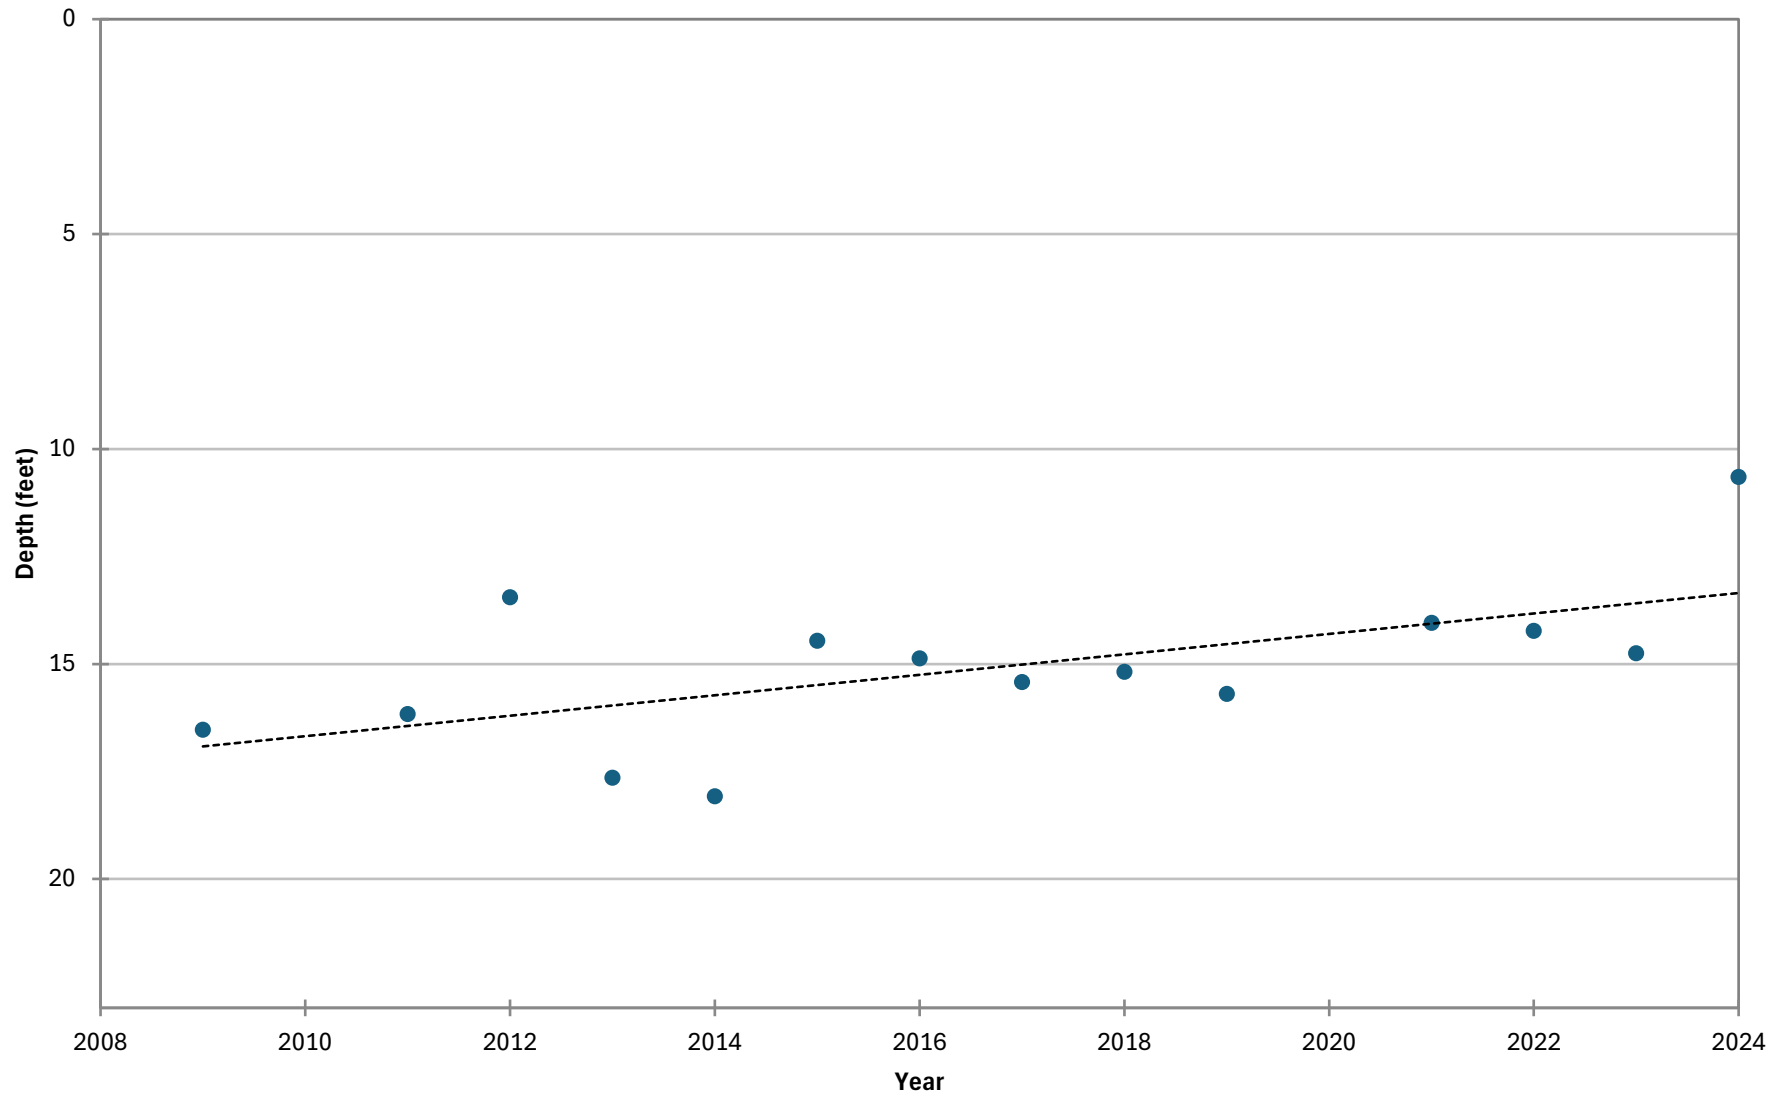
COOPERATIVE LAKES MONITORING PROGRAM
SUMMER MEAN TRANSPARENCY

Birch Lake (Cass Co.), 140187

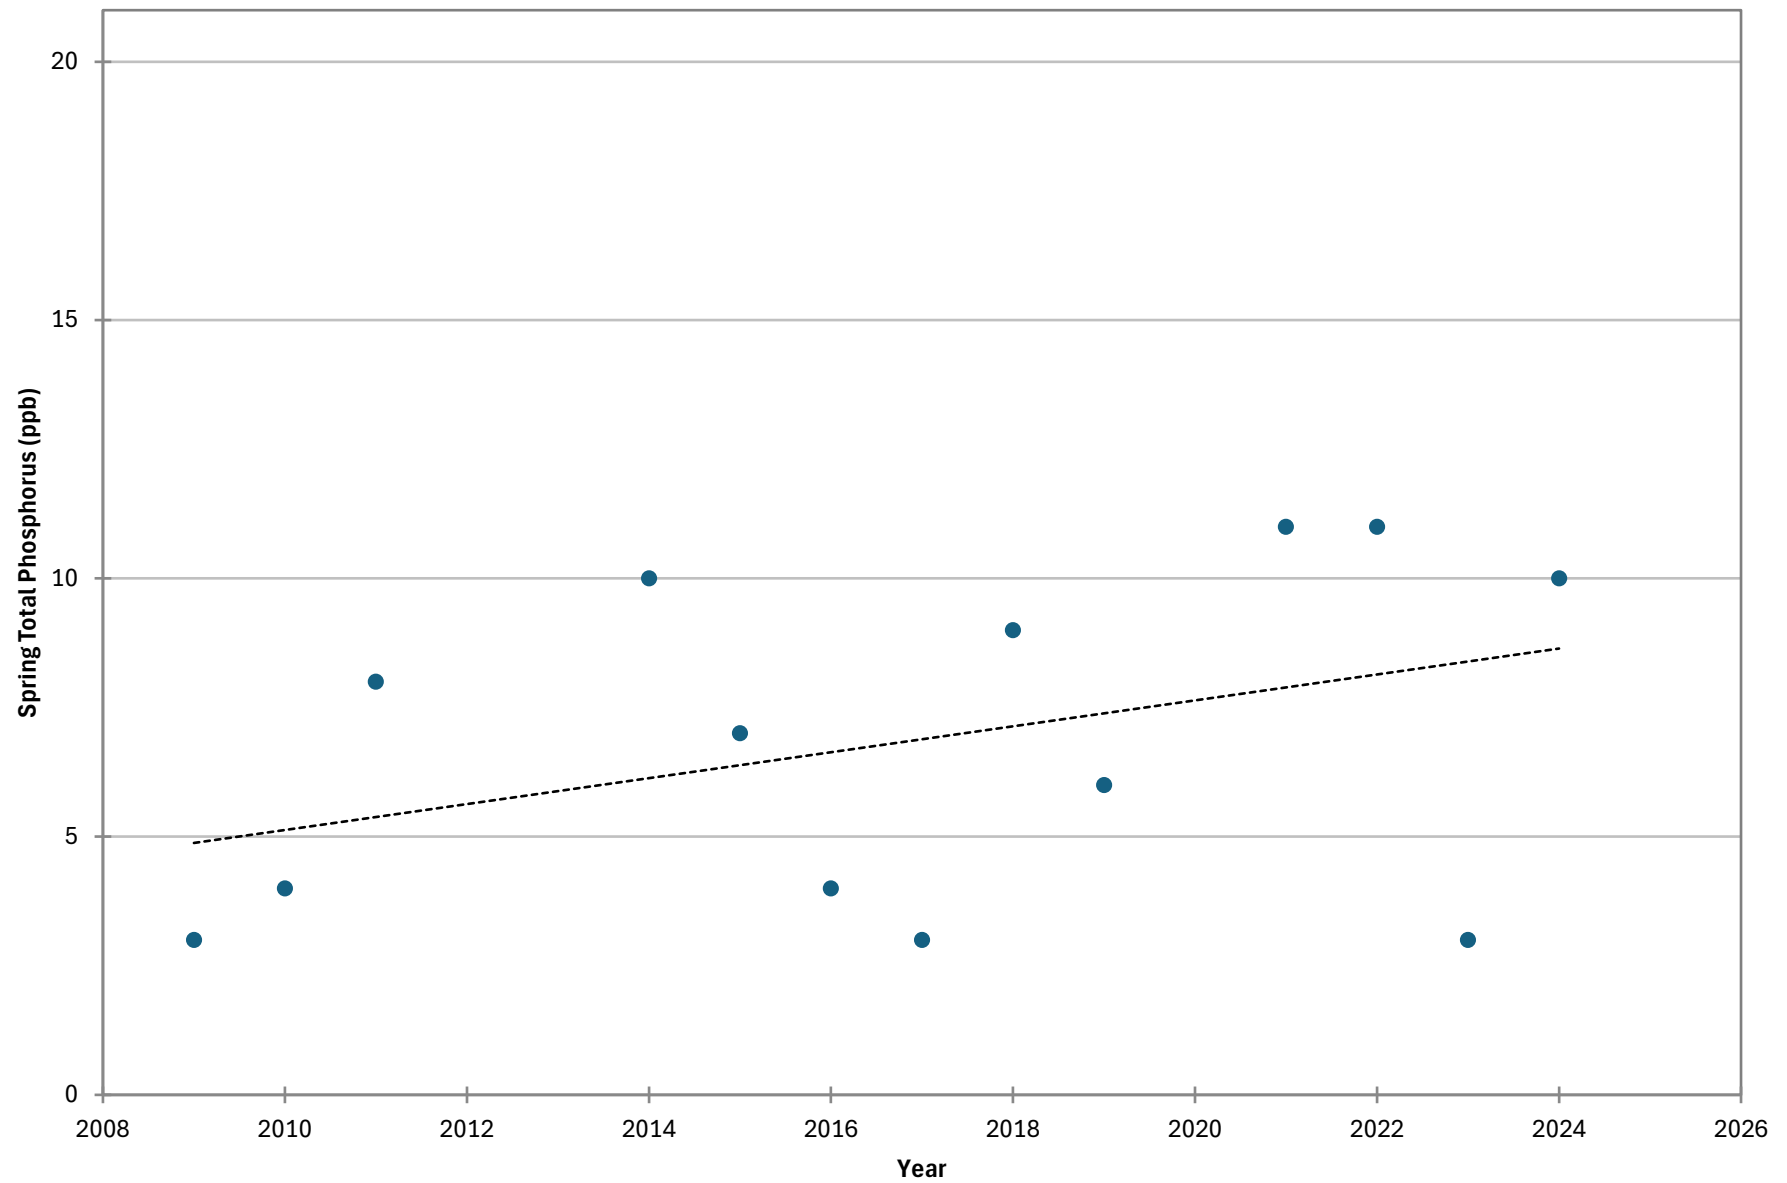
COOPERATIVE LAKES MONITORING PROGRAM
SPRING TOTAL PHOSPHORUS

Birch Lake (Cass Co.), 140187

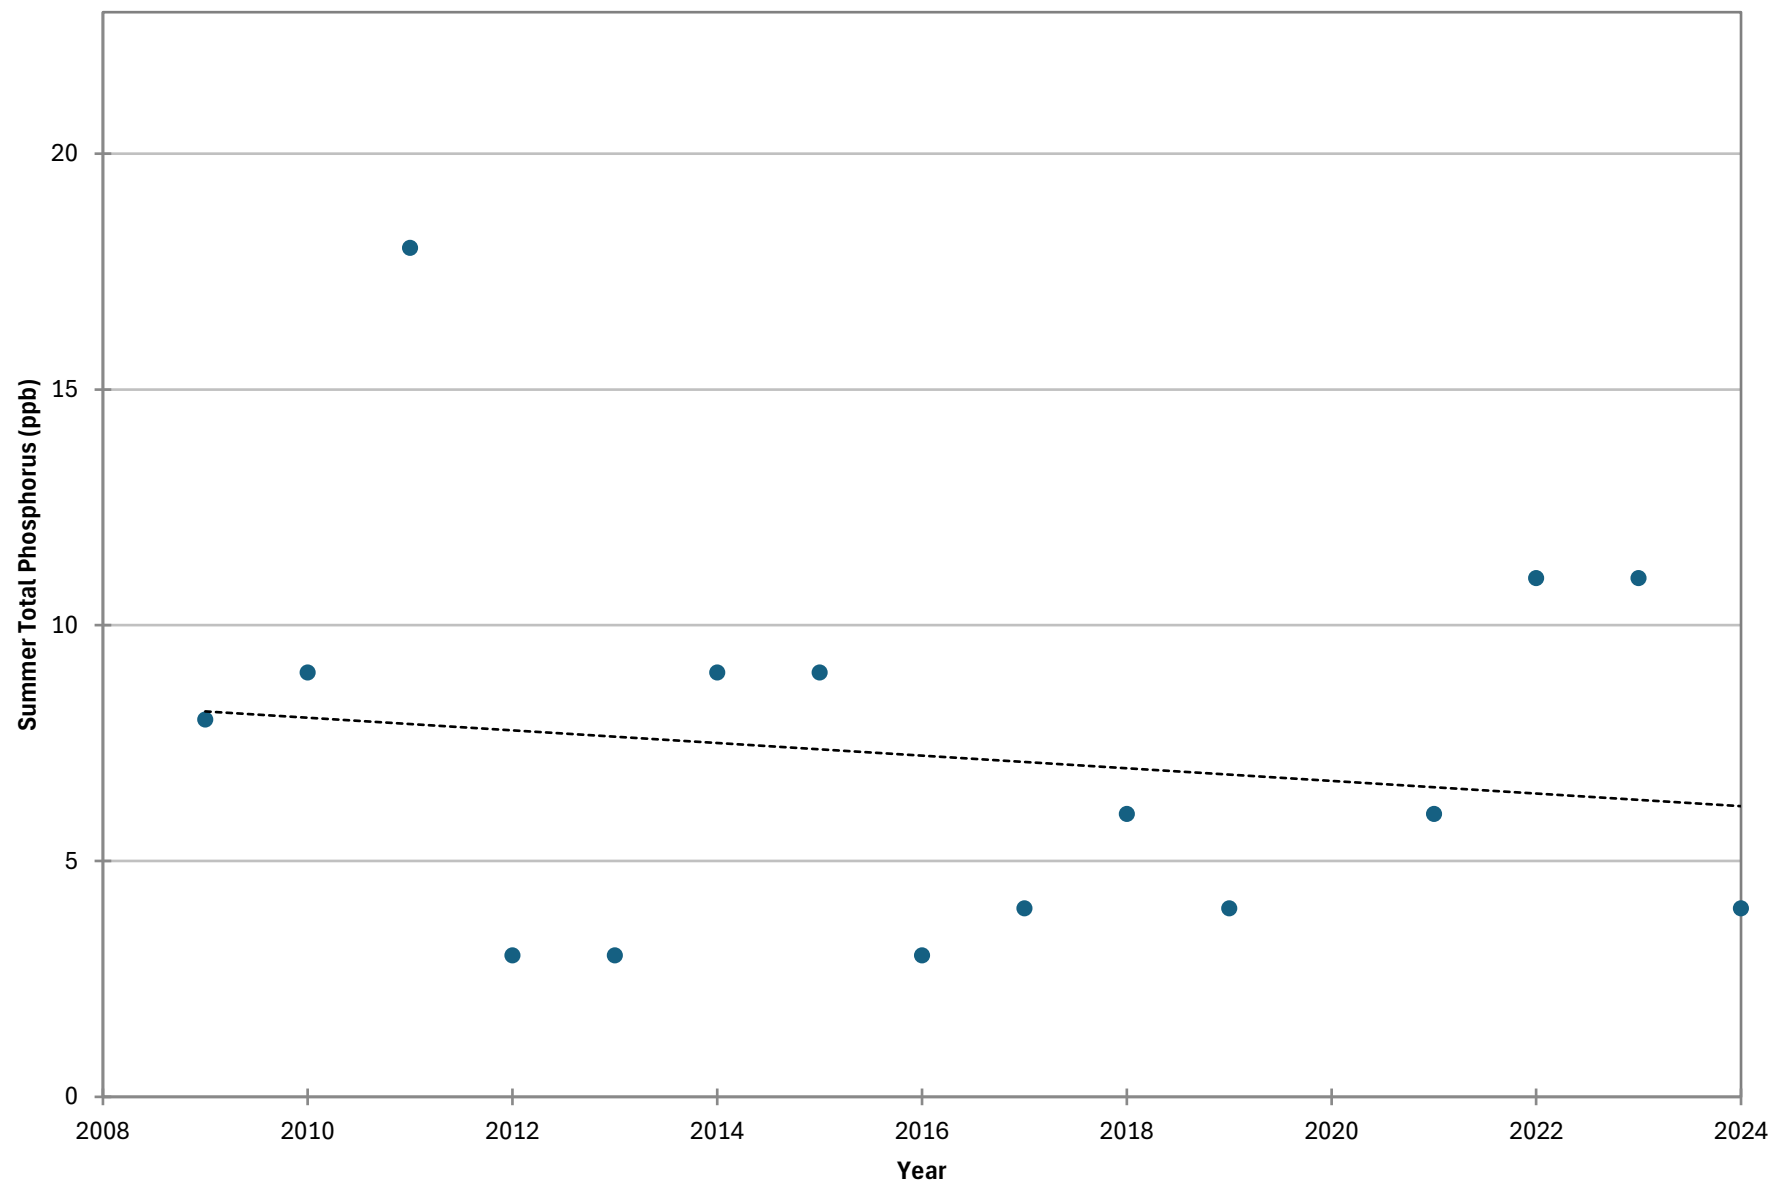
COOPERATIVE LAKES MONITORING PROGRAM
SUMMER TOTAL PHOSPHORUS

Birch Lake (Cass Co.), 140187

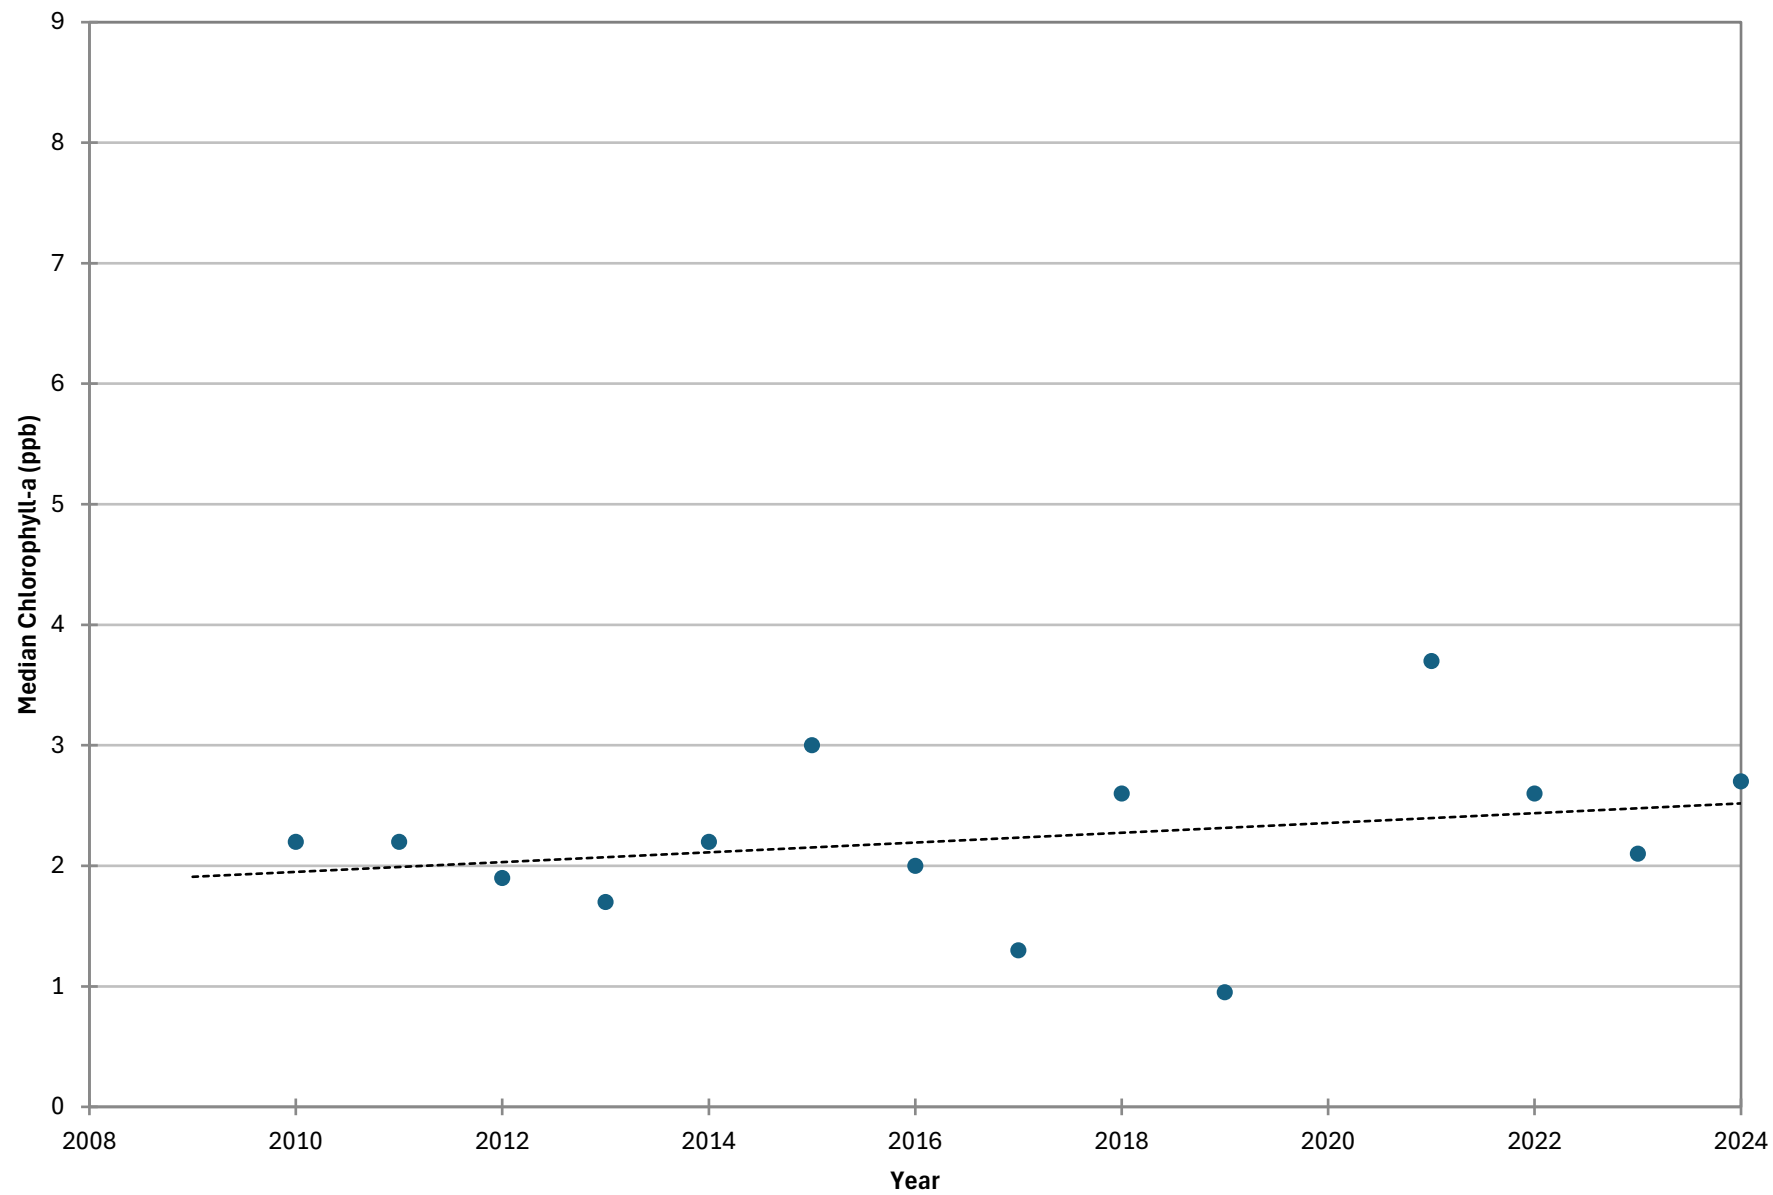
COOPERATIVE LAKES MONITORING PROGRAM
SUMMER MEDIAN CHLOROPHYLL-A

Birch Lake (Cass Co.), 140187

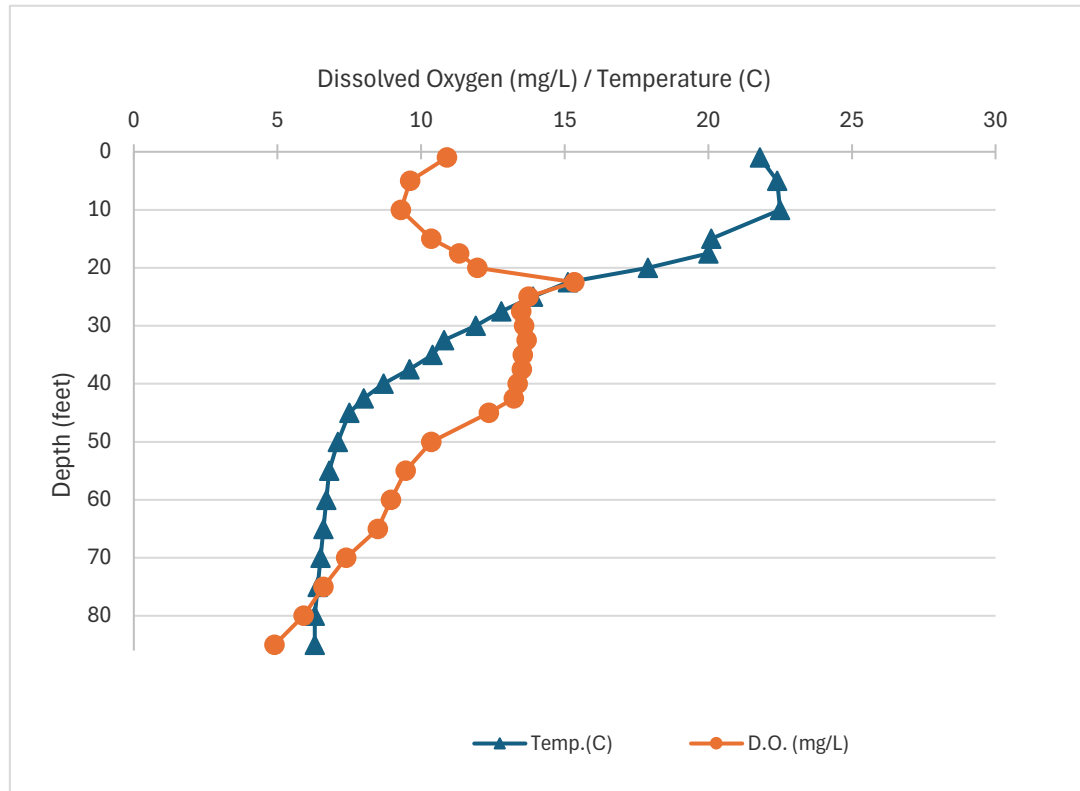
Dissolved Oxygen and Temperature Profile

Name: Birch Lake
County: Cass
Site ID: 140187
Date: 5/24/2024

Depth (ft)	Temp.(C)	D.O. (mg/L)
1	21.8	10.9
5	22.4	9.62
10	22.5	9.3
15	20.1	10.36
17.5	20	11.32
20	17.9	11.96
22.5	15.11	15.33
25	13.9	13.74
27.5	12.8	13.49
30	11.9	13.59
32.5	10.8	13.67
35	10.4	13.54
37.5	9.6	13.51
40	8.7	13.36
42.5	8	13.23
45	7.5	12.36
50	7.1	10.36
55	6.8	9.46
60	6.7	8.95
65	6.6	8.49
70	6.5	7.39
75	6.4	6.6
80	6.3	5.91
85	6.3	4.9

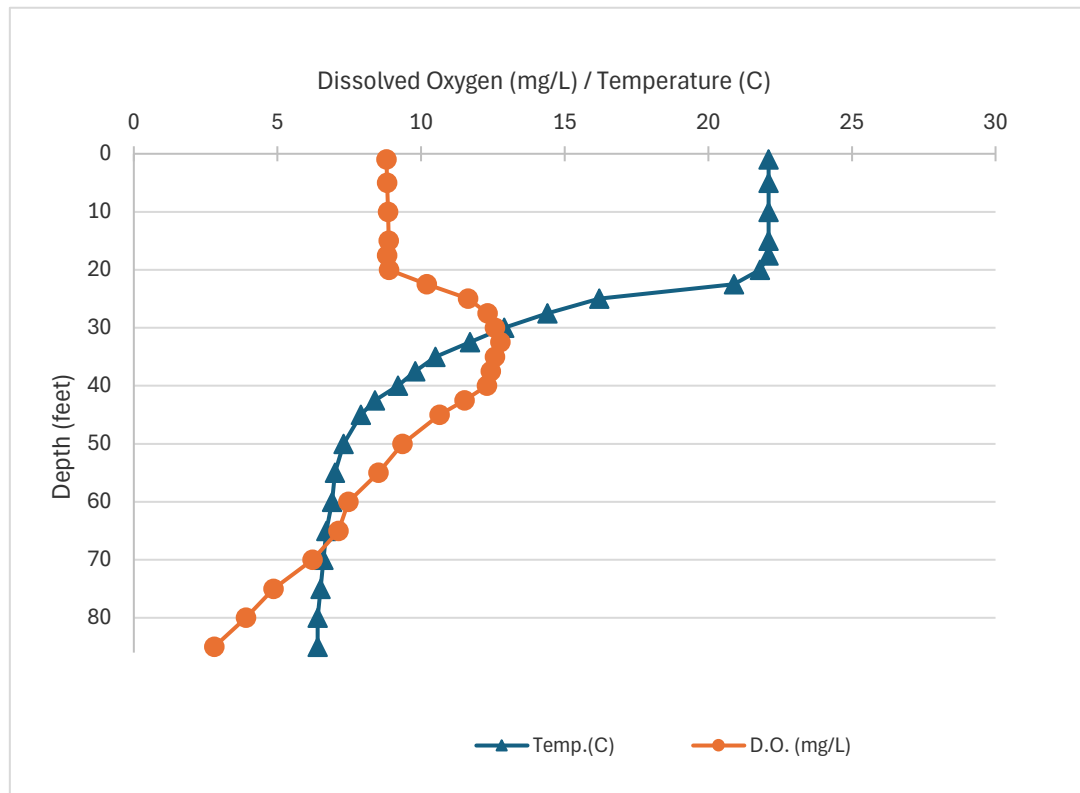
Dissolved Oxygen and Temperature Profile

Name: Birch Lake
County: Cass
Site ID: 140187
Date: 6/8/2024

Depth (ft)	Temp.(C)	D.O. (mg/L)
1	22.1	8.8
5	22.1	8.82
10	22.1	8.85
15	22.1	8.87
17.5	22.1	8.82
20	21.8	8.89
22.5	20.9	10.2
25	16.2	11.64
27.5	14.4	12.32
30	12.9	12.57
32.5	11.7	12.76
35	10.5	12.57
37.5	9.8	12.43
40	9.2	12.29
42.5	8.4	11.51
45	7.9	10.64
50	7.3	9.35
55	7	8.52
60	6.9	7.47
65	6.7	7.12
70	6.6	6.22
75	6.5	4.86
80	6.4	3.91
85	6.4	2.8

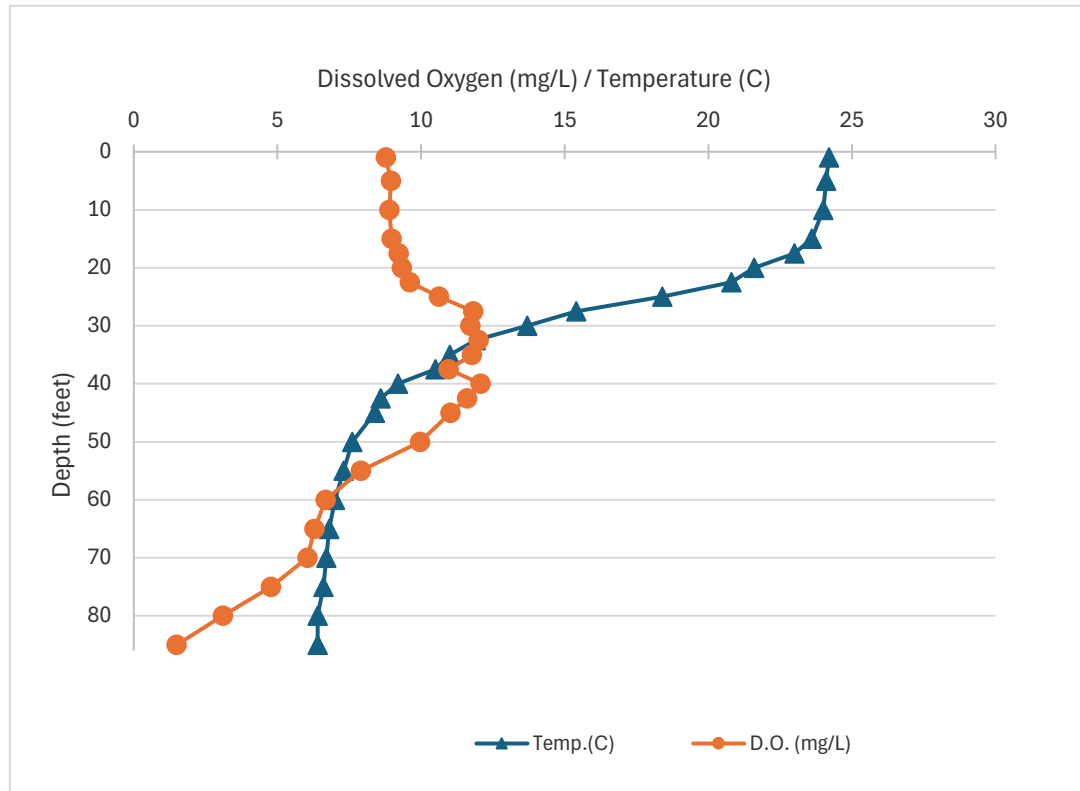
Dissolved Oxygen and Temperature Profile

Name: Birch Lake
County: Cass
Site ID: 140187
Date: 6/17/2024

Depth (ft)	Temp.(C)	D.O. (mg/L)
1	24.2	8.77
5	24.1	8.95
10	24	8.9
15	23.6	8.97
17.5	23	9.22
20	21.6	9.33
22.5	20.8	9.61
25	18.4	10.62
27.5	15.4	11.82
30	13.7	11.72
32.5	11.9	12
35	11	11.77
37.5	10.5	10.96
40	9.2	12.07
42.5	8.6	11.6
45	8.4	11.02
50	7.6	9.97
55	7.3	7.91
60	7	6.68
65	6.8	6.29
70	6.7	6.04
75	6.6	4.77
80	6.4	3.1
85	6.4	1.49

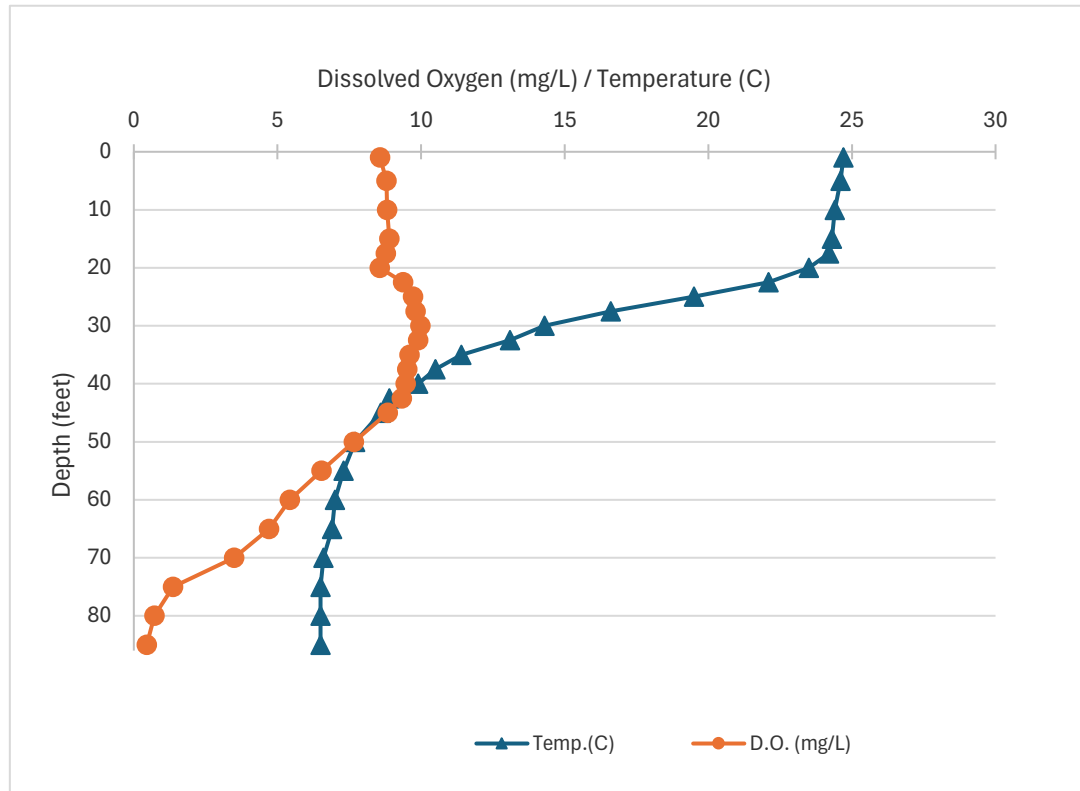
Dissolved Oxygen and Temperature Profile

Name: Birch Lake
County: Cass
Site ID: 140187
Date: 7/4/2024

Depth (ft)	Temp.(C)	D.O. (mg/L)
1	24.7	8.57
5	24.6	8.8
10	24.4	8.82
15	24.3	8.9
17.5	24.2	8.77
20	23.5	8.56
22.5	22.1	9.37
25	19.5	9.72
27.5	16.6	9.81
30	14.3	9.98
32.5	13.1	9.9
35	11.4	9.6
37.5	10.5	9.52
40	9.9	9.46
42.5	8.9	9.33
45	8.6	8.84
50	7.7	7.66
55	7.3	6.53
60	7	5.43
65	6.9	4.71
70	6.6	3.49
75	6.5	1.36
80	6.5	0.72
85	6.5	0.45

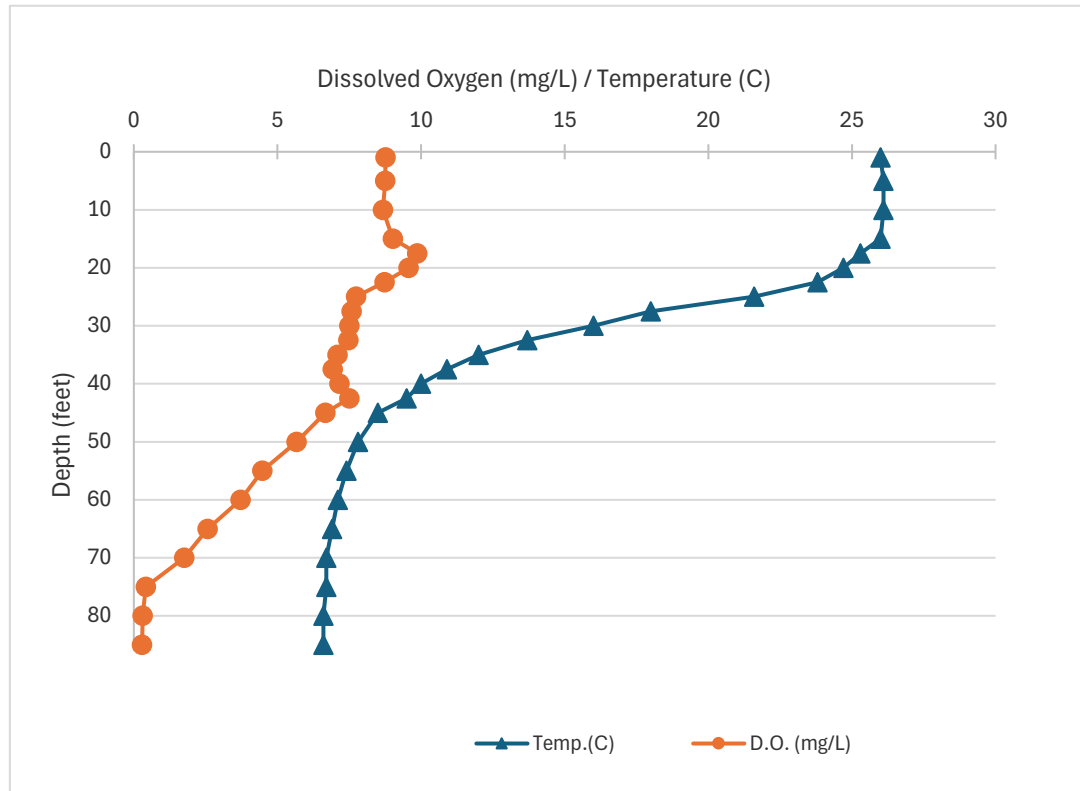
Dissolved Oxygen and Temperature Profile

Name: Birch Lake
County: Cass
Site ID: 140187
Date: 7/18/2024

Depth (ft)	Temp.(C)	D.O. (mg/L)
1	26	8.76
5	26.1	8.75
10	26.1	8.67
15	26	9.02
17.5	25.3	9.87
20	24.7	9.57
22.5	23.8	8.73
25	21.6	7.74
27.5	18	7.58
30	16	7.5
32.5	13.7	7.47
35	12	7.09
37.5	10.9	6.92
40	10	7.16
42.5	9.5	7.5
45	8.5	6.67
50	7.8	5.67
55	7.4	4.47
60	7.1	3.72
65	6.9	2.57
70	6.7	1.75
75	6.7	0.42
80	6.6	0.31
85	6.6	0.29

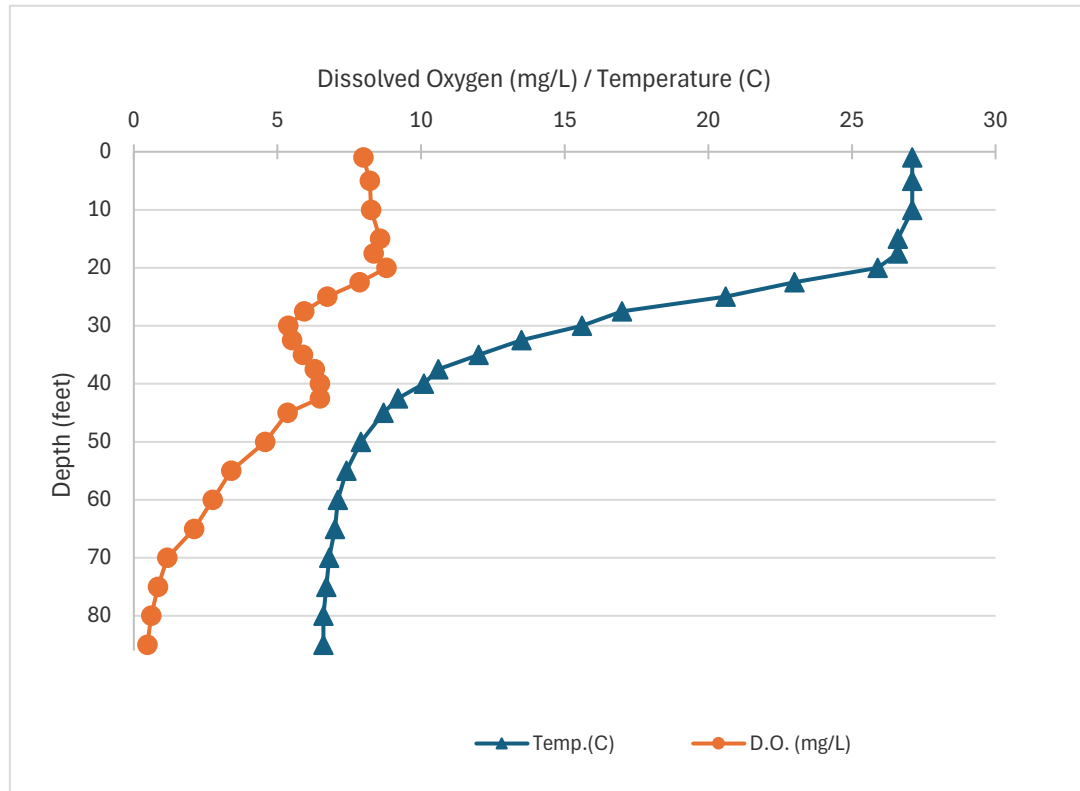
Dissolved Oxygen and Temperature Profile

Name: Birch Lake
County: Cass
Site ID: 140187
Date: 8/2/2024

Depth (ft)	Temp.(C)	D.O. (mg/L)
1	27.1	7.99
5	27.1	8.22
10	27.1	8.26
15	26.6	8.57
17.5	26.6	8.35
20	25.9	8.8
22.5	23	7.86
25	20.6	6.73
27.5	17	5.93
30	15.6	5.38
32.5	13.5	5.51
35	12	5.89
37.5	10.6	6.3
40	10.1	6.48
42.5	9.2	6.48
45	8.7	5.35
50	7.9	4.57
55	7.4	3.39
60	7.1	2.75
65	7	2.1
70	6.8	1.17
75	6.7	0.84
80	6.6	0.61
85	6.6	0.47

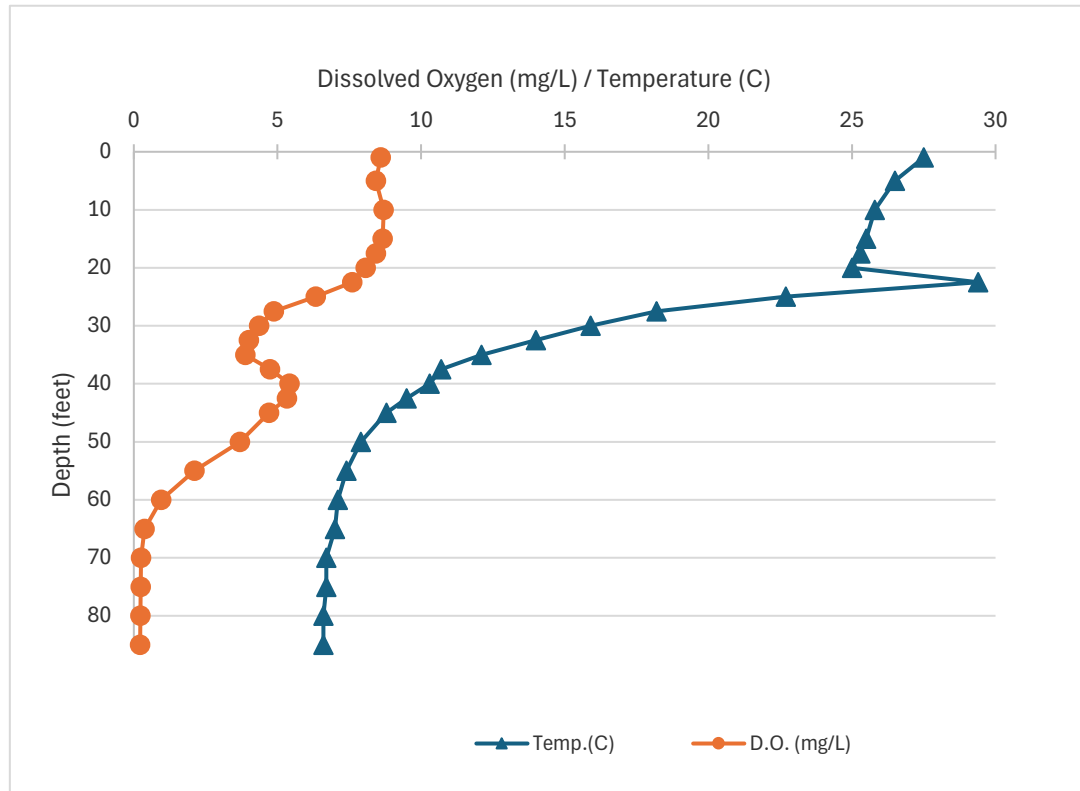
Dissolved Oxygen and Temperature Profile

Name: Birch Lake
County: Cass
Site ID: 140187
Date: 8/14/2024

Depth (ft)	Temp.(C)	D.O. (mg/L)
1	27.5	8.6
5	26.5	8.43
10	25.8	8.7
15	25.5	8.66
17.5	25.3	8.43
20	25	8.07
22.5	29.4	7.6
25	22.7	6.33
27.5	18.2	4.87
30	15.9	4.36
32.5	14	4
35	12.1	3.88
37.5	10.7	4.74
40	10.3	5.42
42.5	9.5	5.33
45	8.8	4.71
50	7.9	3.69
55	7.4	2.11
60	7.1	0.95
65	7	0.37
70	6.7	0.25
75	6.7	0.24
80	6.6	0.23
85	6.6	0.22

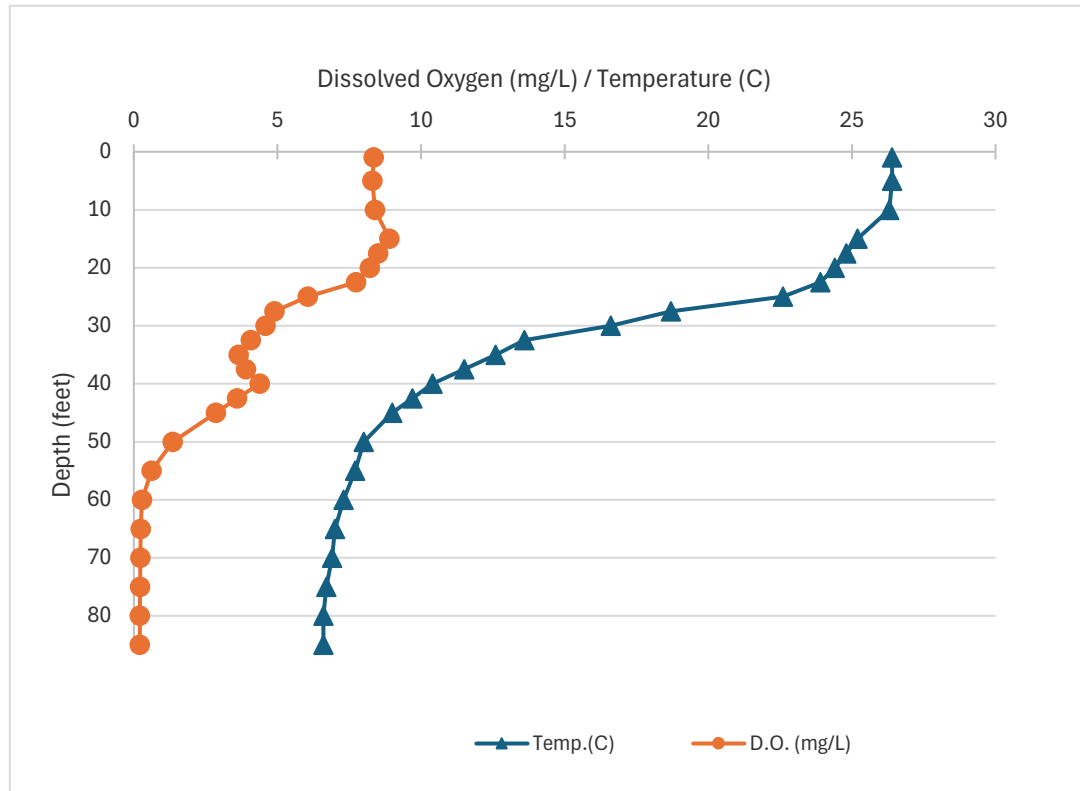
Dissolved Oxygen and Temperature Profile

Name: Birch Lake
County: Cass
Site ID: 140187
Date: 8/30/2024

Depth (ft)	Temp.(C)	D.O. (mg/L)
1	26.4	8.35
5	26.4	8.31
10	26.3	8.4
15	25.2	8.9
17.5	24.8	8.51
20	24.4	8.22
22.5	23.9	7.74
25	22.6	6.06
27.5	18.7	4.9
30	16.6	4.58
32.5	13.6	4.07
35	12.6	3.65
37.5	11.5	3.91
40	10.4	4.38
42.5	9.7	3.59
45	9	2.86
50	8	1.35
55	7.7	0.62
60	7.3	0.28
65	7	0.24
70	6.9	0.23
75	6.7	0.22
80	6.6	0.21
85	6.6	0.21

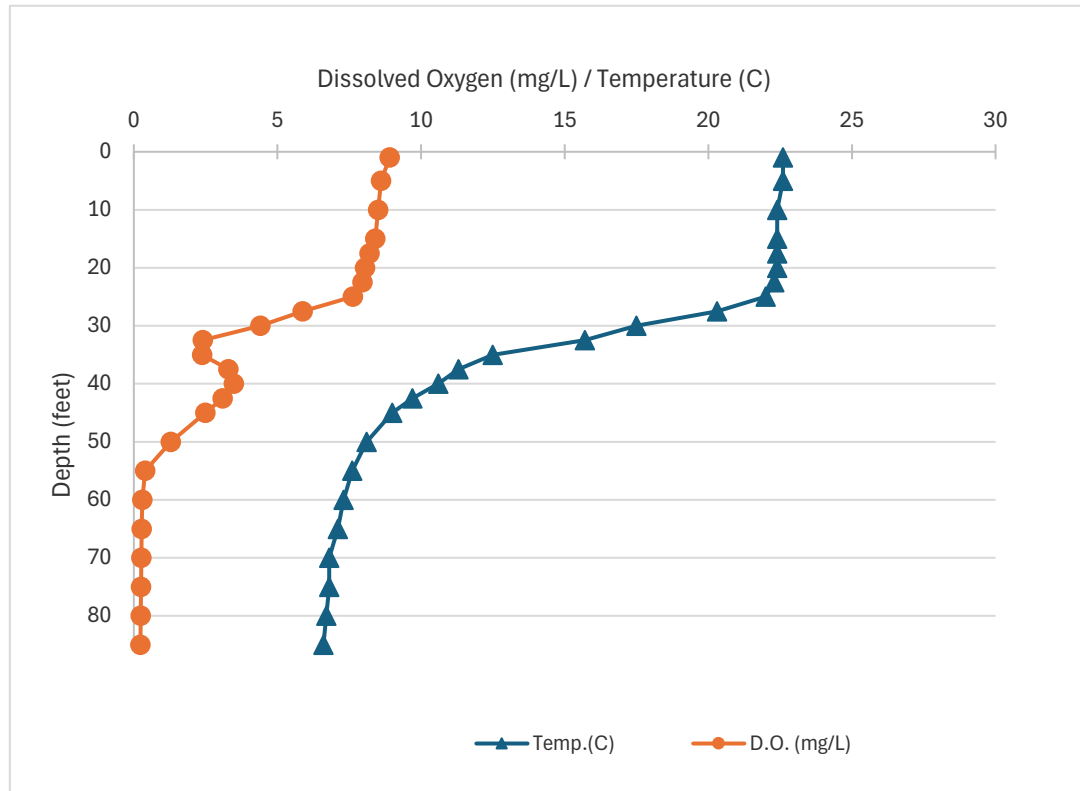
Dissolved Oxygen and Temperature Profile

Name: Birch Lake
County: Cass
Site ID: 140187
Date: 9/10/2024

Depth (ft)	Temp.(C)	D.O. (mg/L)
1	22.6	8.91
5	22.6	8.61
10	22.4	8.51
15	22.4	8.41
17.5	22.4	8.2
20	22.4	8.05
22.5	22.3	7.96
25	22	7.63
27.5	20.3	5.88
30	17.5	4.41
32.5	15.7	2.4
35	12.5	2.38
37.5	11.3	3.29
40	10.6	3.48
42.5	9.7	3.09
45	9	2.49
50	8.1	1.29
55	7.6	0.4
60	7.3	0.3
65	7.1	0.27
70	6.8	0.26
75	6.8	0.25
80	6.7	0.24
85	6.6	0.23

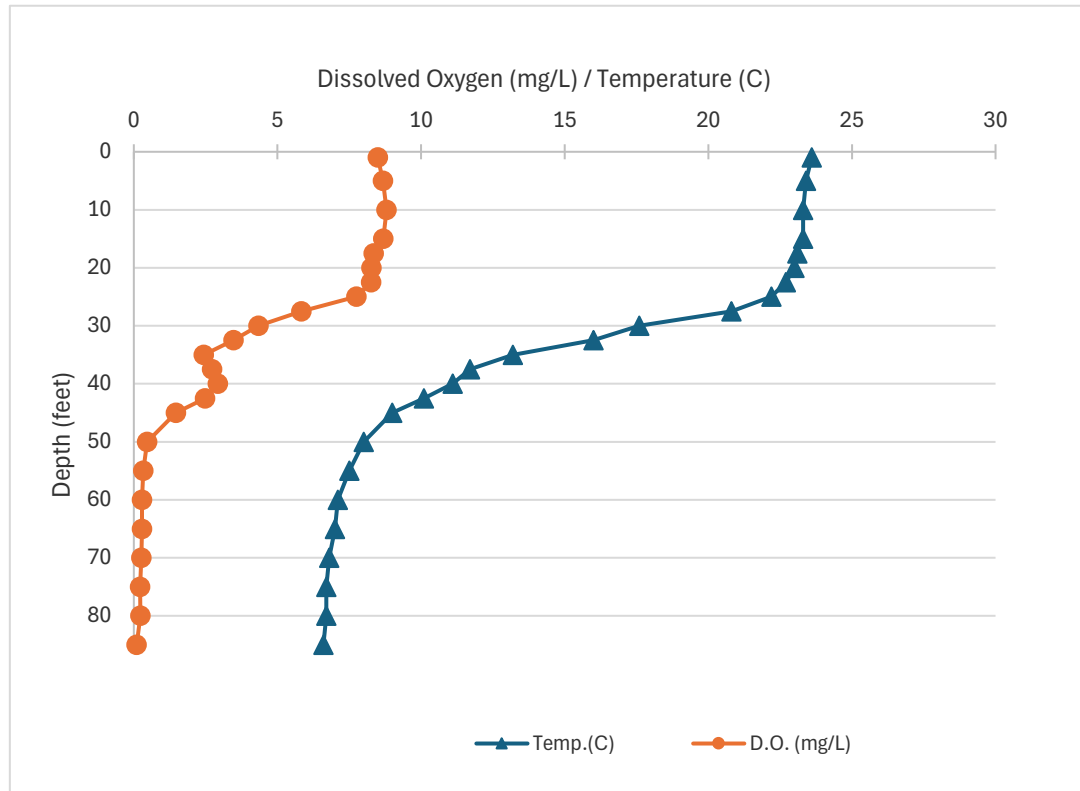
Dissolved Oxygen and Temperature Profile

Name: Birch Lake
County: Cass
Site ID: 140187
Date: 9/21/2024

Depth (ft)	Temp.(C)	D.O. (mg/L)
1	23.6	8.49
5	23.4	8.67
10	23.3	8.8
15	23.3	8.69
17.5	23.1	8.35
20	23	8.27
22.5	22.7	8.26
25	22.2	7.75
27.5	20.8	5.83
30	17.6	4.34
32.5	16	3.47
35	13.2	2.44
37.5	11.7	2.72
40	11.1	2.93
42.5	10.1	2.48
45	9	1.46
50	8	0.46
55	7.5	0.33
60	7.1	0.29
65	7	0.28
70	6.8	0.26
75	6.7	0.22
80	6.7	0.23
85	6.6	0.1
