2024 Data Report for

Cranberry Lake, Ottawa County

Site ID: 700623

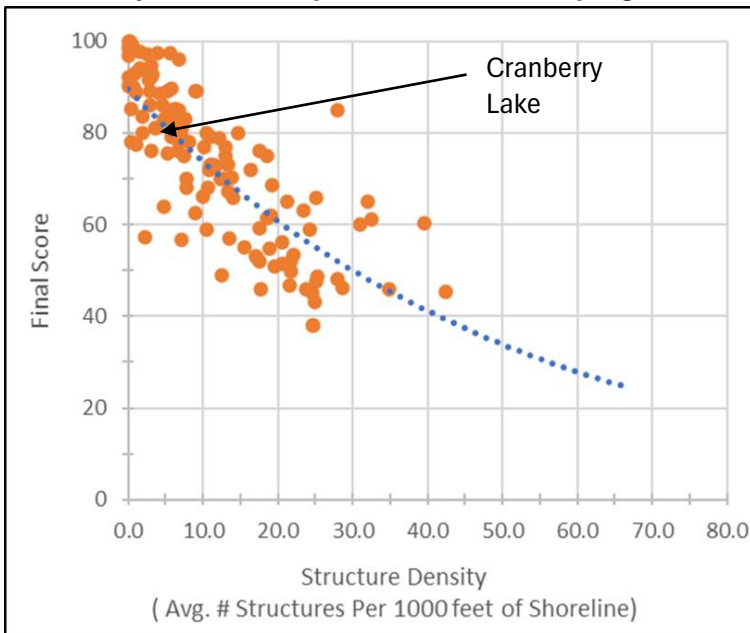
How does your lake compare to others in the program?

Note about graph to the left: The dotted line sets the average expectation of the score of your lake. If your lake is lower than the dotted line, then your shoreline health is lower than average compared to lakes with similar amount of shoreline development. And vice-versa in regards to a lake above the dotted line.

Cranberry Lake	
Number of Sections:	9
Number of Structures:	32
Structure Density:	4
Final Score:	81

All 123 Participating Lakes from 2015-2024:	
Avg. Number of Sections:	16
Avg. Number of Structures:	230
Avg. Structure Density:	12.2
Avg. Final Score:	73.2

Overall, the lakeshore habitat of Cranberry Lake scored about average when compared to other lakes in the program with similar amount of development. Most of the 1000 foot sections scored either Fair or Good (3 fair and 5 good), while 1 section scored Poor.

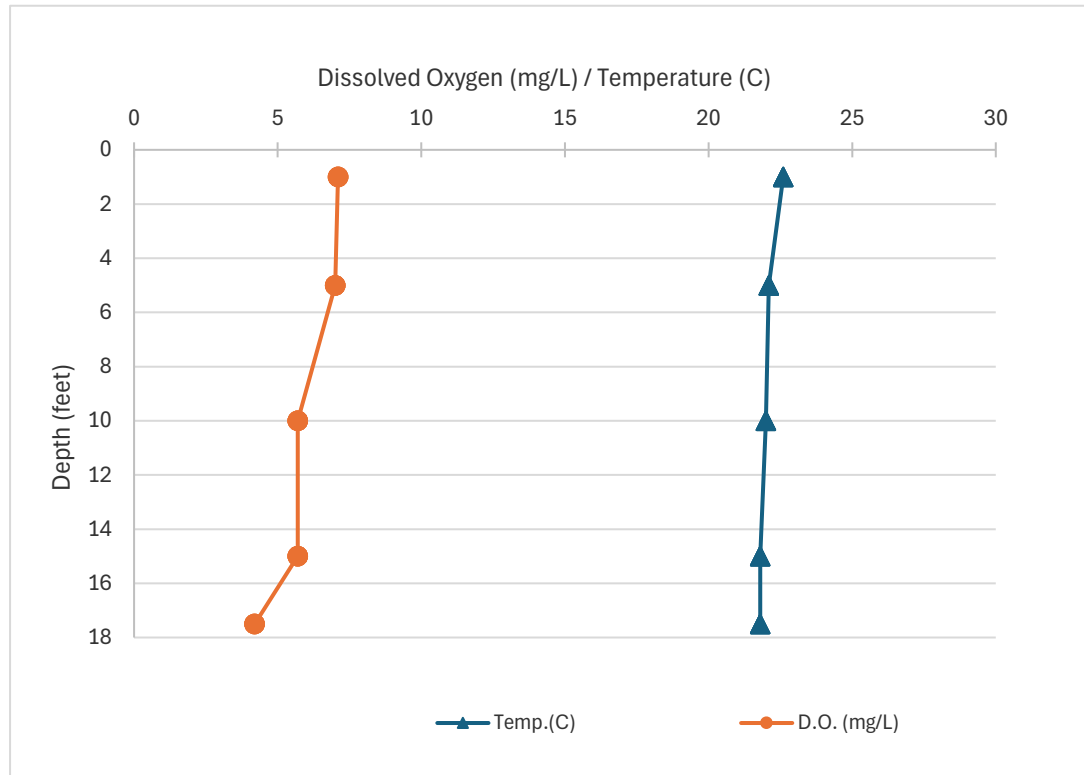
Name: Cranberry Lake
 County: Ottawa
 Site ID: 700623
 Date: 9/16/2002

Dissolved Oxygen and Temperature Profile

Depth (ft)	Temp.(C)	D.O. (mg/L)
1	22.6	7.1
1	22.6	7.1
1	22.6	7.1
1	22.6	7.1
5	22.1	7
5	22.1	7
5	22.1	7
5	22.1	7
10	22	5.7
10	22	5.7
10	22	5.7
10	22	5.7
15	21.8	5.7
15	21.8	5.7
15	21.8	5.7
15	21.8	5.7
17.5	21.8	4.2
17.5	21.8	4.2
17.5	21.8	4.2
17.5	21.8	4.2
