2024 Data Report for Crystal Lake, Hillsdale County

Site ID: 300269

Crystal Lake, Hillsdale County 2024 CLMP Results

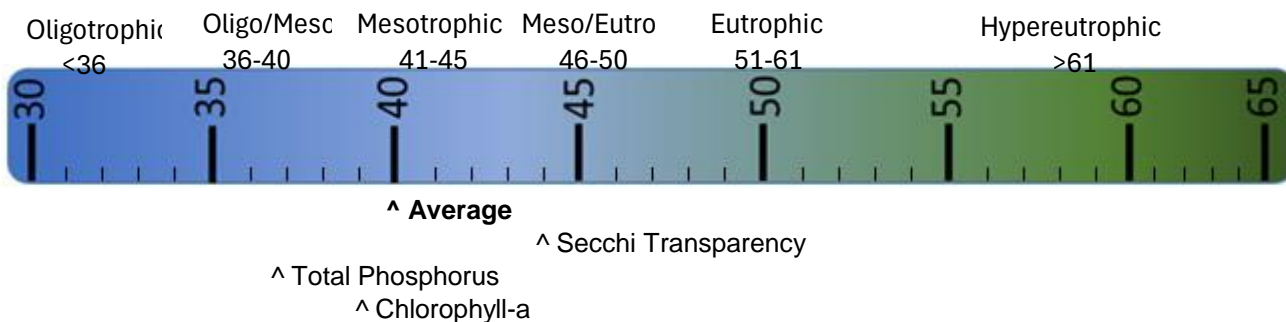
With an average TSI score of 40 based on 2024 Secchi transparency, chlorophyll-a, and summer total phosphorus data, this lake is rated as mesotrophic.

TSI for Crystal Lake in 2024	
Average	40
Secchi Disk	44
Summer TP	37
Chlorophyll-a	39

In 1977, limnologist Dr. Robert Carlson developed a numerical scale (0-100) where the numbers indicate the level of nutrient enrichment. Using the proper equations, we can convert results from Summer Total Phosphorus, Secchi Depth, and Chlorophyll-a to this Trophic Status Index (TSI). The TSI numbers are furthermore grouped into general categories (oligotrophic, mesotrophic, eutrophic, and hypereutrophic), to quickly give us a way to understand the general nutrient level of any lake.

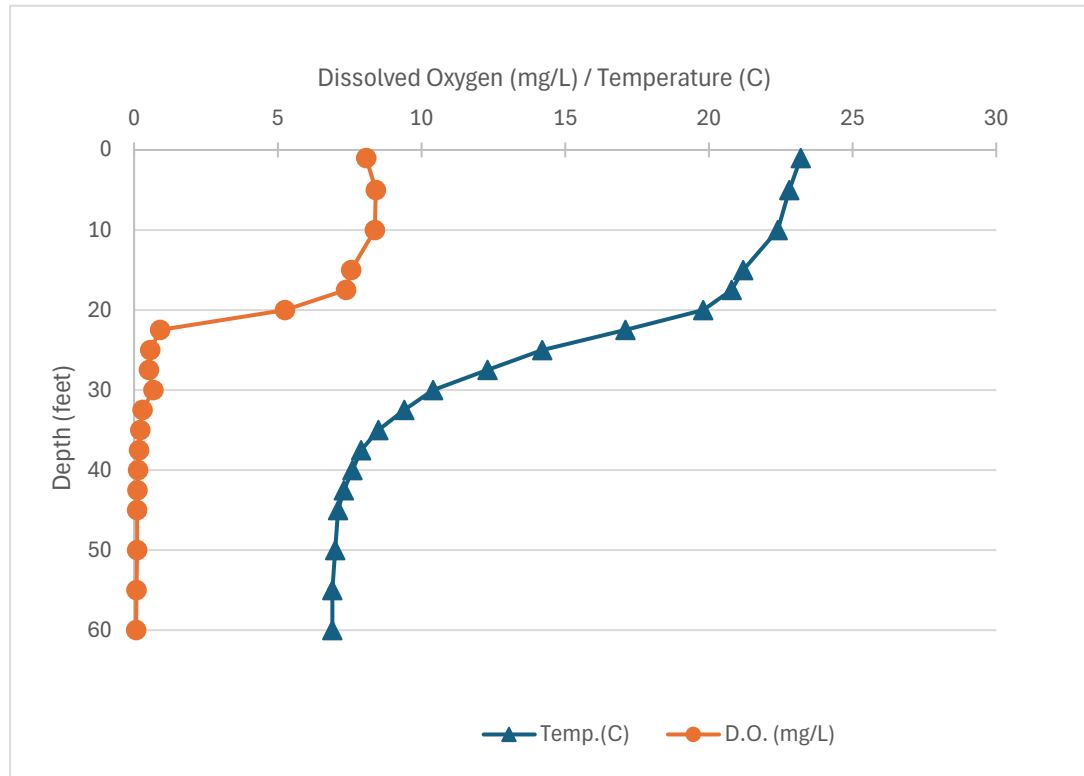
9/16/2024

Dissolved Oxygen and Temperature Profile

Depth (ft)	Temp.(C)	D.O. (mg/L)
1	23.2	8.08
5	22.8	8.41
10	22.4	8.38
15	21.2	7.56
17.5	20.8	7.38
20	19.8	5.25
22.5	17.1	0.91
25	14.2	0.56
27.5	12.3	0.52
30	10.4	0.67
32.5	9.4	0.29
35	8.5	0.22
37.5	7.9	0.17
40	7.6	0.14
42.5	7.3	0.12
45	7.1	0.11
50	7	0.1
55	6.9	0.08
60	6.9	0.07
