2024 Data Report for Diamond Lake, Cass County

Site ID: 140039

41.9038°N, 85.9666°W

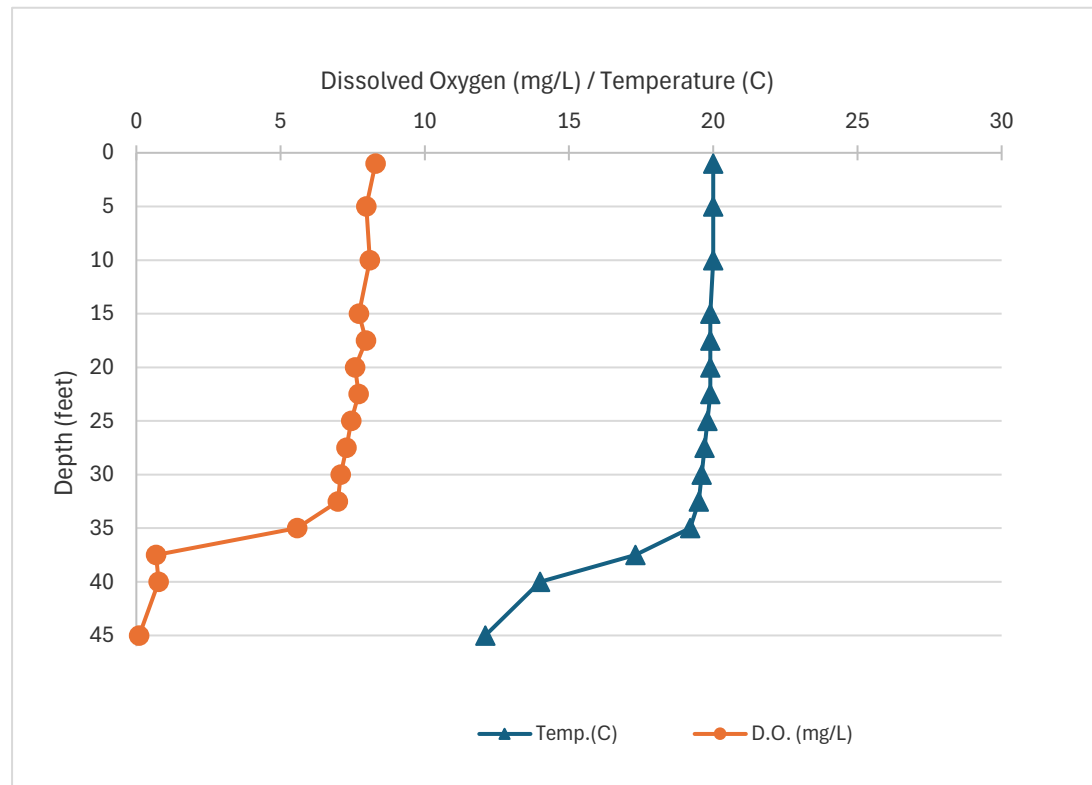
9/13/2017

Dissolved Oxygen and Temperature Profile

Depth (ft)	Temp.(C)	D.O. (mg/L)
1	20	8.29
5	20	7.97
10	20	8.09
15	19.9	7.72
17.5	19.9	7.96
20	19.9	7.59
22.5	19.9	7.71
25	19.8	7.45
27.5	19.7	7.28
30	19.6	7.09
32.5	19.5	6.99
35	19.2	5.58
37.5	17.3	0.68
40	14	0.77
45	12.1	0.1
