## 2024 Data Report for

## Duck Lake, Muskegon County

## Site ID: 610778

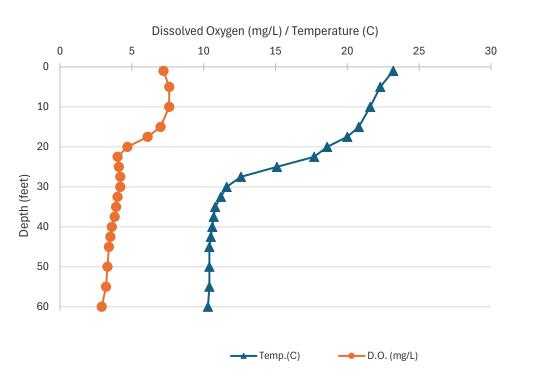
9/16/2024

#### **Dissolved Oxygen and Temperature Profile**

Depth (ft)	Temp.(C)	D.O. (mg/L)
1	23.2	7.2
5	22.3	7.6
10	21.6	7.6
15	20.8	7
17.5	20	6.1
20	18.6	4.7
22.5	17.7	4
25	15.1	4.1
27.5	12.6	4.2
30	11.6	4.2
32.5	11.2	4
35	10.8	3.9
37.5	10.7	3.8
40	10.6	3.6
42.5	10.5	3.5
45	10.4	3.4
50	10.4	3.3
55	10.4	3.2
60	10.3	2.9
