# 2024 Data Report for

## Lake Ellen, Iron County

Site ID: 360050

## Lake Ellen, Iron County 2024 CLMP Results

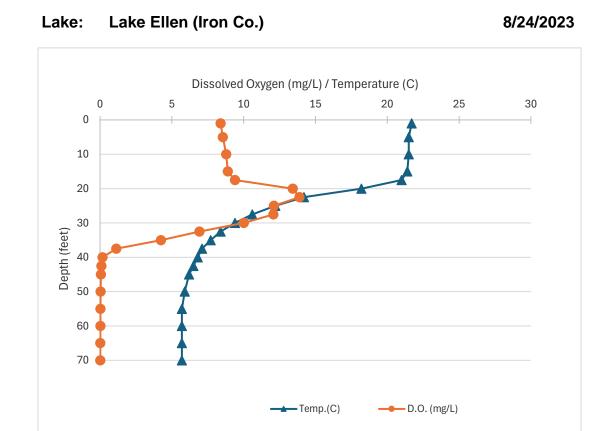
Name: Lake Ellen County: Iron Site ID: 360050 Date: 8/24/2023

Depth (ft)	Temp.(C)	D.O. (mg/L)
1	21.7	8.4
5	21.5	8.55
10	21.5	8.79
15	21.4	8.9
17.5	21	9.4
20	18.2	13.42
22.5	14.2	13.89
25	12.2	12.1
27.5	10.6	12.07
30	9.4	10.01
32.5	8.4	6.92
35	7.7	4.24
37.5	7.1	1.13
40	6.8	0.17
42.5	6.5	0.09
45	6.2	0.06
50	5.9	0.04
55	5.7	0.03
60	5.7	0.03
65	5.7	0.02
70	5.7	0.02
