2024 Data Report for

Fishers Lake, St. Joseph County

Site ID: 750139

Fishers Lake, St. Joseph County 2024 CLMP Results

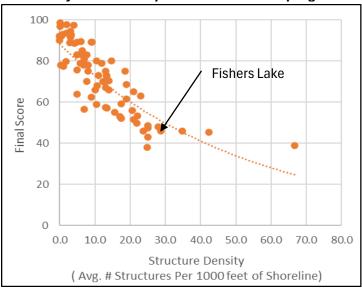
How does your lake compare to others in the program?

Fishers Lake				
Number of Sections:	21			
Number of Structures:	601			
Structure Density:	29			
Final Score:	46

All 78 Participating Lakes from 2015-2021:				
Avg. Number of Sections: 16				
Avg. Number of Structures:	214			
Avg. Structure Density:	12.2			
Avg. Final Score:	72

Note about graph to the left: The dotted line sets your average expectation of the score of your lake. If your lake is lower than the dotted line, then your shoreline health is lower than average compared to *lakes with similar amount of shoreline development*. And vice-versa in regards to a lake above the dotted line.

Overall, the lakeshore habitat of Fishers Lake is below average when compared to the other lakes in the program. Most of the lake sections scored poor (17 poor, 2 fair, 2 good).

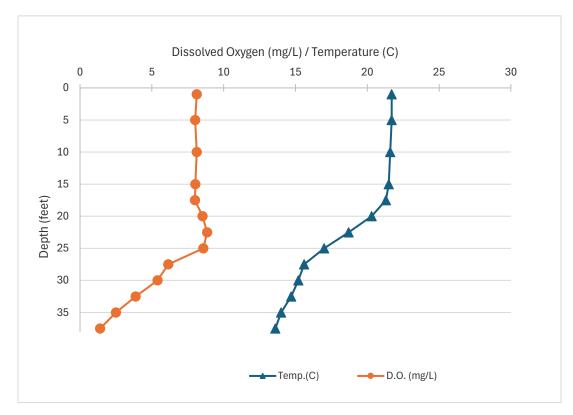
Name: Fishers Lake County: St. Joseph Site ID: 750139 Date: 5/3/2024

Depth (ft)	Temp.(C)	D.O. (mg/L)
1	21.7	8.13
5	21.7	8.02
10	21.6	8.13
15	21.5	8.03
17.5	21.3	8.01
20	20.3	8.53
22.5	18.7	8.85
25	17	8.58
27.5	15.6	6.15
30	15.2	5.4
32.5	14.7	3.87
35	14	2.5
37.5	13.6	1.4

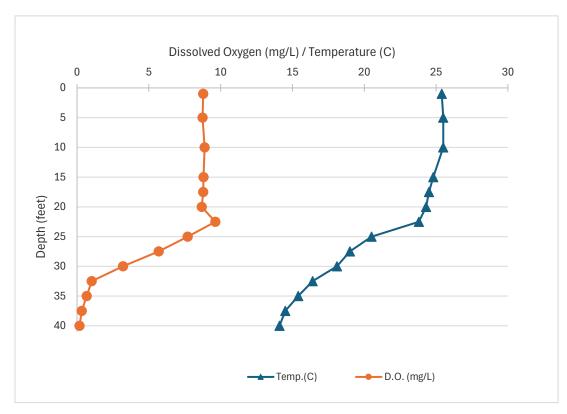
Name: Fishers Lake County: St. Joseph Site ID: 750139 Date: 6/30/2024

Depth (ft)	Temp.(C)	D.O. (mg/L)
1	25.4	8.78
5	25.5	8.74
10	25.5	8.88
15	24.8	8.81
17.5	24.5	8.78
20	24.3	8.69
22.5	23.8	9.63
25	20.5	7.7
27.5	19	5.69
30	18.1	3.2
32.5	16.4	1.02
35	15.4	0.68
37.5	14.5	0.33
40	14.1	0.17

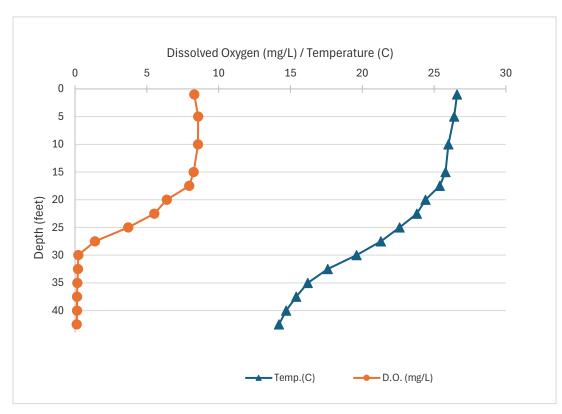
Name: Fishers Lake County: St. Joseph Site ID: 750139 Date: 7/21/2024

Depth (ft)	Temp.(C)	D.O. (mg/L)
1	26.6	8.31
5	26.4	8.57
10	26	8.56
15	25.8	8.26
17.5	25.4	7.95
20	24.4	6.39
22.5	23.8	5.52
25	22.6	3.7
27.5	21.3	1.39
30	19.6	0.23
32.5	17.6	0.21
35	16.2	0.16
37.5	15.4	0.14
40	14.7	0.14
42.5	14.2	0.12

This lake displays a normal stratification pattern. The lake maintains some dissolved oxygen in the bottom waters through early summer, but by mid-summer the lake has stratified and the bottom water is devoid of oxygen.

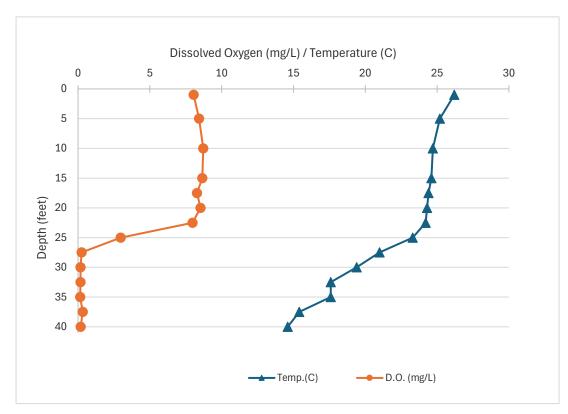
Name: Fishers Lake County: St. Joseph Site ID: 750139 Date: 8/13/2024

Depth (ft)	Temp.(C)	D.O. (mg/L)
1	26.2	8.05
5	25.2	8.43
10	24.7	8.72
15	24.6	8.65
17.5	24.4	8.28
20	24.3	8.53
22.5	24.2	7.97
25	23.3	2.97
27.5	21	0.25
30	19.4	0.17
32.5	17.6	0.17
35	17.6	0.15
37.5	15.4	0.33
40	14.6	0.18

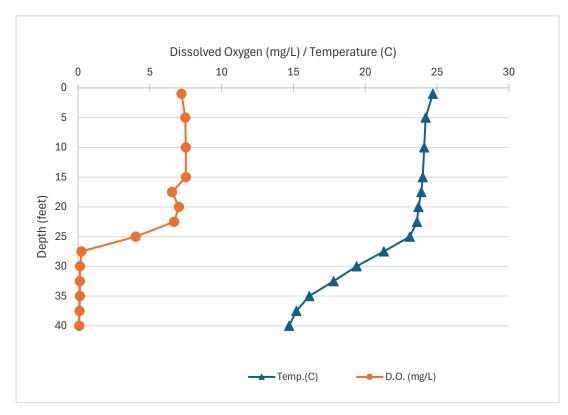
Name: Fishers Lake County: St. Joseph Site ID: 750139 Date: 8/21/2024

Depth (ft)	Temp.(C)	D.O. (mg/L)
1	24.7	7.2
5	24.2	7.47
10	24.1	7.5
15	24	7.51
17.5	23.9	6.55
20	23.7	7.02
22.5	23.6	6.69
25	23.1	4.02
27.5	21.3	0.24
30	19.4	0.14
32.5	17.8	0.13
35	16.1	0.13
37.5	15.2	0.11
40	14.7	0.08

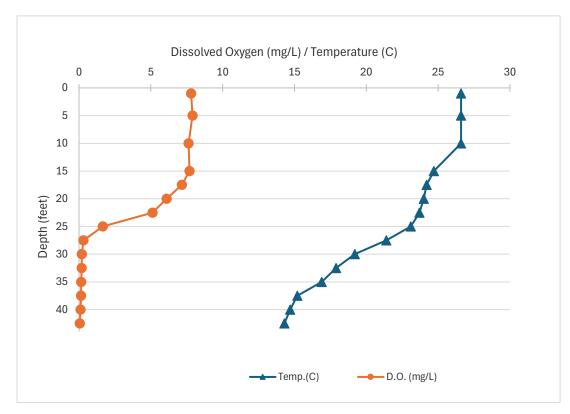
Name: Fishers Lake County: St. Joseph Site ID: 750139 Date: 8/29/2024

Depth (ft)	Temp.(C)	D.O. (mg/L)
1	26.6	7.8
5	26.6	7.9
10	26.6	7.63
15	24.7	7.69
17.5	24.2	7.16
20	24	6.1
22.5	23.7	5.12
25	23.1	1.66
27.5	21.4	0.31
30	19.2	0.2
32.5	17.9	0.18
35	16.9	0.15
37.5	15.2	0.14
40	14.7	0.11
42.5	14.3	0.05

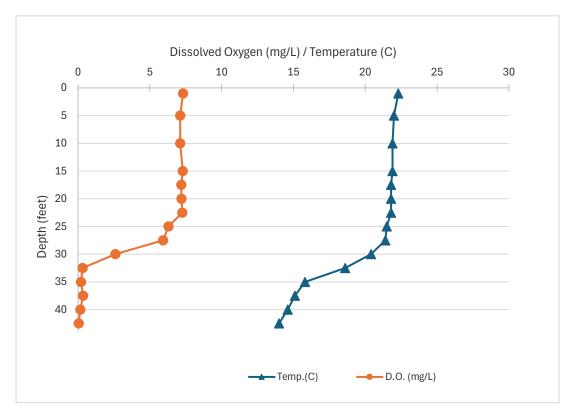
Name: Fishers Lake County: St. Joseph Site ID: 750139 Date: 9/10/2024

Depth (ft)	Temp.(C)	D.O. (mg/L)
1	22.3	7.31
5	22	7.11
10	21.9	7.11
15	21.9	7.29
17.5	21.8	7.19
20	21.8	7.2
22.5	21.8	7.26
25	21.5	6.3
27.5	21.4	5.92
30	20.4	2.6
32.5	18.6	0.32
35	15.8	0.21
37.5	15.1	0.35
40	14.6	0.16
42.5	14	0.05

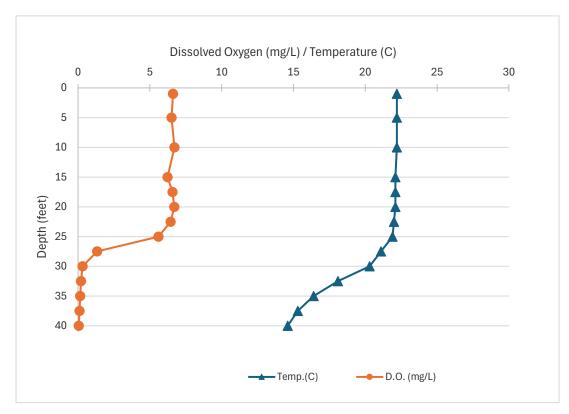
Name: Fishers Lake County: St. Joseph Site ID: 750139 Date: 9/25/2024

Depth (ft)	Temp.(C)	D.O. (mg/L)
1	22.2	6.61
5	22.2	6.51
10	22.2	6.71
15	22.1	6.23
17.5	22.1	6.58
20	22.1	6.7
22.5	22	6.45
25	21.9	5.6
27.5	21.1	1.33
30	20.3	0.32
32.5	18.1	0.21
35	16.4	0.15
37.5	15.3	0.11
40	14.6	0.05
