2024 Data Report for Juno Lake, Cass County

Site ID: 140058

2024 CLMP Results

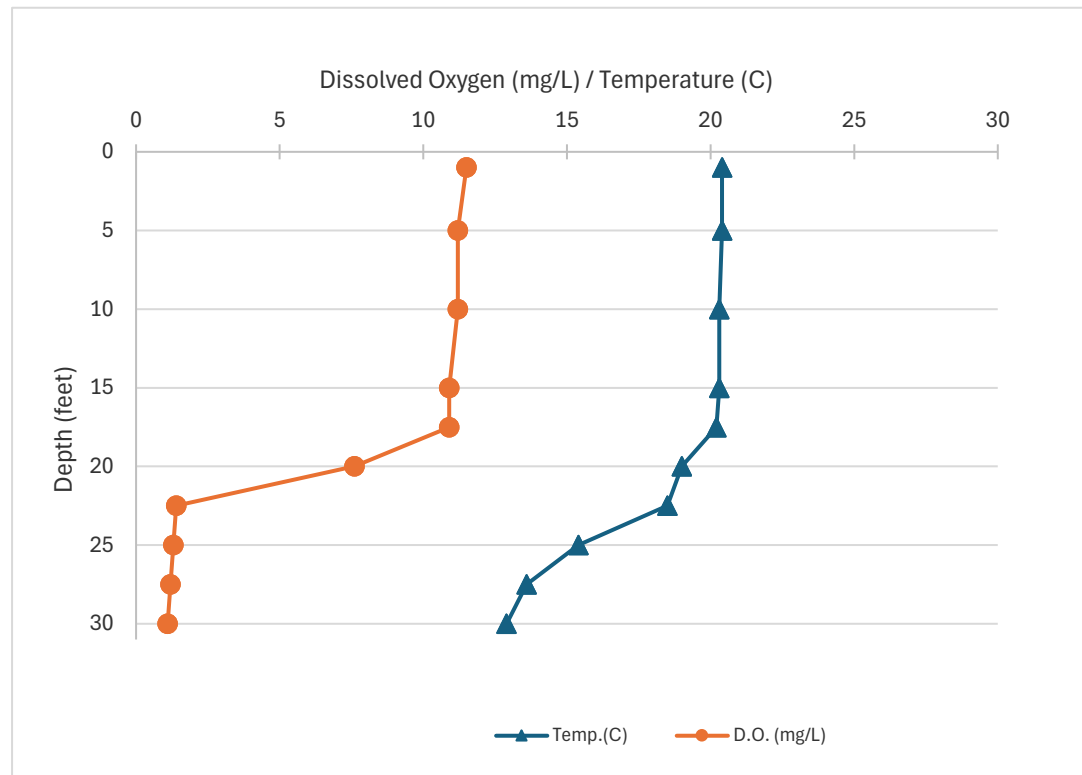
9/24/2022

Dissolved Oxygen and Temperature Profile

Depth (ft)	Temp.(C)	D.O. (mg/L)
1	20.4	11.5
1	20.4	11.5
5	20.4	11.2
5	20.4	11.2
10	20.3	11.2
10	20.3	11.2
15	20.3	10.9
15	20.3	10.9
17.5	20.2	10.9
17.5	20.2	10.9
20	19	7.6
20	19	7.6
22.5	18.5	1.4
22.5	18.5	1.4
25	15.4	1.3
25	15.4	1.3
27.5	13.6	1.2
27.5	13.6	1.2
30	12.9	1.1
30	12.9	1.1
