2024 Data Report for

Lake of the Woods, Branch County

Site ID: 120111

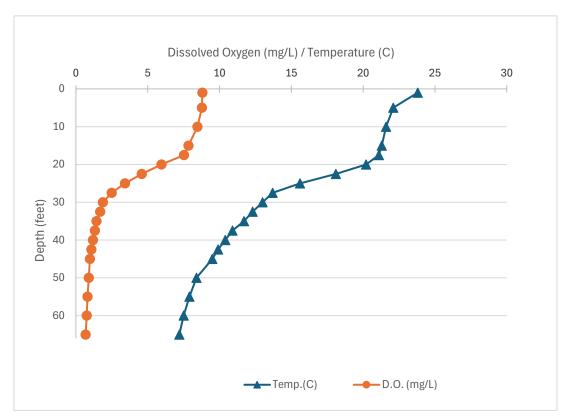
County: Branch
Site ID: 120111
Date: 9/19/2024

Depth (ft) Temp.(C) D.O. (mg/L) 23.8 8.81 5 22.1 8.77 10 21.6 8.46 15 21.3 7.84 17.5 21.1 7.53 20 20.2 5.95 22.5 18.1 4.58 25 15.6 3.42 2.49 27.5 13.7 30 13 1.88 32.5 12.3 1.69 35 11.7 1.43 37.5 10.9 1.32 40 10.4 1.19 42.5 9.9 1.07 45 9.5 0.97 50 8.4 0.9 55 7.9 0.81 60 7.5 0.75 65 7.2 0.68
