2024 Data Report for

Maceday Lake, Oakland County

Site ID: 630415

Maceday Lake, Oakland County 2024 CLMP Results

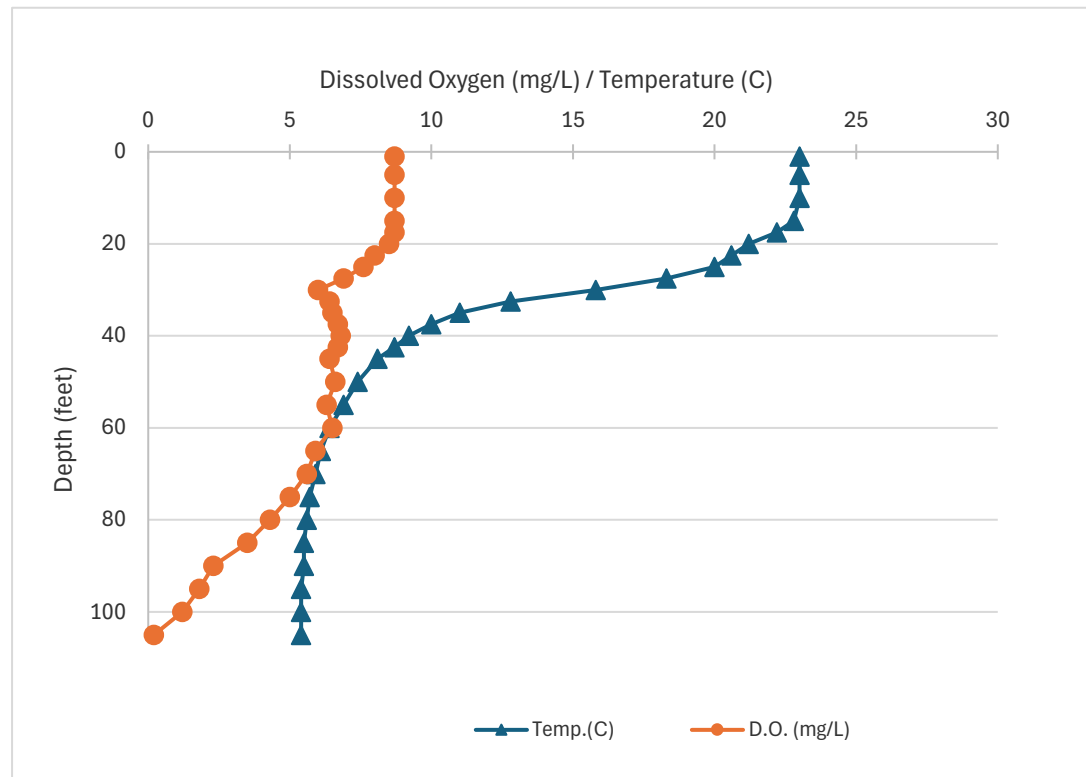
9/20/2024

Dissolved Oxygen and Temperature Profile

Depth (ft)	Temp.(C)	D.O. (mg/L)
1	23	8.7
5	23	8.7
10	23	8.7
15	22.8	8.7
17.5	22.2	8.7
20	21.2	8.5
22.5	20.6	8
25	20	7.6
27.5	18.3	6.9
30	15.8	6
32.5	12.8	6.4
35	11	6.5
37.5	10	6.7
40	9.2	6.8
42.5	8.7	6.7
45	8.1	6.4
50	7.4	6.6
55	6.9	6.3
60	6.4	6.5
65	6.1	5.9
70	5.9	5.6
75	5.7	5
80	5.6	4.3
85	5.5	3.5
90	5.5	2.3
95	5.4	1.8
100	5.4	1.2
105	5.4	0.2
