2024 Data Report for Perch Lake, Otsego County

Site ID: 690150

2024 CLMP Results

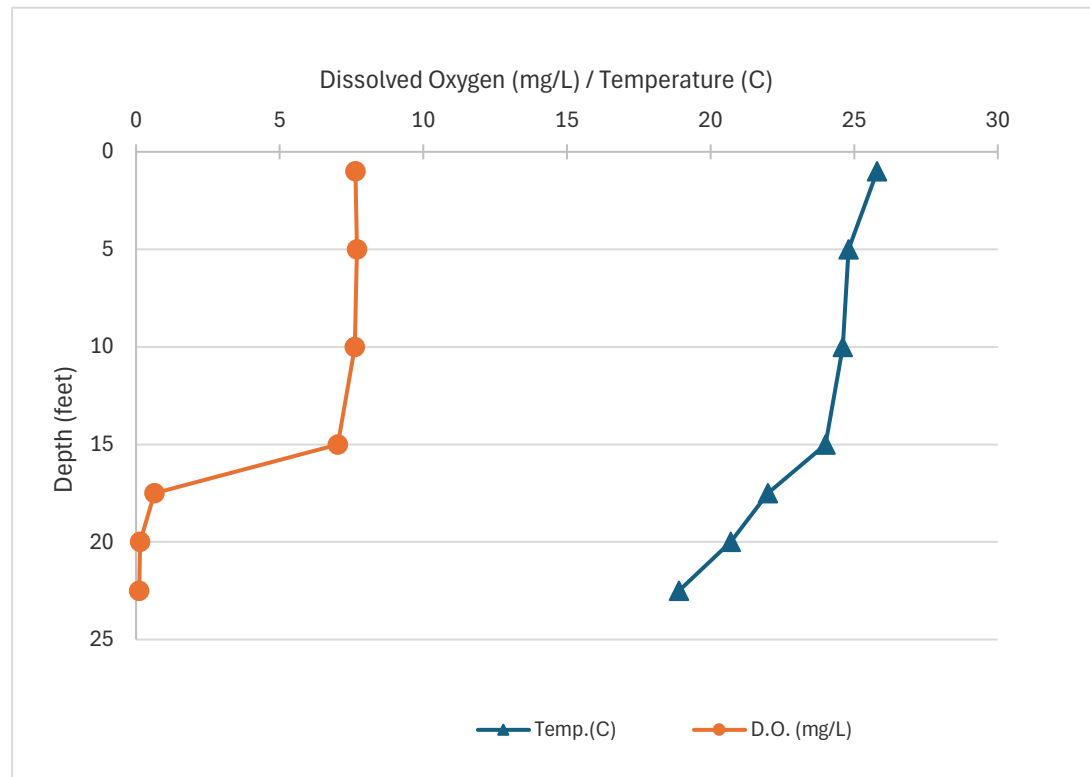
Name: Perch Lake
County: Otsego
Site ID: 690150
Date: 7/28/2024

Depth (ft)	Temp.(C)	D.O. (mg/L)
1	25.8	7.64
5	24.8	7.69
10	24.6	7.61
15	24	7.03
17.5	22	0.64
20	20.7	0.14
22.5	18.9	0.11
