2024 Data Report for Pleasant (Northwest Basin) Lake, Washtenaw County

Site ID: 810266

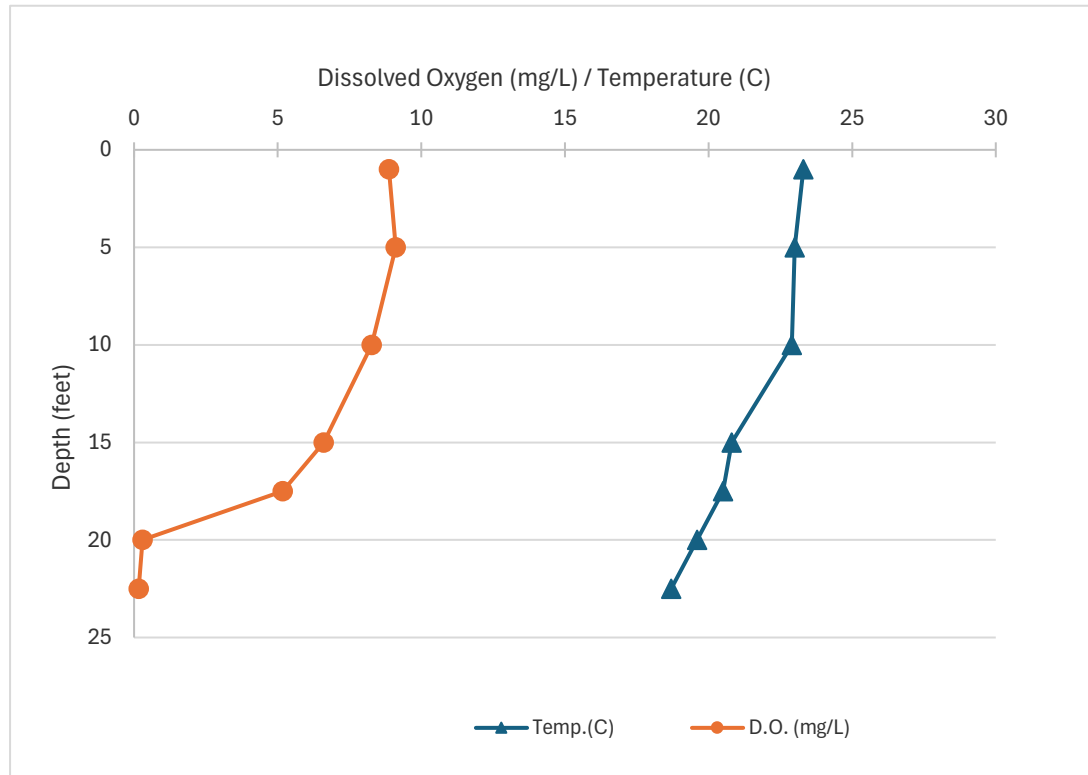
Name: Pleasant (Northwest Basin) Lake
County: Washtenaw
Site ID: 810266
Date: 9/14/2024

Dissolved Oxygen and Temperature Profile
