2024 Data Report for

Rennie Lake, Grand Traverse County

Site ID: 280430

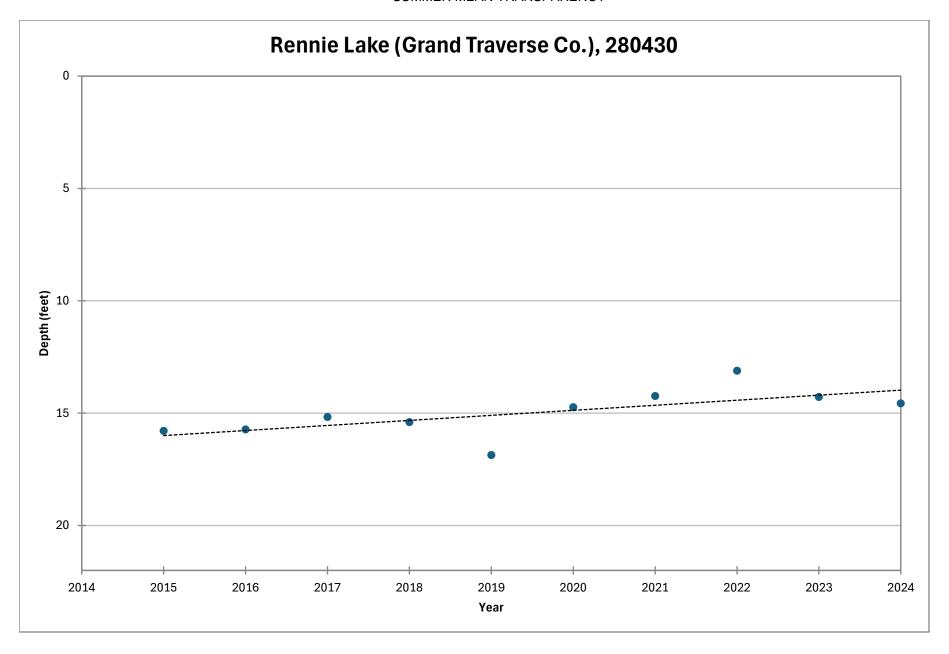
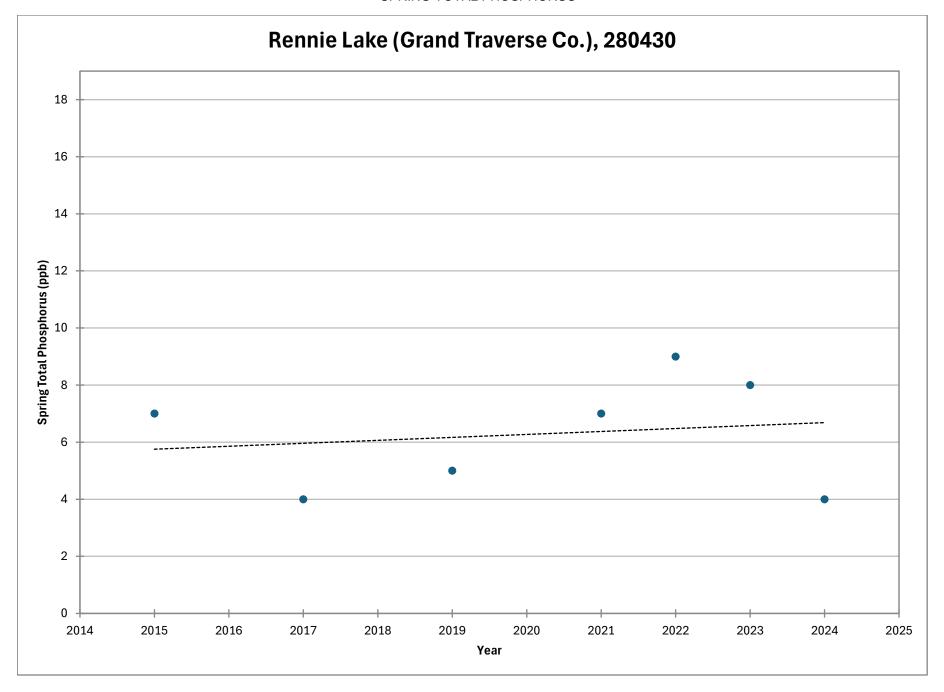
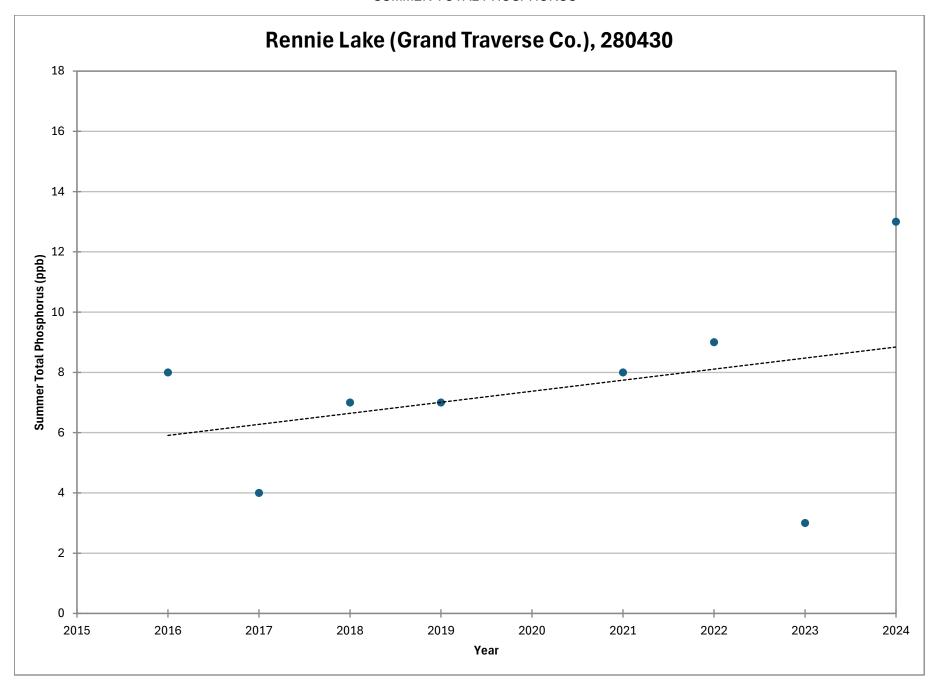
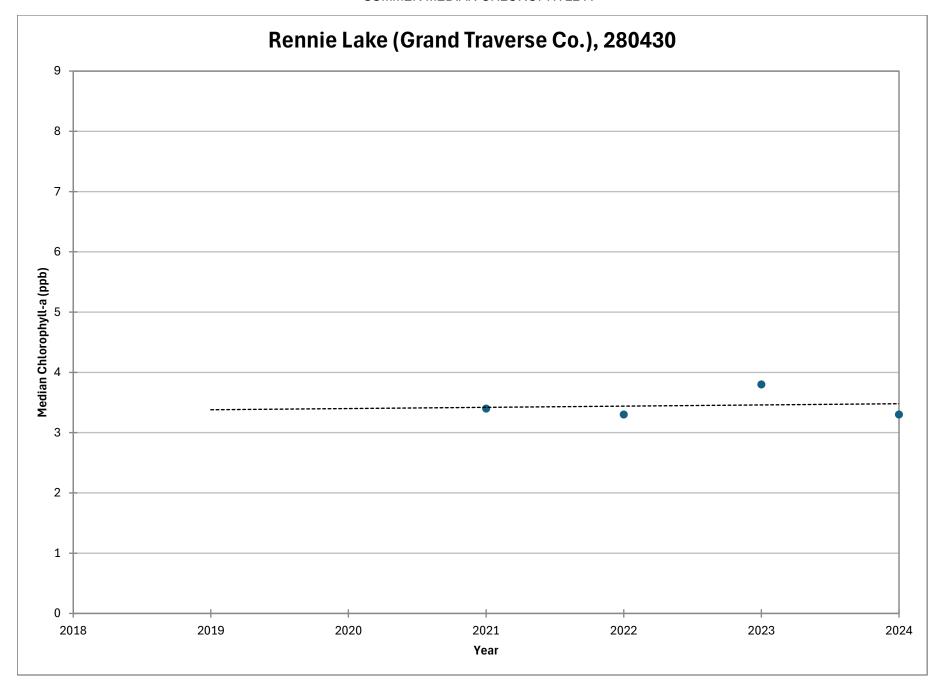
Site ID: 280430 Date: 5/17/2021

Temp.(C)	D.O. (mg/L)
15.3	11.9
14.8	12
14.4	12
12.9	12.5
12.4	12.5
12.2	12.3
12.2	12.2
12.2	12.2
	15.3 14.8 14.4 12.9 12.4 12.2

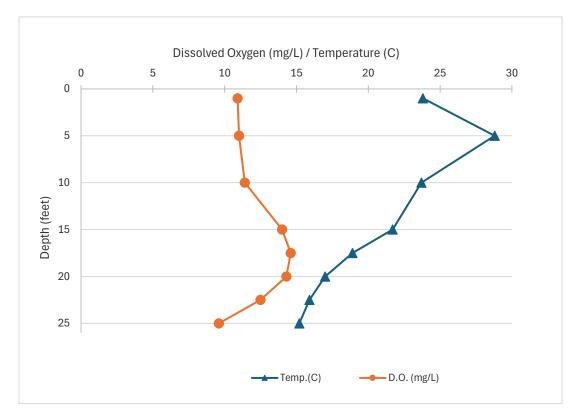
Site ID: 280430 Date: 6/17/2021

Depth (ft)	Temp.(C)	D.O. (mg/L)
1	23.8	10.9
5	28.8	11
10	23.7	11.4
15	21.7	14
17.5	18.9	14.6
20	17	14.3
22.5	15.9	12.5
25	15.2	9.6

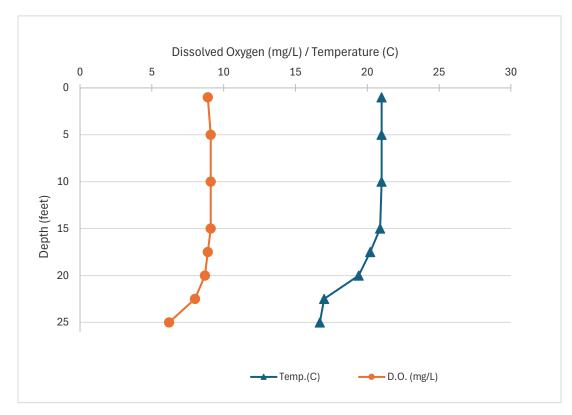
Site ID: 280430 Date: 6/23/2021

Depth (ft)	Temp.(C)	D.O. (mg/L)
1	21	8.9
5	21	9.1
10	21	9.1
15	20.9	9.1
17.5	20.2	8.9
20	19.4	8.7
22.5	17	8
25	16.7	6.2

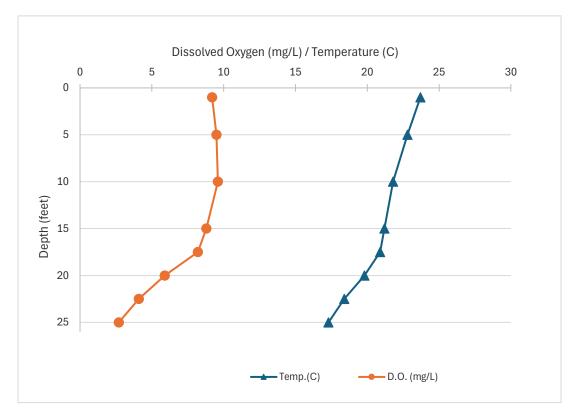
Site ID: 280430 Date: 6/30/2021

Depth (ft)	Temp.(C)	D.O. (mg/L)
1	23.7	7 9.2
5	22.8	9.5
10	21.8	9.6
15	21.2	2 8.8
17.5	20.9	8.2
20	19.8	5.9
22.5	18.4	4.1
25	17.3	3 2.7

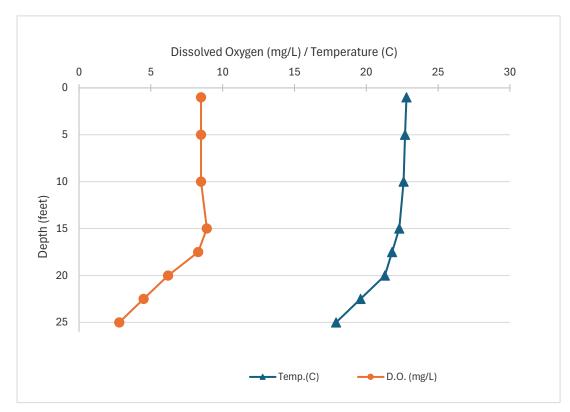
Site ID: 280430 Date: 7/9/2021

Temp.(C)	D.O. (mg/L)
22.8	8.5
22.7	8.5
22.6	8.5
22.3	8.9
21.8	8.3
21.3	6.2
19.6	4.5
17.9	2.8
	22.8 22.7 22.6

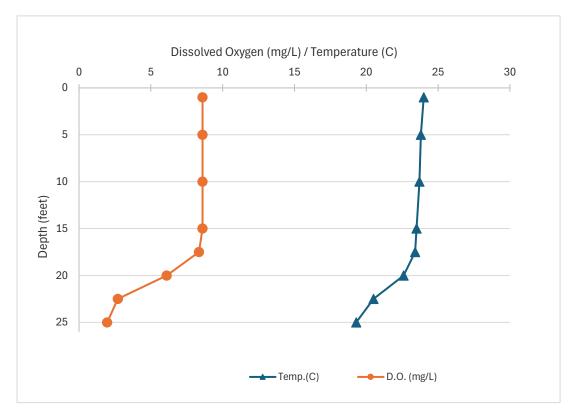
Site ID: 280430 Date: 7/16/2021

Depth (ft)	Temp.(C)	D.O. (mg/L)
1	24	8.6
5	23.8	8.6
10	23.7	8.6
15	23.5	8.6
17.5	23.4	8.35
20	22.6	6.1
22.5	20.5	2.7
25	19.3	1.96

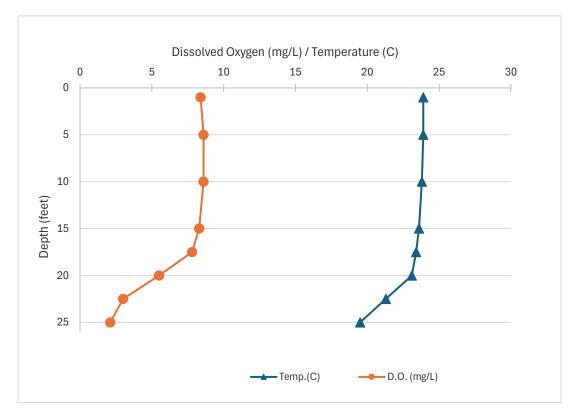
Site ID: 280430 Date: 7/21/2021

Depth (ft)	Temp.(C)	D.O. (mg/L)
1	23.9	8.4
5	23.9	8.6
10	23.8	8.6
15	23.6	8.3
17.5	23.4	7.8
20	23.1	5.5
22.5	21.3	3
25	19.5	2.1

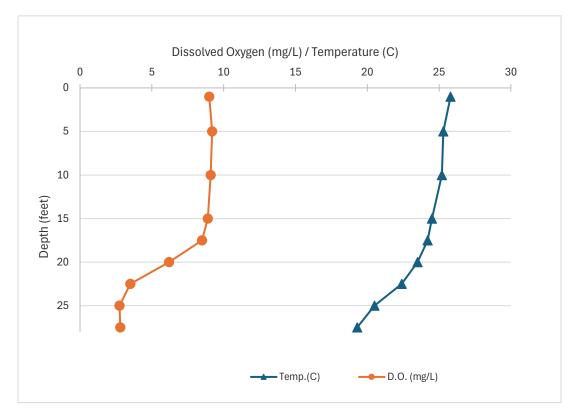
Site ID: 280430 Date: 7/28/2021

Depth (ft)	Temp.(C)	D.O. (mg/L)
1	25.8	9
5	25.3	9.2
10	25.2	9.1
15	24.5	8.9
17.5	24.2	8.5
20	23.5	6.2
22.5	22.4	3.5
25	20.5	2.75
27.5	19.3	2.8

This lake displays a normal stratification pattern. The lake maintains some dissolved oxygen in the bottom waters through early summer. By mid-summer, the lake has stratified and the bottom water is mostly devoid of oxygen.

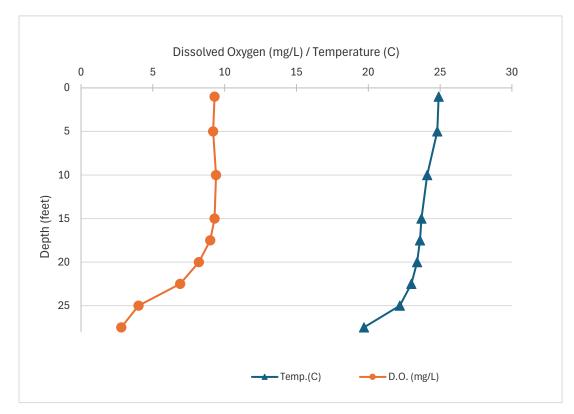
Site ID: 280430 Date: 8/5/2021

Depth (ft)	Temp.(C)	D.O. (mg/L)
1	24.9	9.3
5	24.8	9.2
10	24.1	9.4
15	23.7	9.3
17.5	23.6	9
20	23.4	8.2
22.5	23	6.9
25	22.2	4
27.5	19.7	2.8

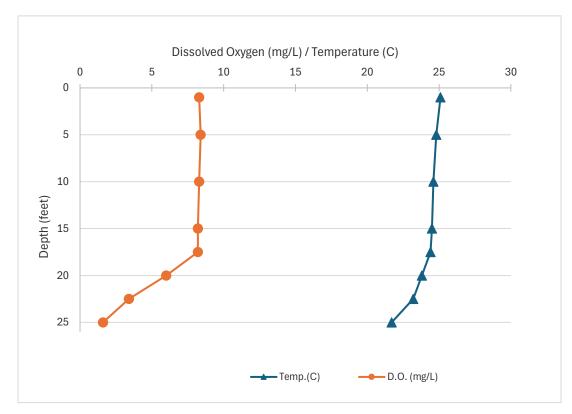
Site ID: 280430 Date: 8/13/2021

Depth (ft)	Temp.(C)	D.O. (mg/L)
1	25.1	8.3
5	24.8	8.4
10	24.6	8.3
15	24.5	8.2
17.5	24.4	8.2
20	23.8	6
22.5	23.2	3.4
25	21.7	1.6

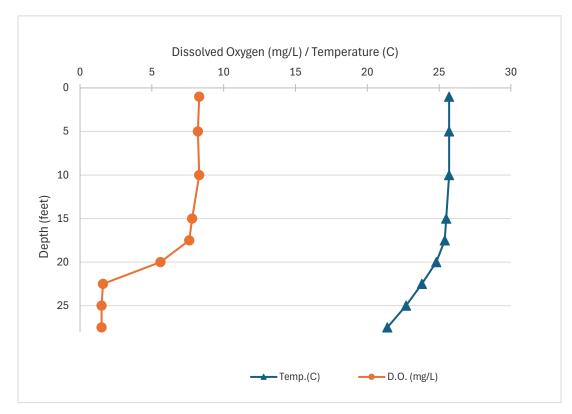
Site ID: 280430 Date: 8/26/2021

Depth (ft)	Temp.(C)	D.O. (mg/L)
1	25.7	8.3
5	25.7	8.2
10	25.7	8.3
15	25.5	7.8
17.5	25.4	7.6
20	24.8	5.6
22.5	23.8	1.6
25	22.7	7 1.5
27.5	21.4	1.5

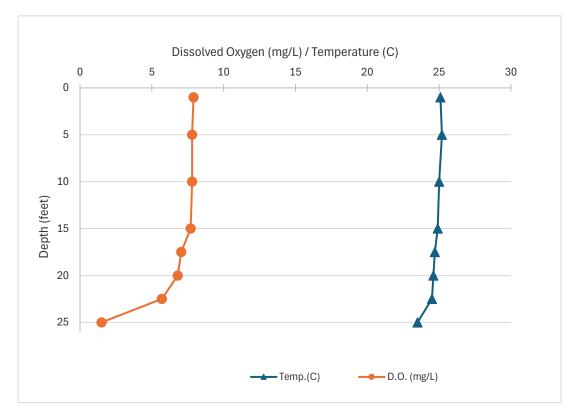
Site ID: 280430 Date: 8/31/2021

Depth (ft)	Temp.(C)	D.O. (mg/L)
1	25.1	7.9
5	25.2	7.8
10	25	7.8
15	24.9	7.7
17.5	24.7	7.05
20	24.6	6.8
22.5	24.5	5.7
25	23.5	1.5

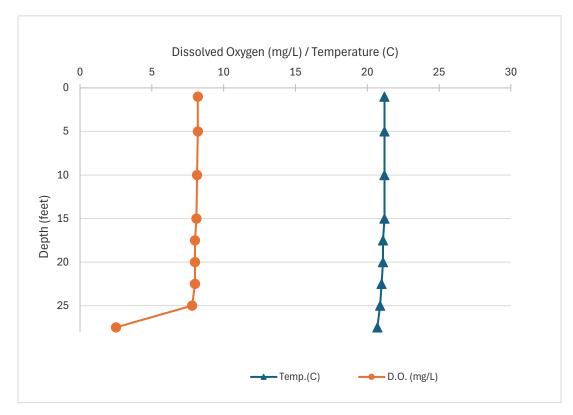
Site ID: 280430 Date: 9/9/2021

Depth (ft)	Temp.(C)	D.O. (mg/L)
1	21.2	8.2
5	21.2	8.2
10	21.2	8.15
15	21.2	8.1
17.5	21.1	8
20	21.1	8
22.5	21	8
25	20.9	7.8
27.5	20.7	2.5

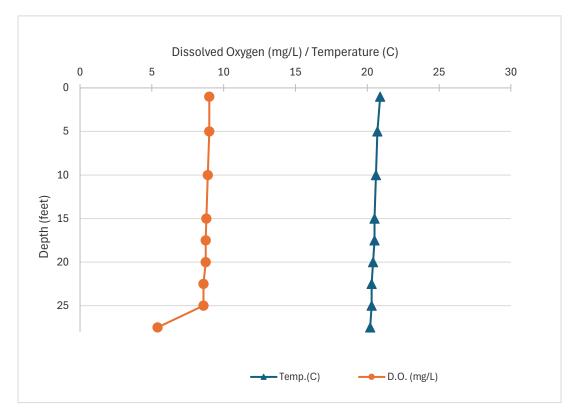
Site ID: 280430 Date: 9/13/2021

Depth (ft)	Temp.(C)	D.O. (mg/L)
1	20.9	9
5	20.7	9
10	20.6	8.9
15	20.5	8.8
17.5	20.5	8.75
20	20.4	8.75
22.5	20.3	8.6
25	20.3	8.6
27.5	20.2	5.4
