2024 Data Report for Rose Lake, Shiawassee County

Site ID: 780276

2024 CLMP Results

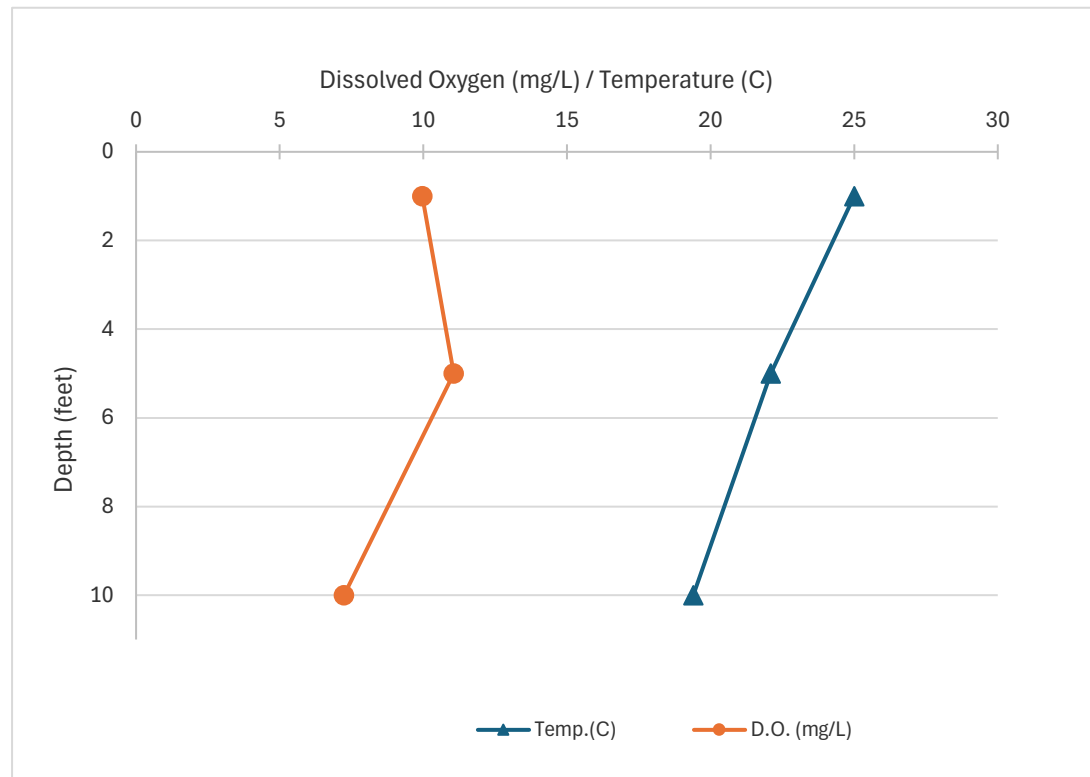
Name: Rose Lake
County: Shiawassee
Site ID: 780276
Date: 9/5/2024

Depth (ft)	Temp.(C)	D.O. (mg/L)
1	25	9.97
5	22.1	11.06
10	19.4	7.24
