2017 Data Report for

Buck Lake, Livingston County

Site ID: 360072

2017 CLMP Results

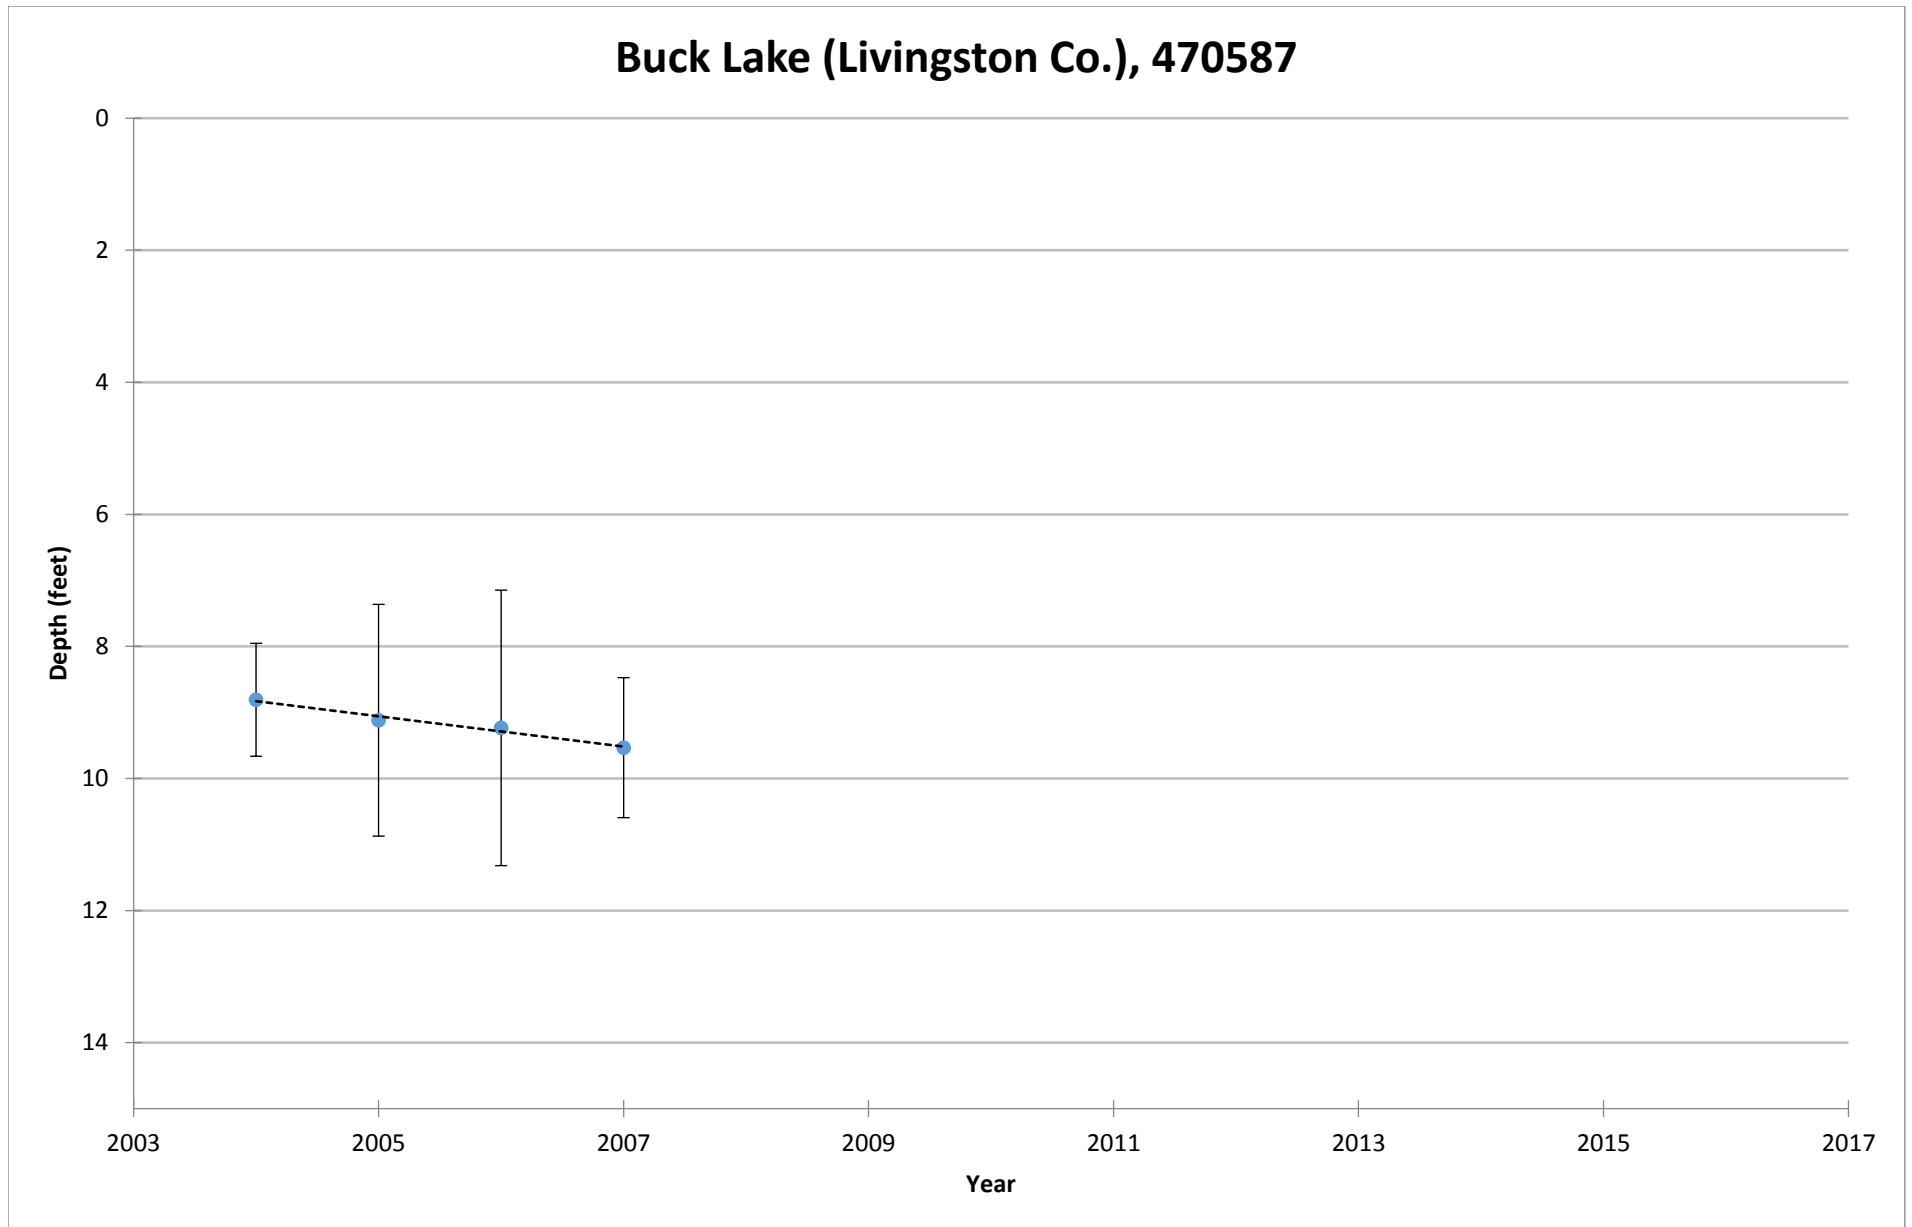
COOPERATIVE LAKES MONITORING PROGRAM
SUMMER MEAN TRANSPARENCY

Buck Lake (Livingston Co.), 470587

Vertical bars indicate standard deviation

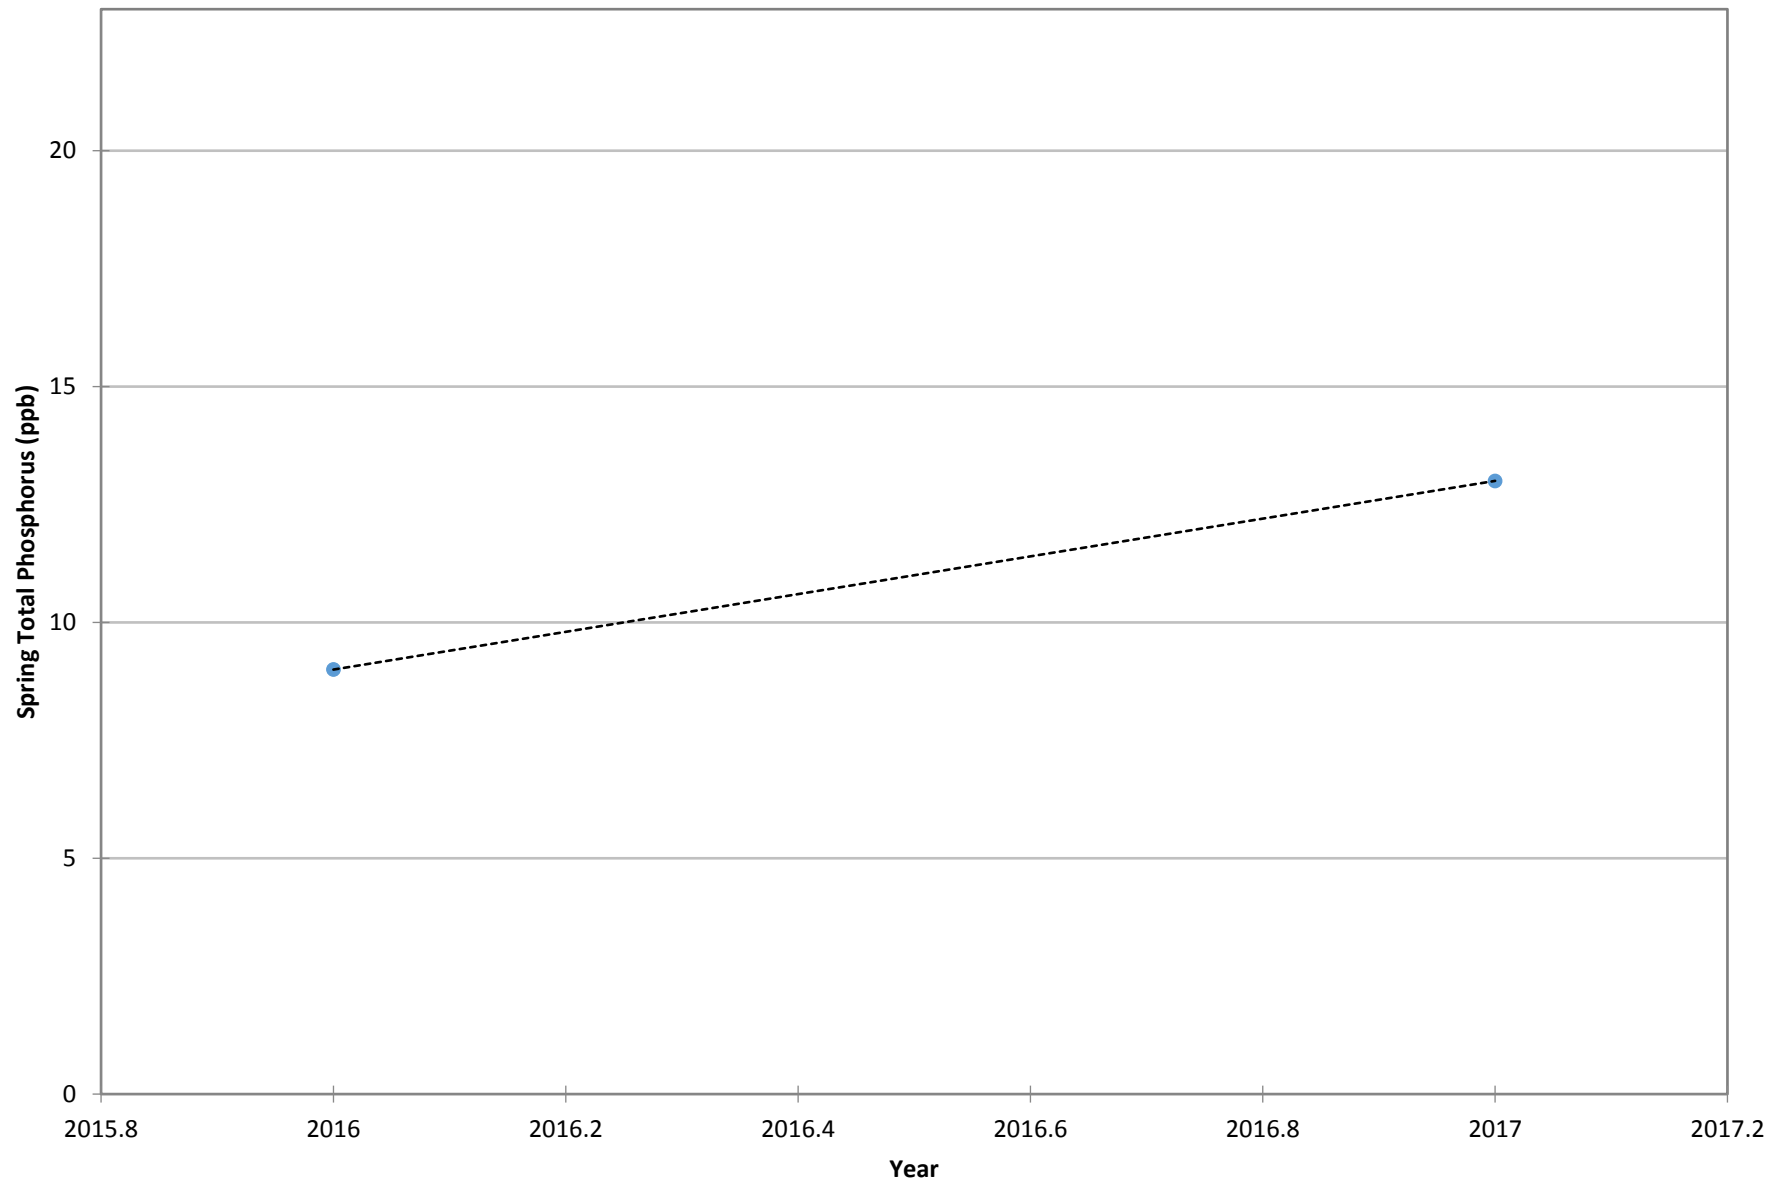
COOPERATIVE LAKES MONITORING PROGRAM
SPRING TOTAL PHOSPHORUS

Buck Lake (Iron Co.), 360072
