# 2017 Data Report for Cobb Lake, Barry County

Site ID: 080259

# Cobb Lake, Barry County 2017 CLMP Results

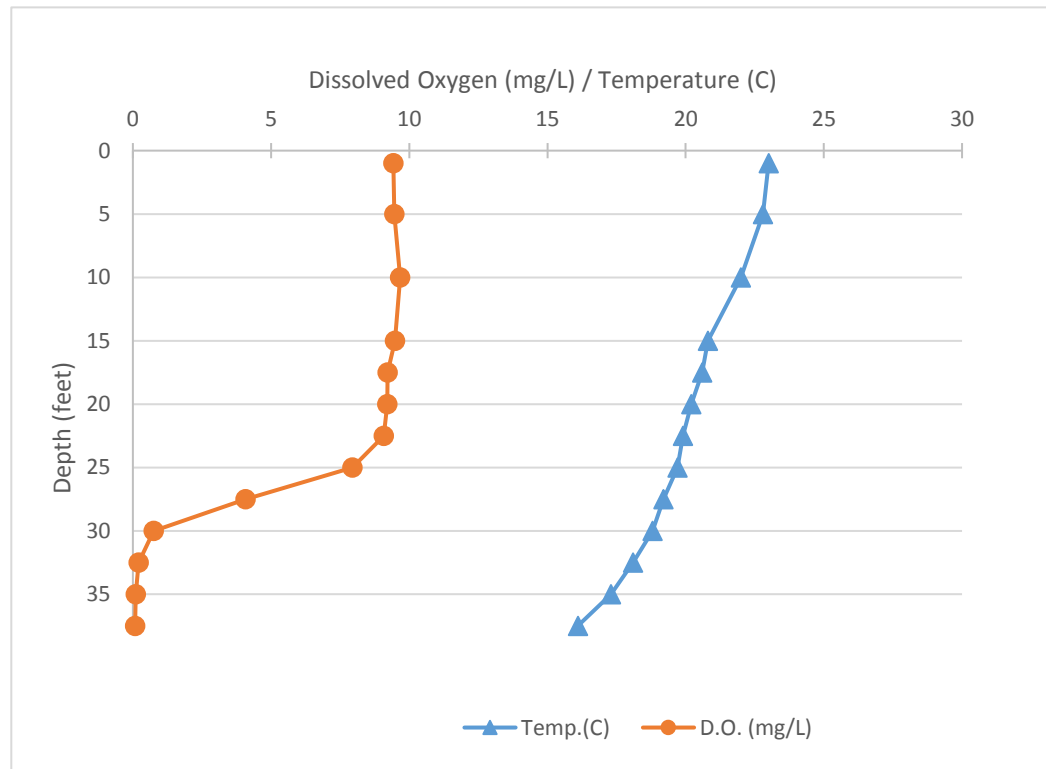
9/17/2017

### Dissolved Oxygen and Temperature Profile

Depth (ft)	Temp.(C)	D.O. (mg/L)
1	23	9.43
5	22.8	9.46
10	22	9.67
15	20.8	9.48
17.5	20.6	9.22
20	20.2	9.2
22.5	19.9	9.08
25	19.7	7.94
27.5	19.2	4.07
30	18.8	0.75
32.5	18.1	0.21
35	17.3	0.11
37.5	16.1	0.08
