**2017 Data Report
for
Diamond Lake, Cass County**

Site ID: 140039

Diamond Lake, Cass County 2017 CLMP Results

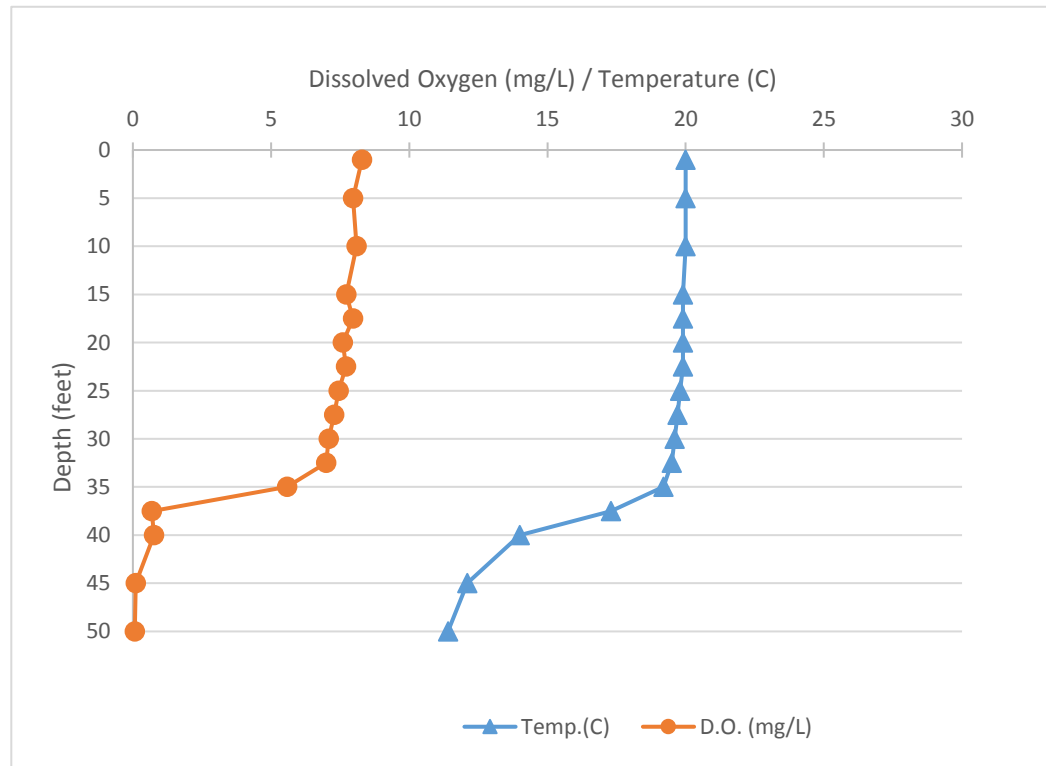
Name: Diamond Lake
 County: Cass
 Site ID: 140039
 Date: 9/13/2017

Depth (ft)	Temp.(C)	D.O. (mg/L)
1	20	8.29
5	20	7.97
10	20	8.09
15	19.9	7.72
17.5	19.9	7.96
20	19.9	7.59
22.5	19.9	7.71
25	19.8	7.45
27.5	19.7	7.28
30	19.6	7.09
32.5	19.5	6.99
35	19.2	5.58
37.5	17.3	0.68
40	14	0.77
45	12.1	0.1
50	11.4	0.07
