**2017 Data Report  
for  
Lake Diane, Hillsdale County**

Site ID: 300173

# Lake Diane, Hillsdale County 2017 CLMP Results

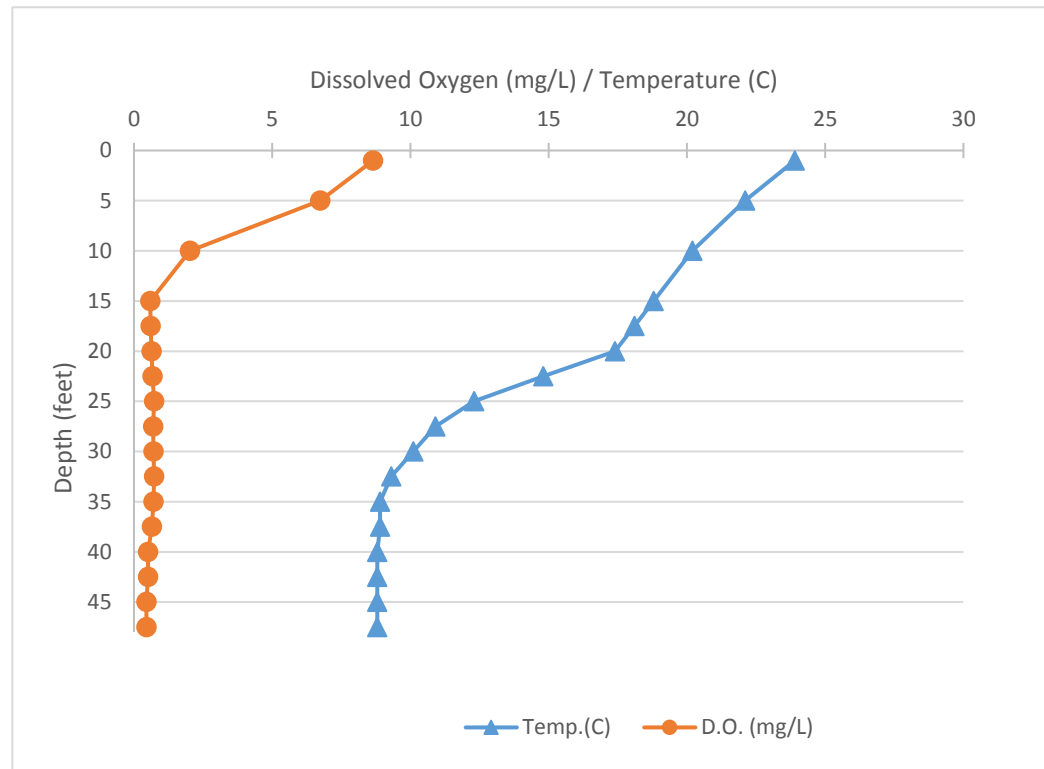
9/16/2017

### Dissolved Oxygen and Temperature Profile

Depth (ft)	Temp.(C)	D.O. (mg/L)
1	23.9	8.65
5	22.1	6.74
10	20.2	2.03
15	18.8	0.59
17.5	18.1	0.6
20	17.4	0.64
22.5	14.8	0.67
25	12.3	0.73
27.5	10.9	0.69
30	10.1	0.71
32.5	9.3	0.73
35	8.9	0.7
37.5	8.9	0.65
40	8.8	0.51
42.5	8.8	0.51
45	8.8	0.45
47.5	8.8	0.45
