2017 Data Report for First Fortune Lake, Iron County

Site ID: 360080

First Fortune Lake, Iron County 2017 CLMP Results

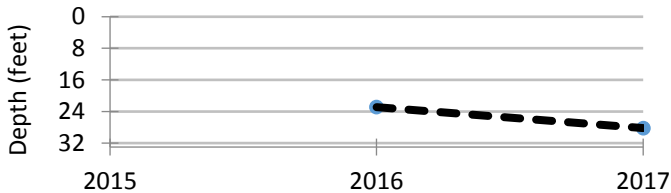
Secchi Disk Transparency (feet)

Year	# Readings	Min	Max	Average	Std. Dev	Carlson TSI
2017	10	21.0	39.5	28.2	6.7	29
2016	14	18.0	31.5	28.2	3.7	32

2017 All CLMP Lakes	2949	1.0	52.0	12.3	2.7	43
---------------------	------	-----	------	------	-----	----

The CLMP Leadership Team is made of: Marcy Knoll Wilmes, Jean Roth, Jo Latimore, Paul Steen, Scott Brown, Laura Kaminski, and Michele Leduc-Lapierre

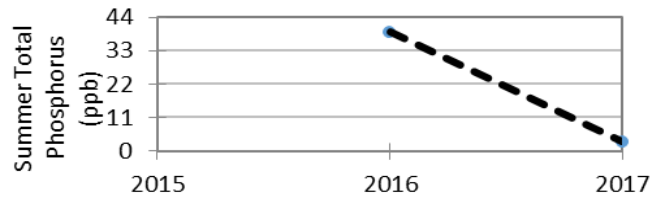
Summer Phosphorus (parts per billion)

Year	# Samples	Min	Max	Average	Std. Dev	Carlson TSI
2017	1	<=3 W	<=3 W	<=3 W	NA	<27
2016	1	39.0	39.0	39.0	NA	57

2017 All CLMP Lakes	208	<= 3	52.0	11.1	8.4	39
---------------------	-----	------	------	------	-----	----

There is too little data to assess long term trends. CLMP recommends eight years of consistent monitoring in order to develop a strong data baseline. Clearly, the phosphorus measurement was much lower in 2017 than in 2016; which is interesting, and perhaps the lead volunteer could provide explanation for this difference. Was 2016 taken during an algae bloom?

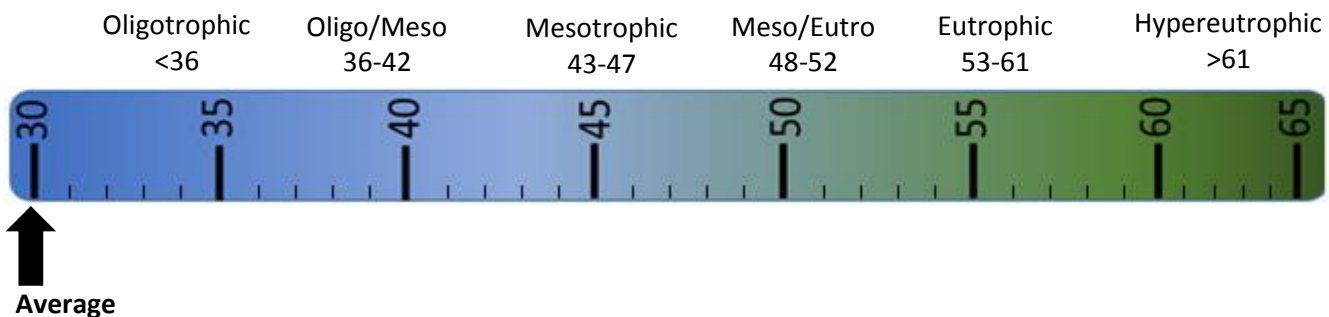
TSI for First Fortune Lake in 2017	
Average	28
Secchi Disk	29
Summer TP	<27
Chlorophyll-a

In 1977, limnologist Dr. Robert Carlson developed a numerical scale (0-100) where the numbers indicate the level of nutrient enrichment. Using the proper equations, we can convert results from Summer Total Phosphorus, Secchi Depth, and Chlorophyll-a to this Trophic Status Index (TSI). The TSI numbers are furthermore grouped into general categories (oligotrophic, mesotrophic, eutrophic, and hypereutrophic), to quickly give us a way to understand the general nutrient level of any lake.

The tables below give the results-to-TSI conversions for the water quality data ranges normally seen in the CLMP. The formulas for this conversion can be found in the CLMP manual (<https://micorps.net/wp-content/uploads/CLMP-Manual.pdf>).

With an average TSI score of 28 based on 2017 Secchi transparency and summer total phosphorus data, this lake is rated as an oligotrophic lake.

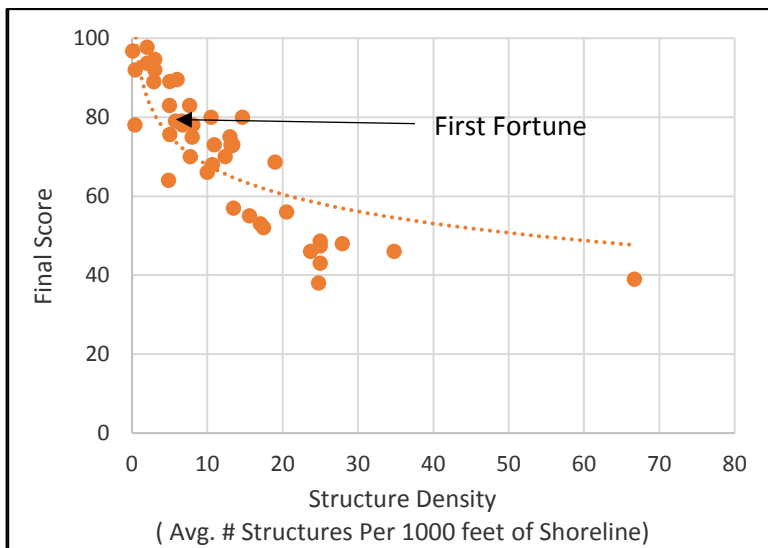
How does your lake compare to others in the program?

First Fortune Lake:	
Number of Sections:	18
Number of Structures:	121
Structure Density:	6.7
Final Score:	78

All 42 Participating Lakes from 2015-2018:	
Avg. Number of Sections:	16.3
Avg. Number of Structures:	248.5
Avg. Structure Density:	15.2
Avg. Final Score:	70.5

There is a very tight relationship between Final Score and Structure Density. It will be interesting to see if and how this changes as more lakes go through this scoring process.

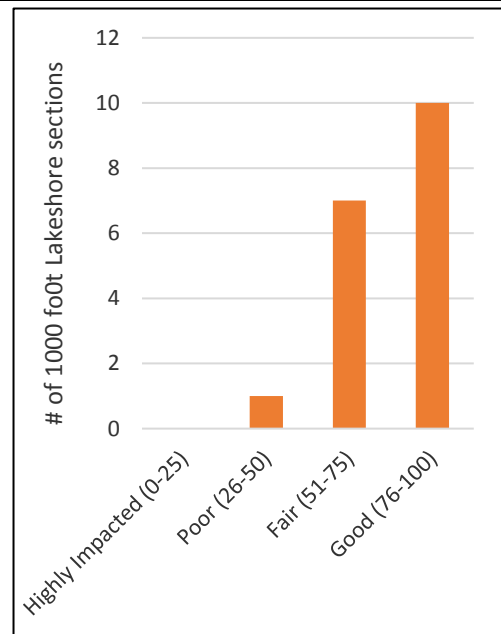
Overall, the lakeshore habitat of First Fortune Lake is doing well, with all of the 1000 foot sections scoring Poor through Good: 1 poor, 7 fair, and 10 good.

The sections scored highest for erosion control, with an average of 85.6, meaning that there is a low amount of sea walls and other shoreline erosion structures.

In terms of possible improvements, consider section 3, the only section on this lake to score a poor with a score of 49. The worst part of section 3 was the riparian zone, which could be improved by reducing the amount of mowed grass and increasing the amount of unmowed vegetation along the lakeshore.

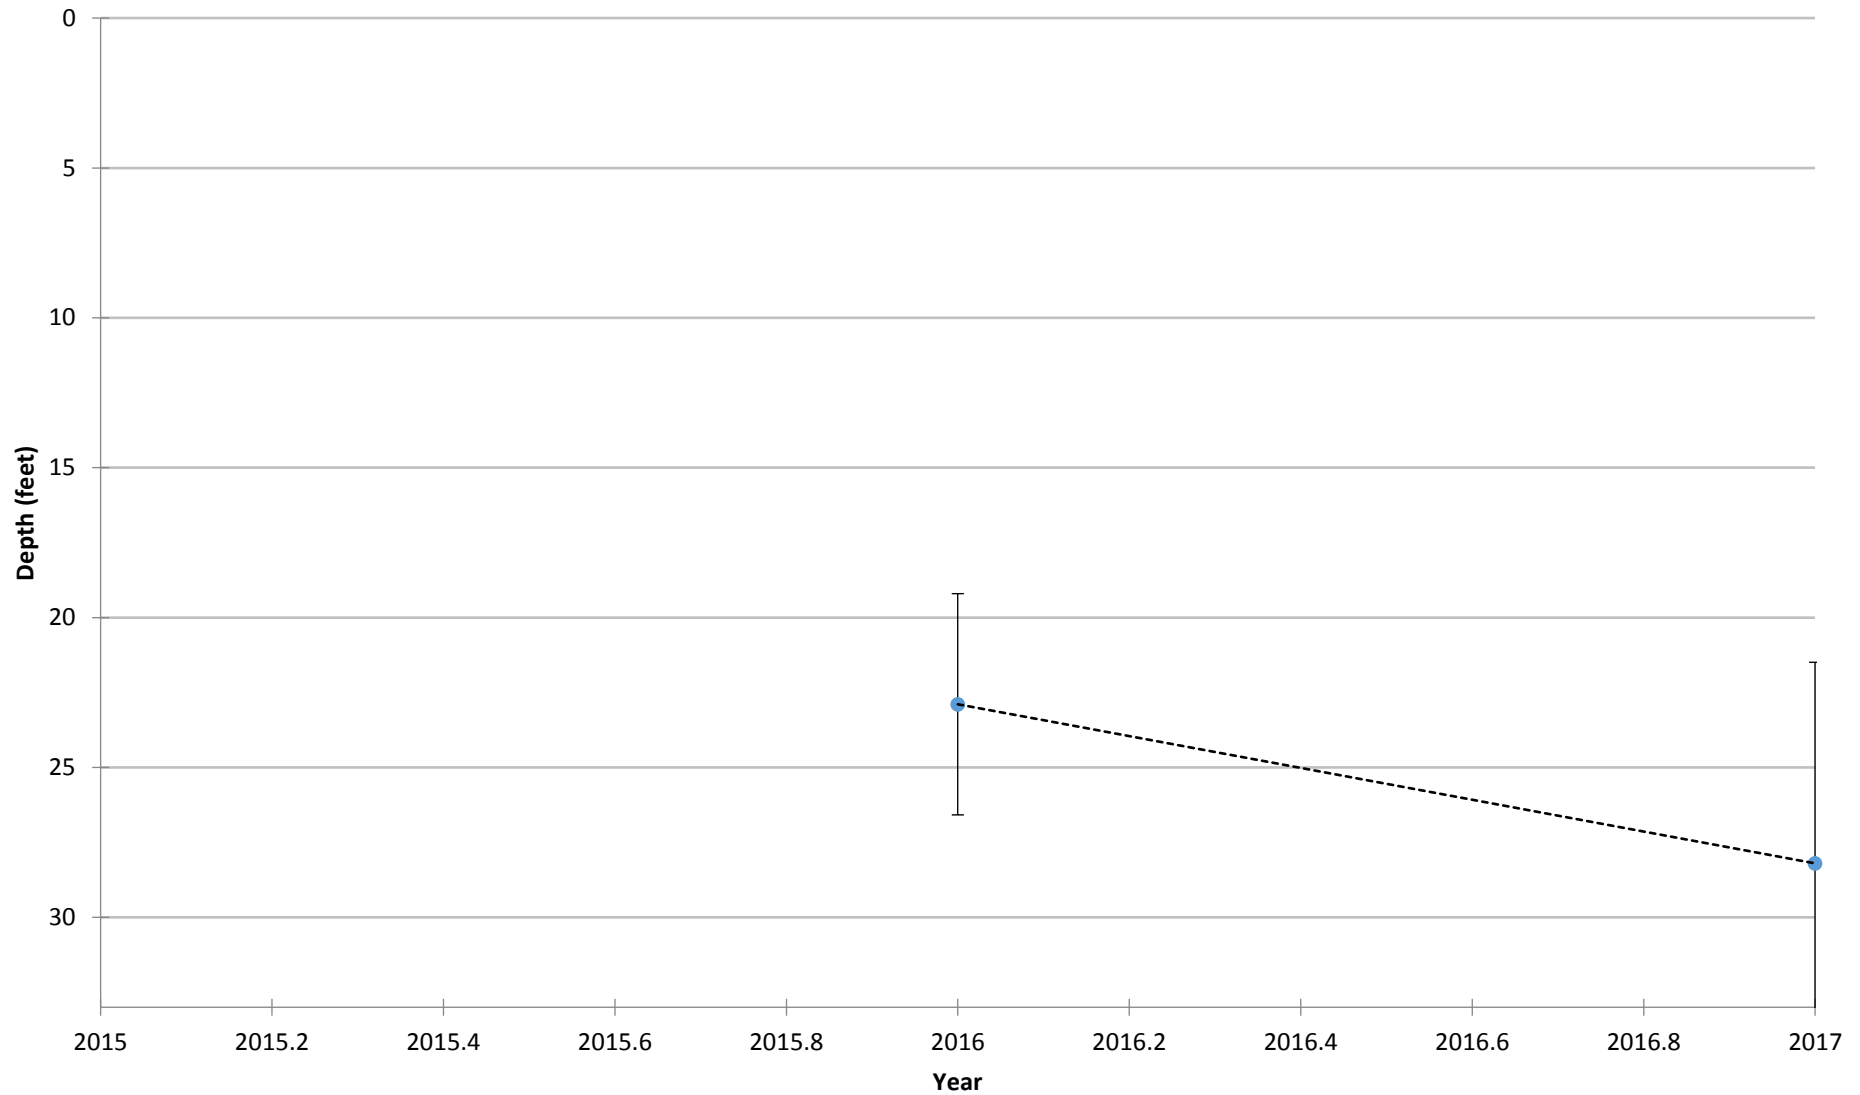
COOPERATIVE LAKES MONITORING PROGRAM
SUMMER MEAN TRANSPARENCY

First Fortune Lake (Iron Co.), 360080

Vertical bars indicate standard deviation

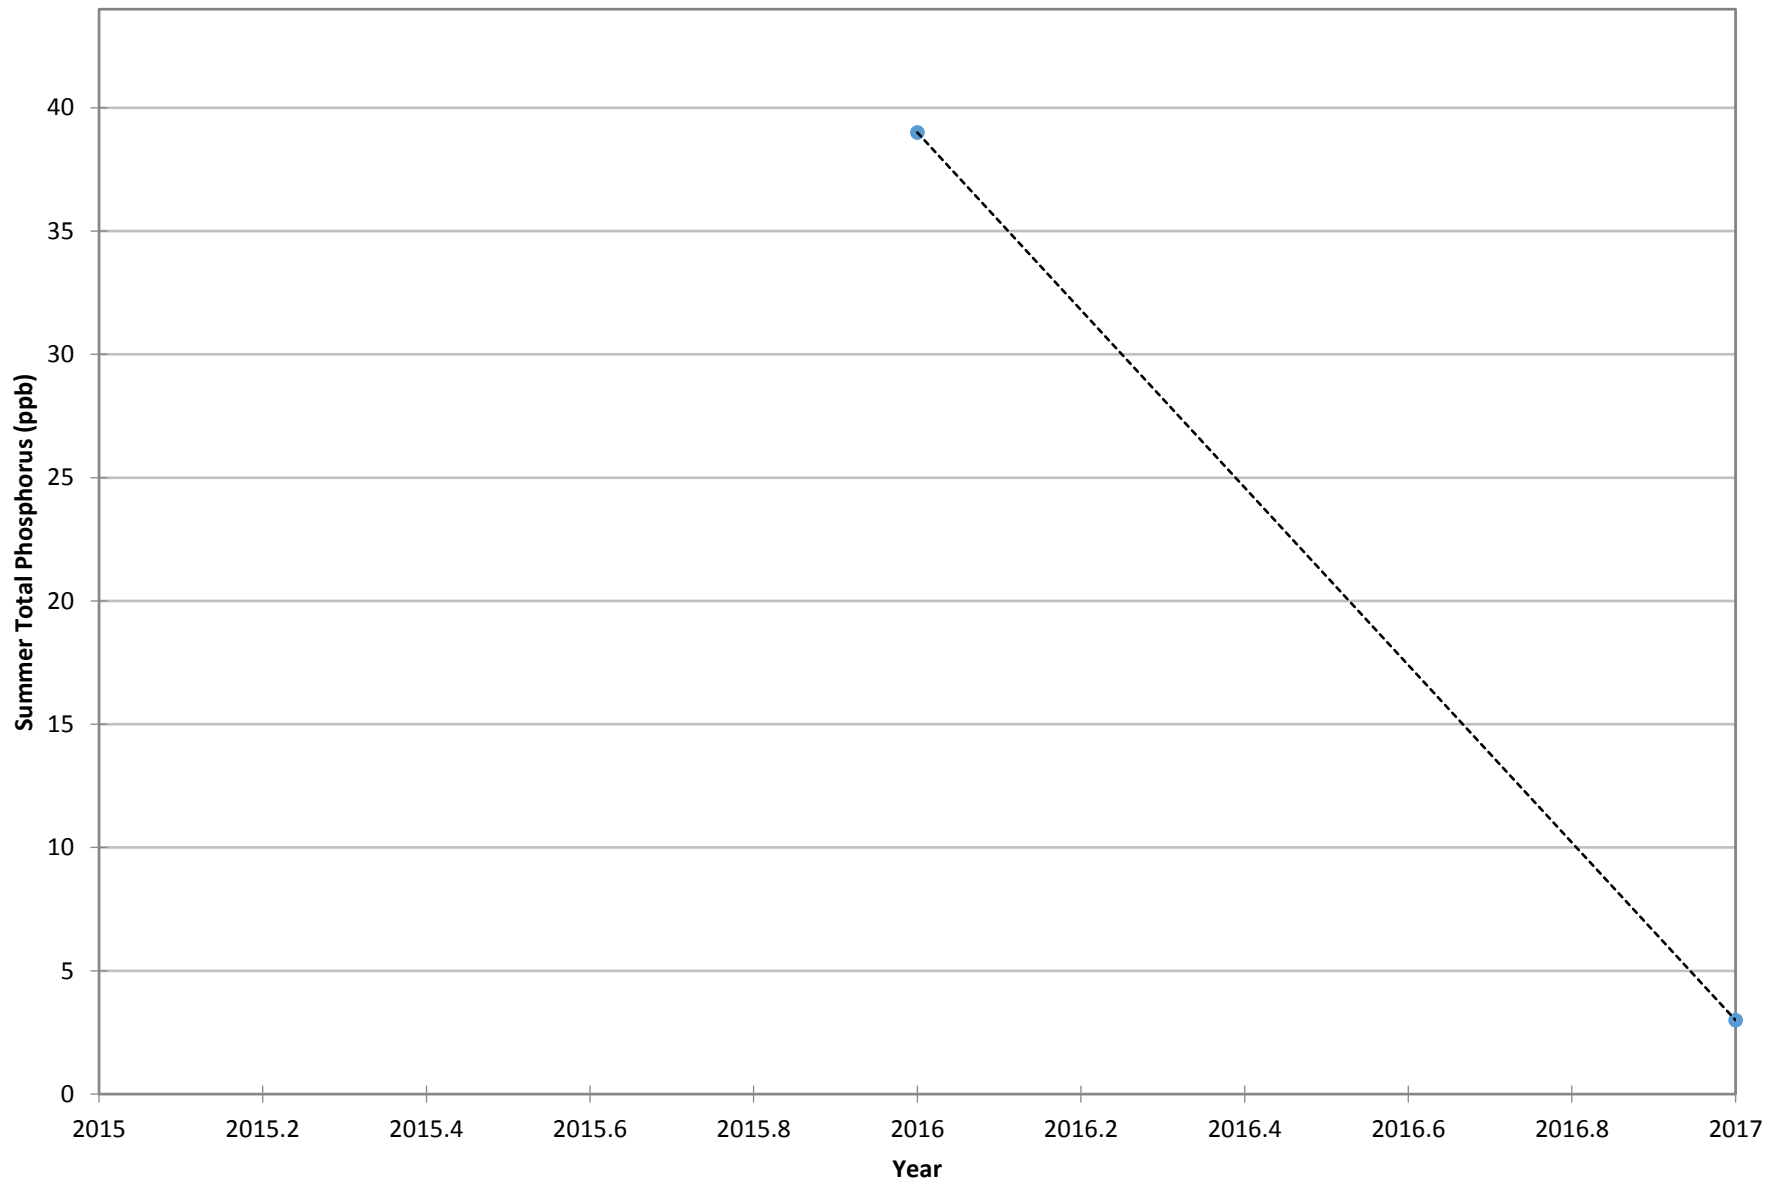
COOPERATIVE LAKES MONITORING PROGRAM
SUMMER TOTAL PHOSPHORUS

First Fortune Lake (Iron Co.), 360080
