# 2017 Data Report for

# Lower Hamlin Lake, Mason County

Site ID: 530073

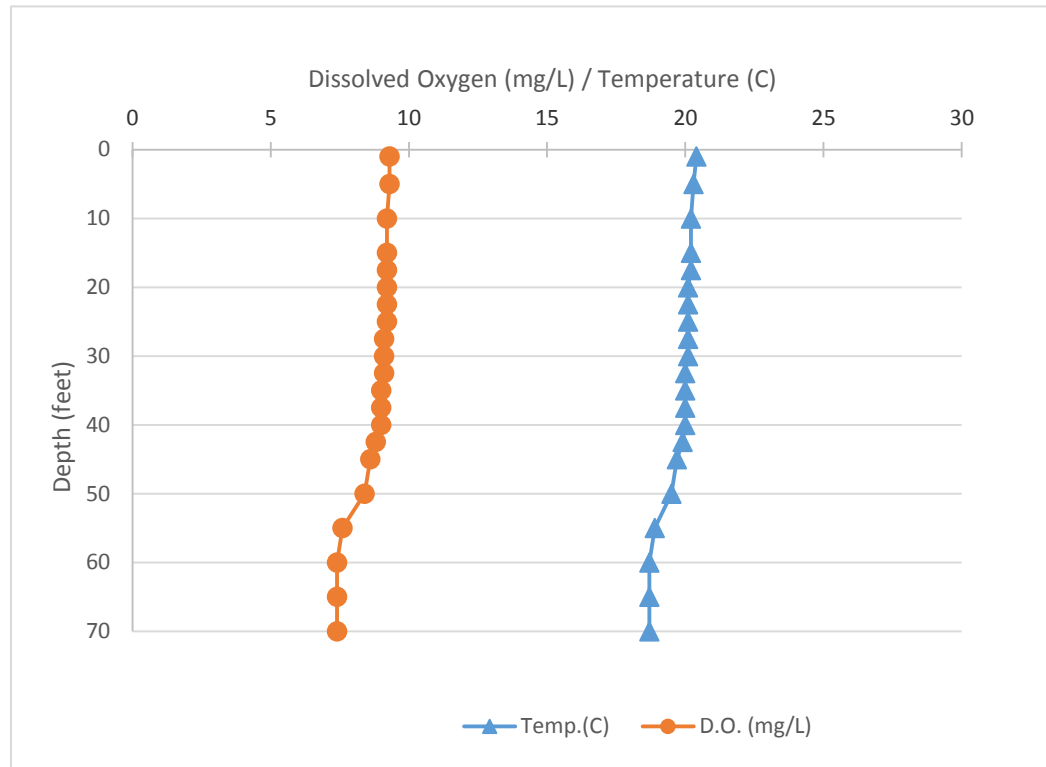
9/15/2017

Depth (ft)	Temp.(C)	D.O. (mg/L)
1	20.4	9.3
5	20.3	9.3
10	20.2	9.2
15	20.2	9.2
17.5	20.2	9.2
20	20.1	9.2
22.5	20.1	9.2
25	20.1	9.2
27.5	20.1	9.1
30	20.1	9.1
32.5	20	9.1
35	20	9
37.5	20	9
40	20	9
42.5	19.9	8.8
45	19.7	8.6
50	19.5	8.4
55	18.9	7.6
60	18.7	7.4
65	18.7	7.4
70	18.7	7.4
