2017 Data Report for

Upper Hamlin Lake, Mason County

Site ID: 530074

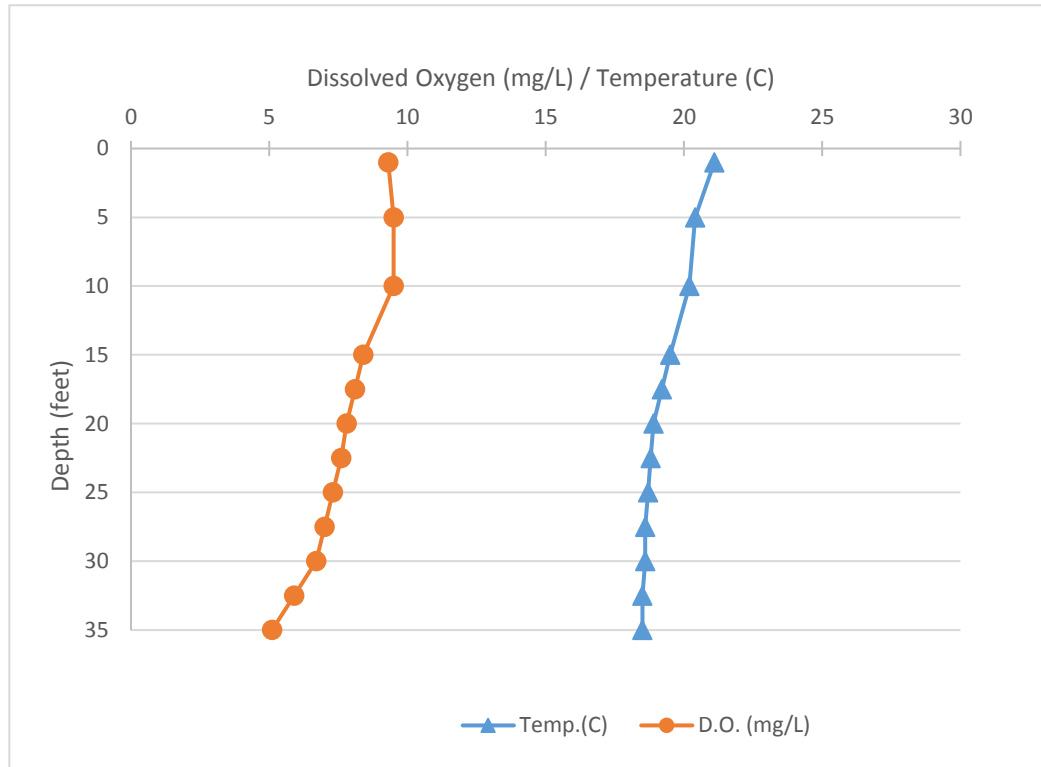
9/15/2017

Depth (ft)	Temp.(C)	D.O. (mg/L)
1	21.1	9.3
5	20.4	9.5
10	20.2	9.5
15	19.5	8.4
17.5	19.2	8.1
20	18.9	7.8
22.5	18.8	7.6
25	18.7	7.3
27.5	18.6	7
30	18.6	6.7
32.5	18.5	5.9
35	18.5	5.1
