2017 Data Report for Lower Herring Lake, Benzie County

Site ID: 100085

Lower Herring Lake, Benzie County 2017 CLMP Results

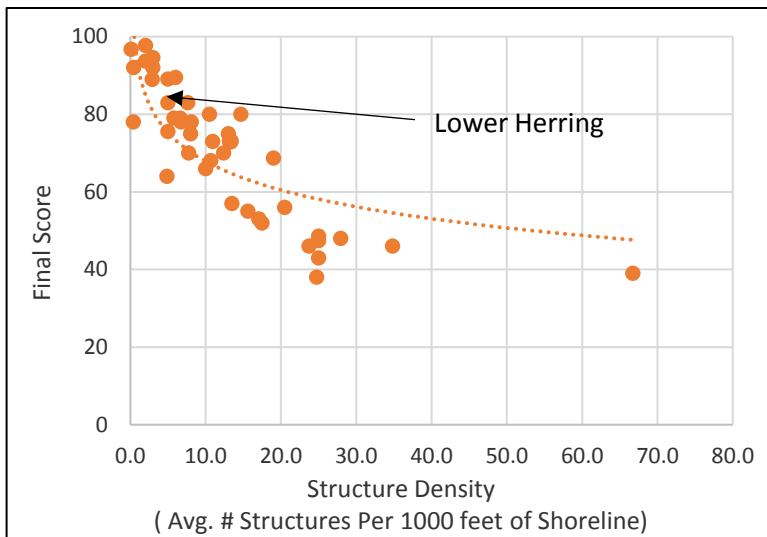
How does your lake compare to others in the program?

Lower Herring Lake:	
Number of Sections:	22
Number of Structures:	168
Structure Density:	7.6
Final Score:	83

All 42 Participating Lakes from 2015-2018:	
Avg. Number of Sections:	16.3
Avg. Number of Structures:	248.5
Avg. Structure Density:	15.2
Avg. Final Score:	70.5

There is a very tight relationship between Final Score and Structure Density. It will be interesting to see if and how this changes as more lakes go through this scoring process.

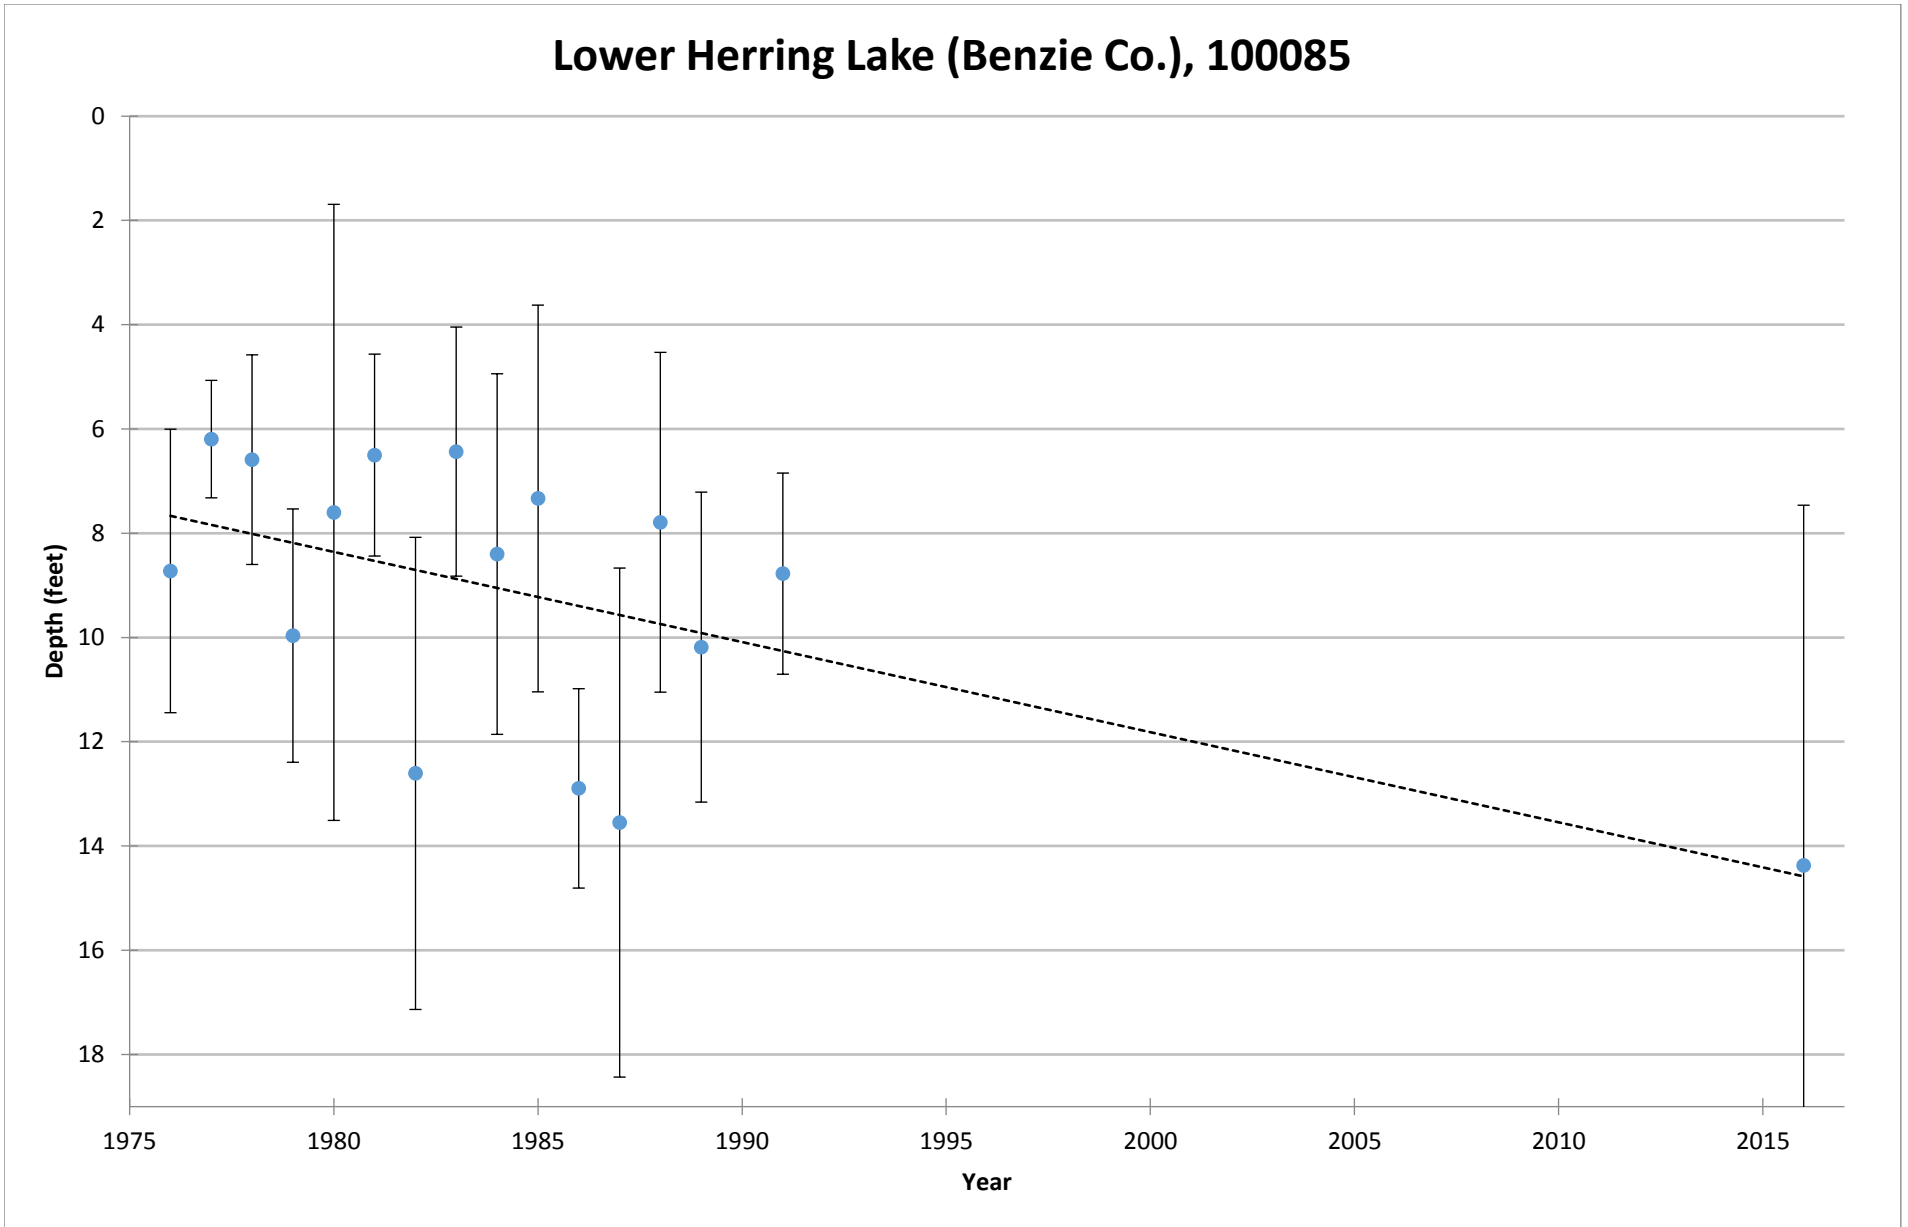
COOPERATIVE LAKES MONITORING PROGRAM
SUMMER MEAN TRANSPARENCY

Lower Herring Lake (Benzie Co.), 100085

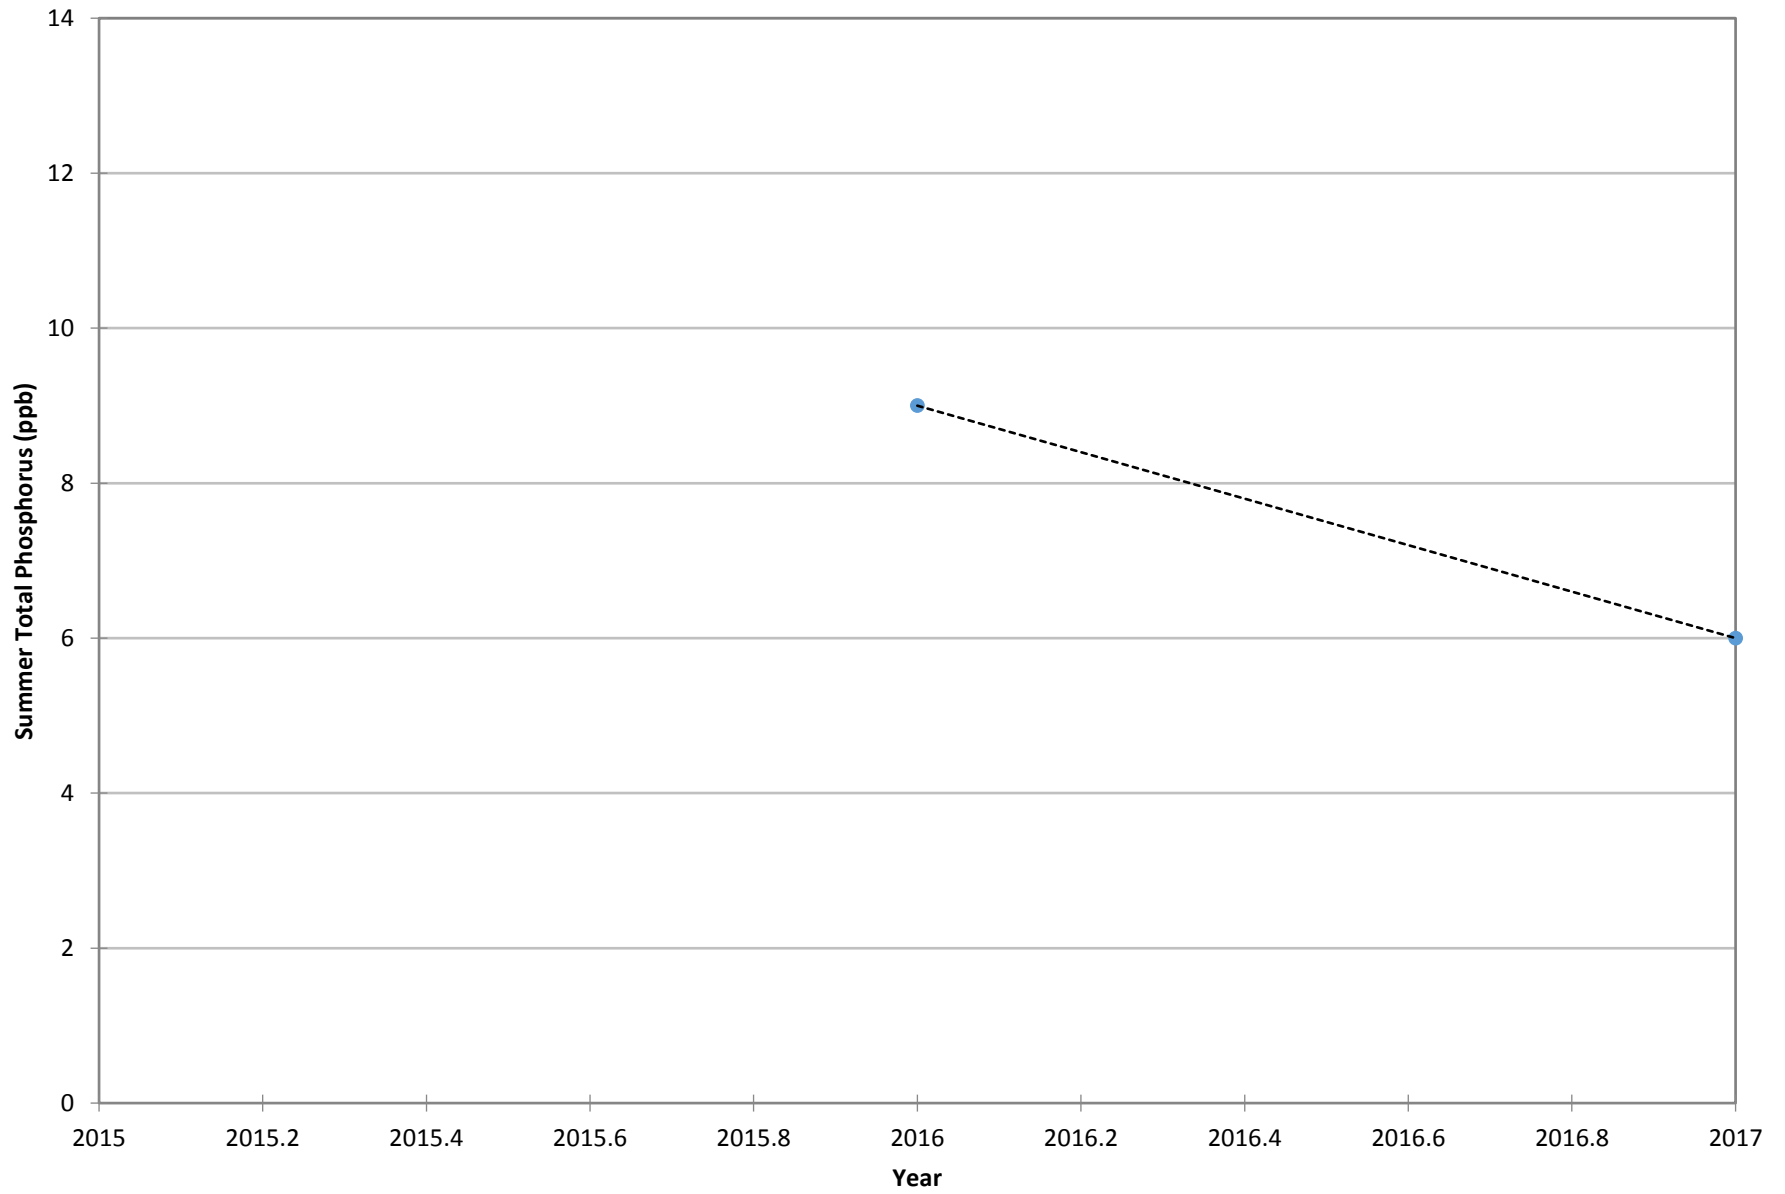
COOPERATIVE LAKES MONITORING PROGRAM
SUMMER TOTAL PHOSPHORUS

Lower Herring Lake (Benzie Co.), 100085

There is too little data to assess short term trends. However, the trend based on historical data shows a lake that has become much more nutrient-poor over time.
