2017 Data Report for Lake Lancer, Gladwin County

Site ID: 260116

Lake Lancer, Gladwin County 2017 CLMP Results

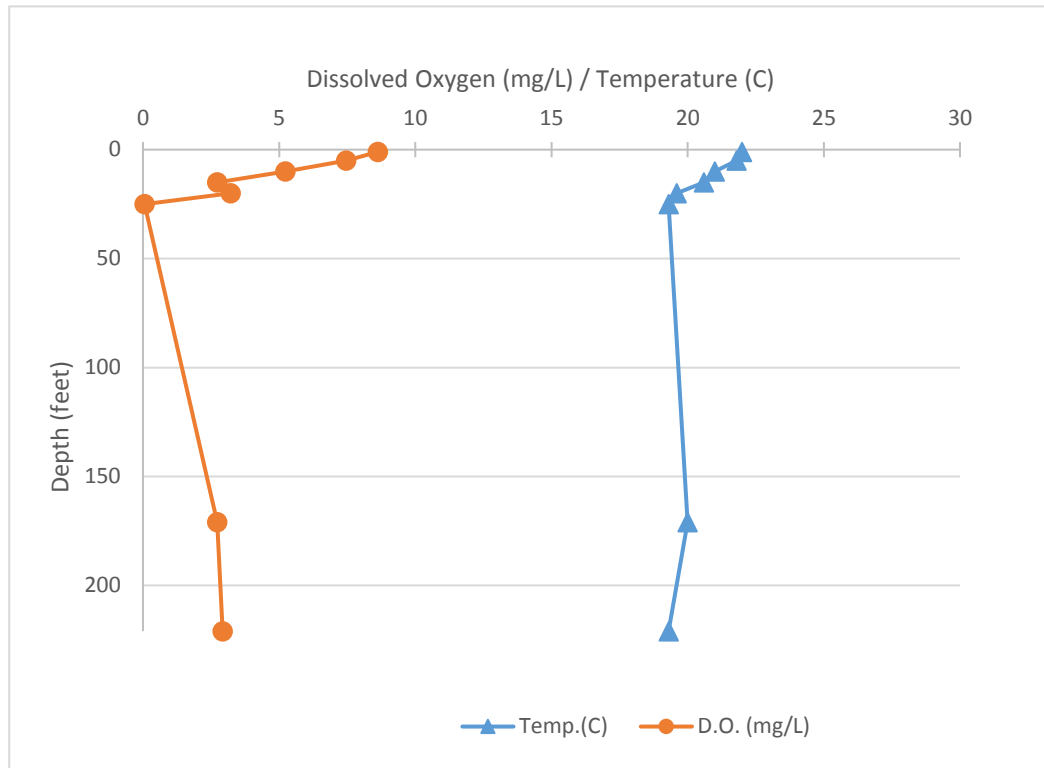
8/29/2017

Dissolved Oxygen and Temperature Profile

Depth (ft)	Temp.(C)	D.O. (mg/L)
1	22	8.63
5	21.8	7.46
10	21	5.23
15	20.6	2.73
20	19.6	3.22
25	19.3	0.06
171	20	2.73
221	19.3	2.93
