**2017 Data Report
for
List Lake, Lake County**

Site ID: 430636

List Lake, Lake County 2017 CLMP Results

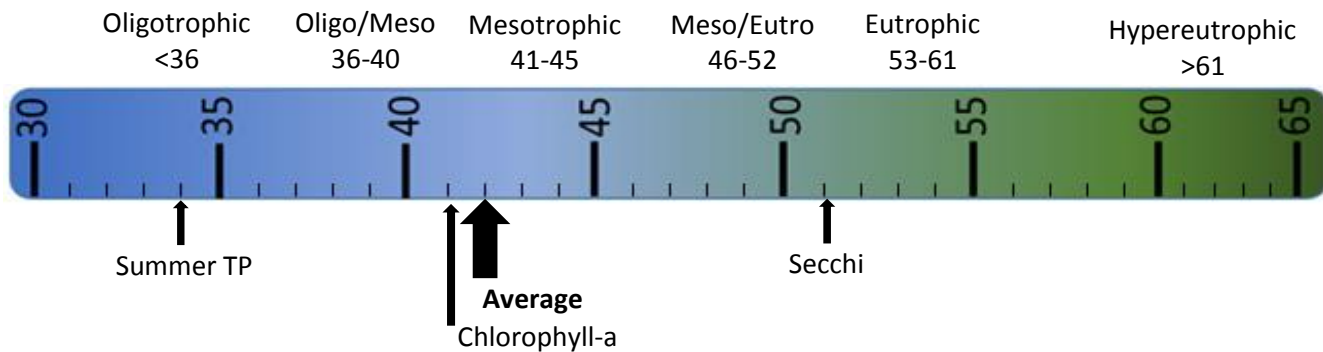
With an average TSI score of 42 based on 2017 Secchi transparency, chlorophyll-a, and summer total phosphorus data, this lake is rated as a mesotrophic lake.

TSI for List Lake in 2017	
Average	42
Secchi Disk	51
Summer TP	34
Chlorophyll-a	41

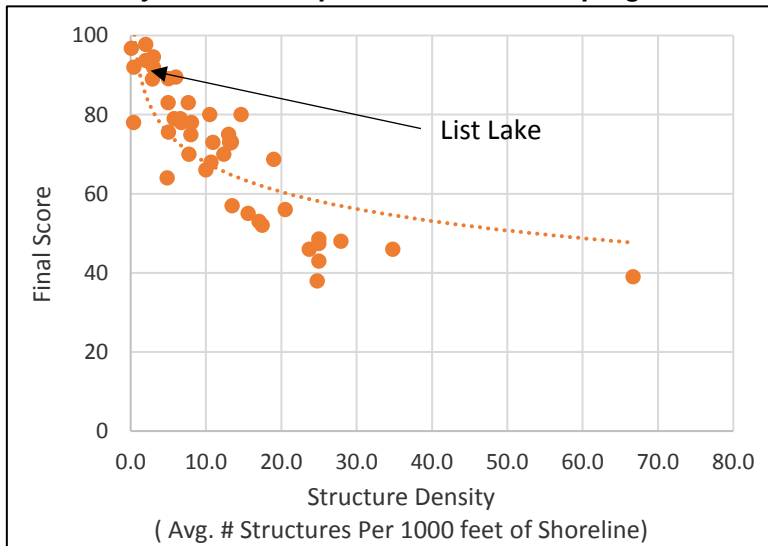
How does your lake compare to others in the program?

List Lake:	
Number of Sections:	3
Number of Structures:	6
Structure Density:	2
Final Score:	94

All 42 Participating Lakes from 2015-2018:	
Avg. Number of Sections:	16.3
Avg. Number of Structures:	248.5
Avg. Structure Density:	15.2
Avg. Final Score:	70.5

There is a very tight relationship between Final Score and Structure Density. It will be interesting to see if and how this changes as more lakes go through this scoring process.

Overall, the lakeshore habitat of List Lake is nearly pristine. It has scored much higher than average when compared to other lakes in the program. All 3 of the 1000 foot sections scored Good (highest category possible).

There is not much room for improvement in the lakeshore habitat. Maintaining it is the most important thing residents or managers can do. Keep mowed grass to a minimum; maximize native plants. Prevent rip-rap and seawalls from being placed on the shoreline; and don't remove woody debris that falls into the water.

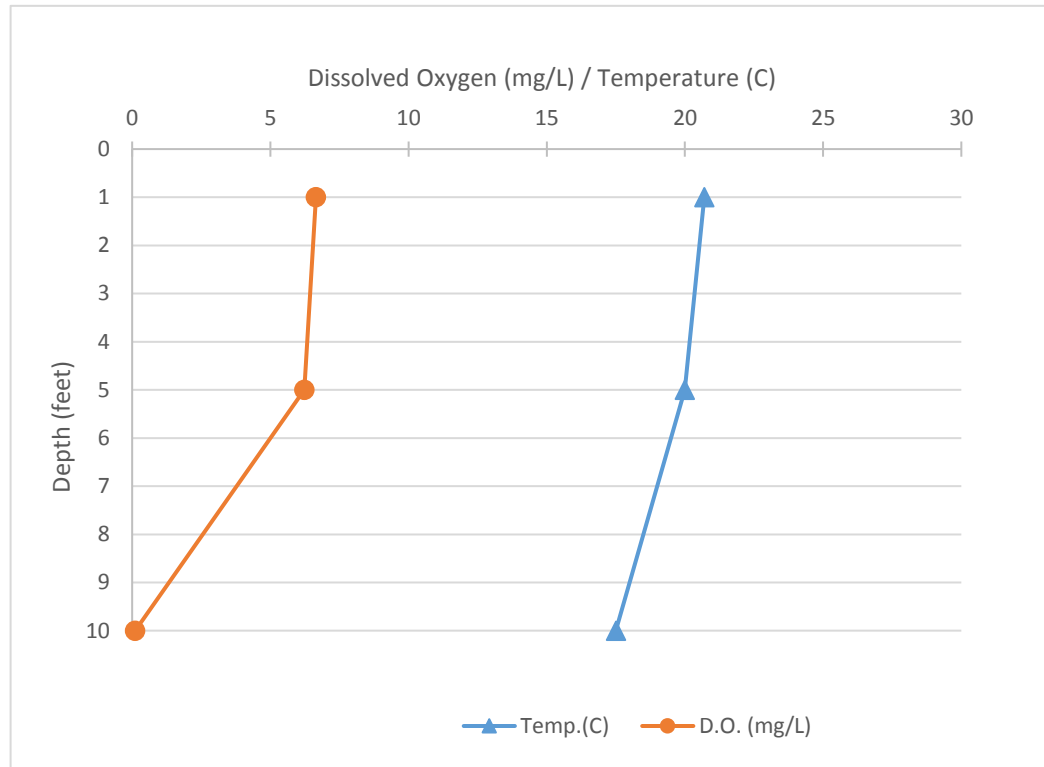
9/7/2017

Depth (ft)	Temp.(C)	D.O. (mg/L)
1	20.7	6.65
5	20	6.23
10	17.5	0.11
