2017 Data Report for

Perrin Lake, St. Joseph County

Site ID: 750314

2017 CLMP Results

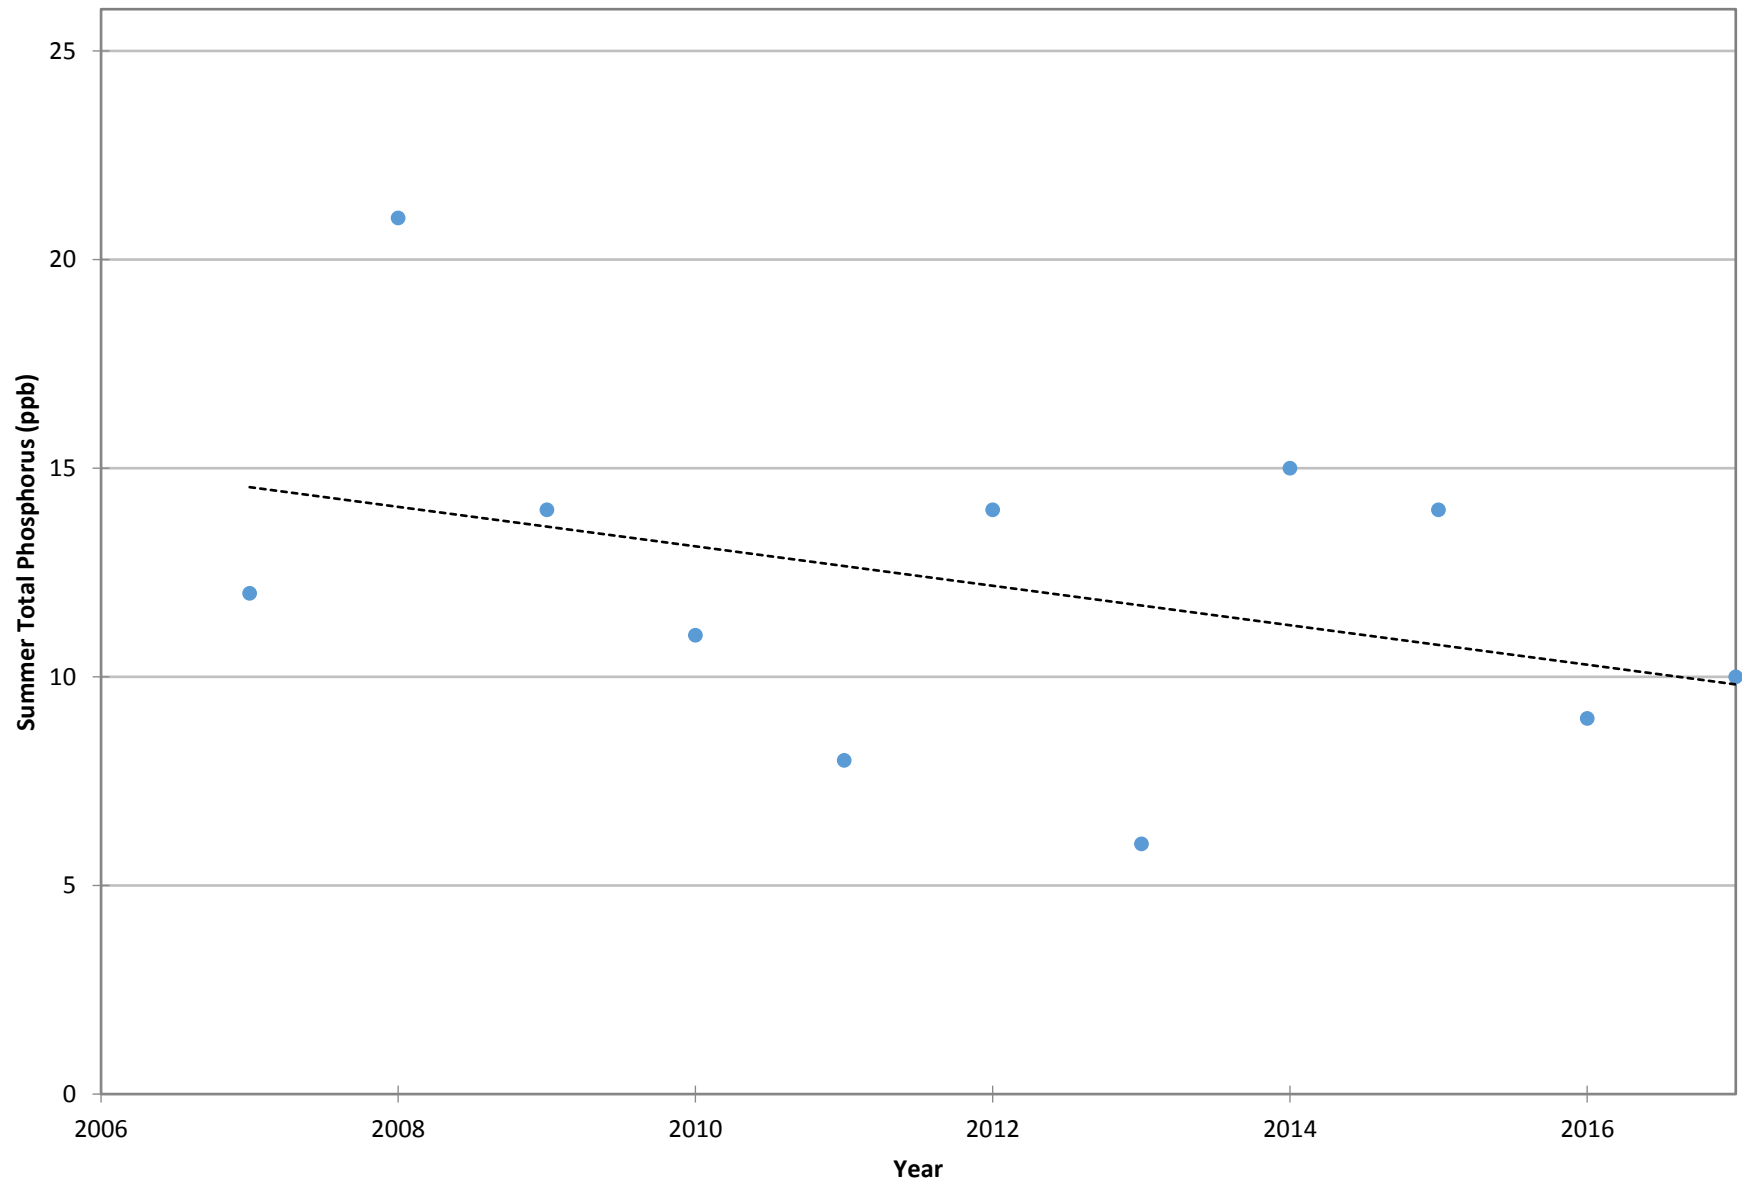
COOPERATIVE LAKES MONITORING PROGRAM
SUMMER TOTAL PHOSPHORUS

Perrin Lake (St. Joseph Co.), 750314
