2017 Data Report for Sanford Lake, Midland County

Site ID: 560169

Sanford Lake, Midland County 2017 CLMP Results

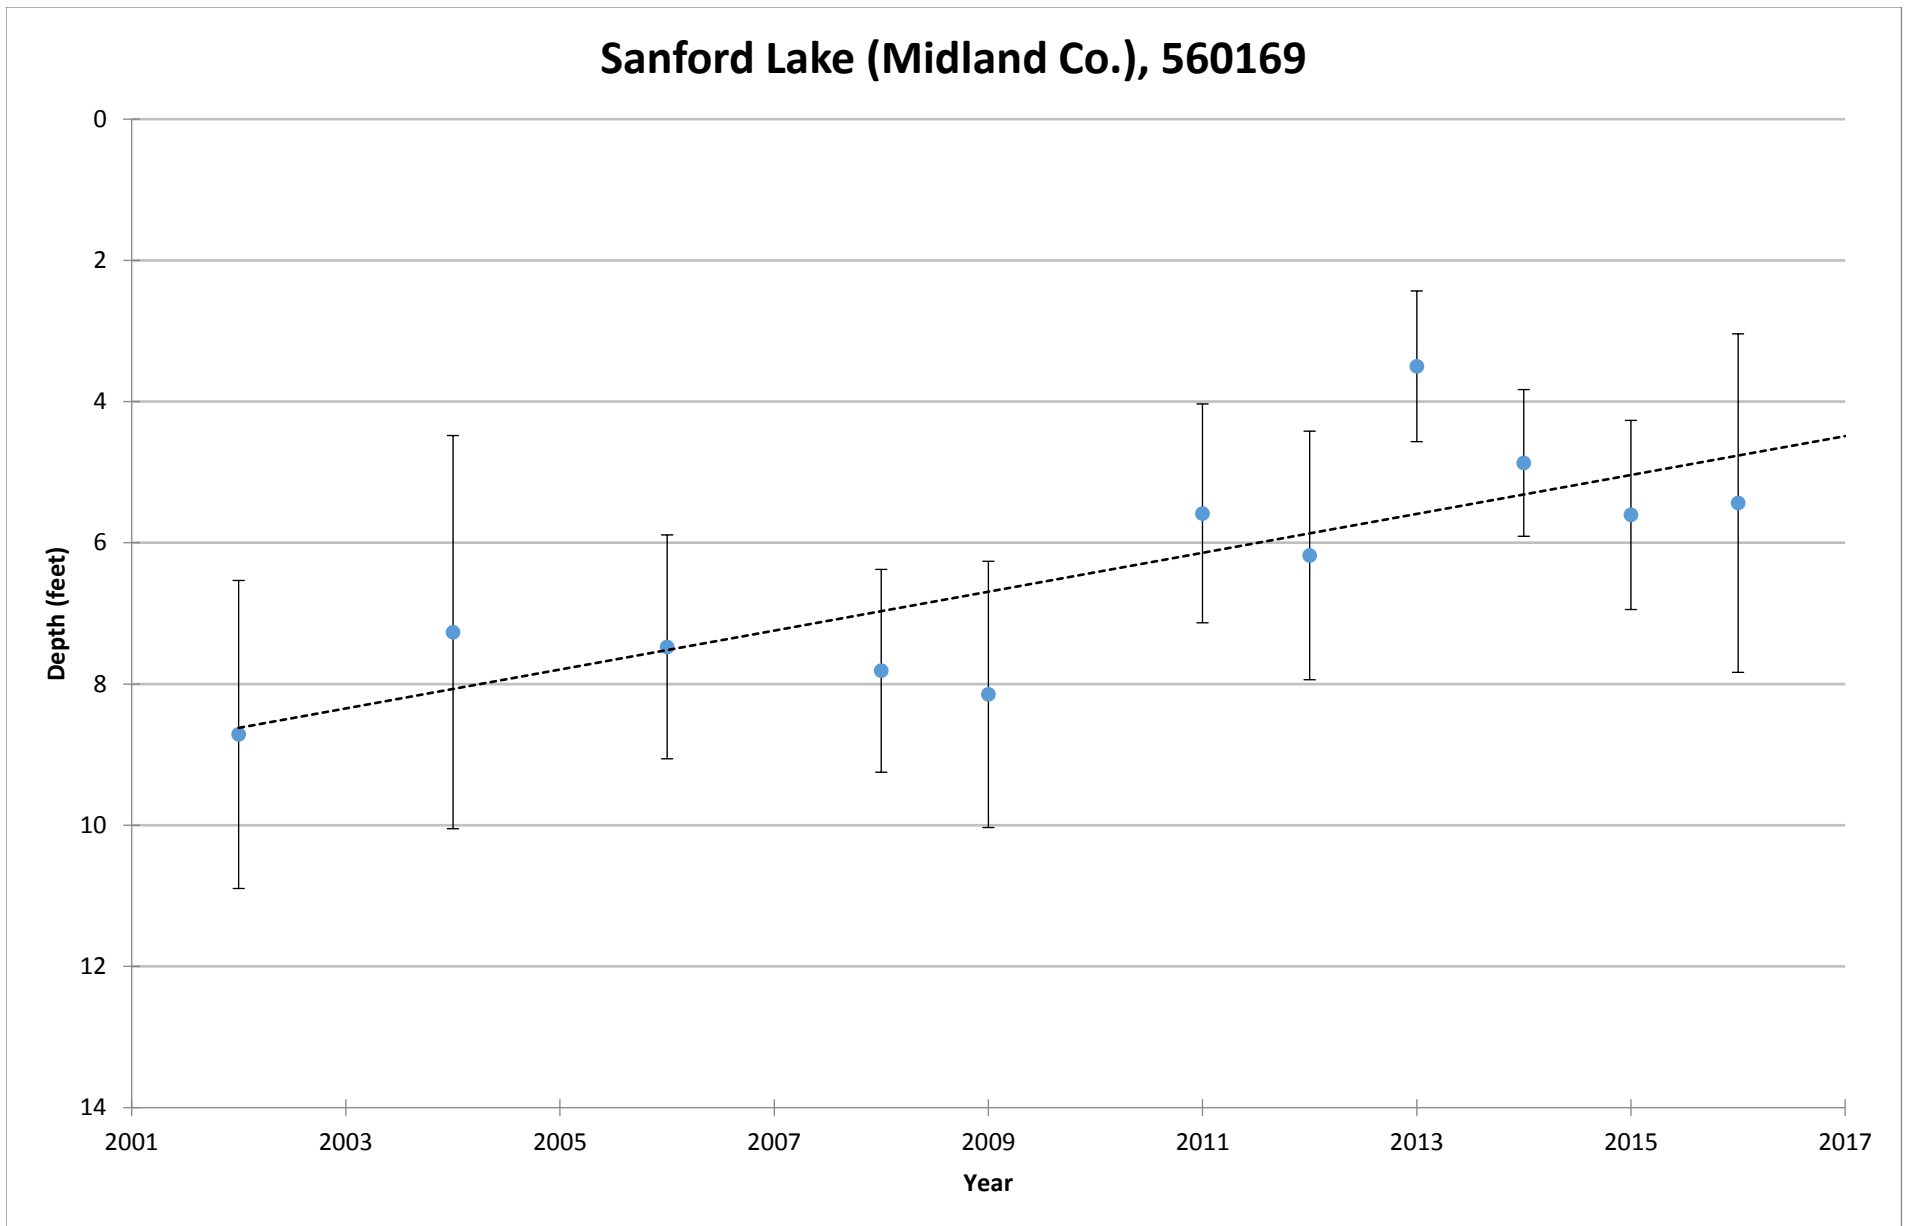
COOPERATIVE LAKES MONITORING PROGRAM
SUMMER MEAN TRANSPARENCY

Sanford Lake (Midland Co.), 560169

Vertical bars indicate standard deviation

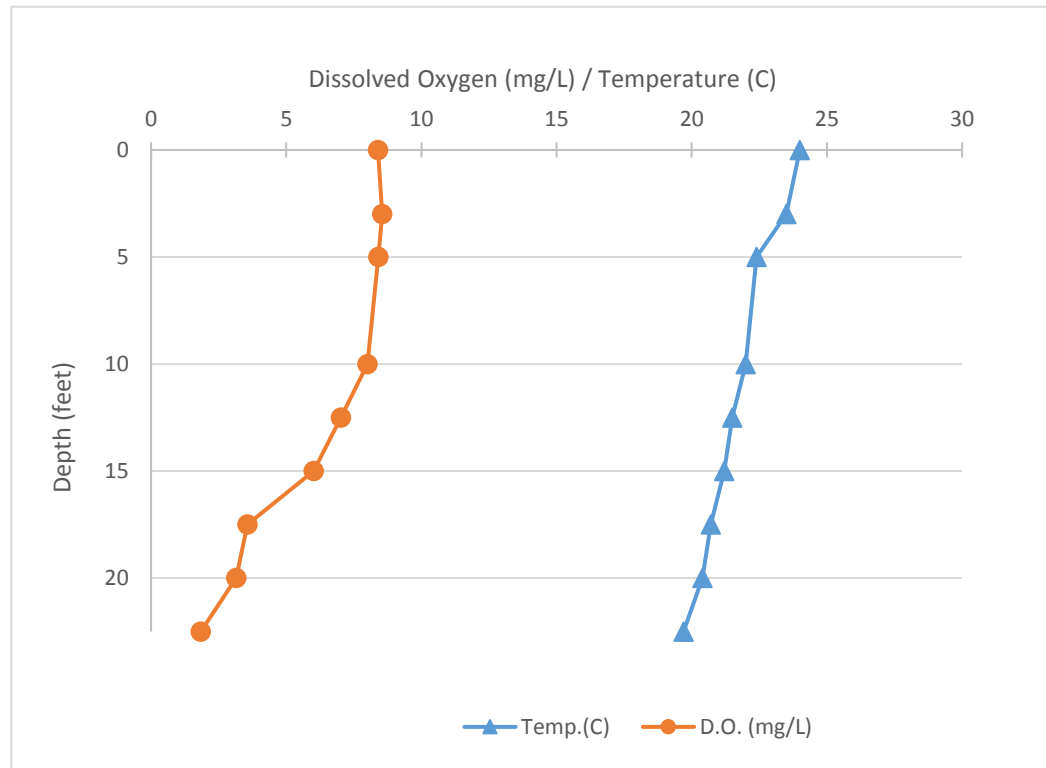
Dissolved Oxygen and Temperature Profile

Name: Sanford Lake
County: Midland
Site ID: 560169
Date: 9/22/2017

Depth (ft)	Temp.(C)	D.O. (mg/L)
0	24	8.4
3	23.5	8.55
5	22.4	8.41
10	22	8
12.5	21.5	7.02
15	21.2	6.01
17.5	20.7	3.56
20	20.4	3.15
22.5	19.7	1.84
